HELEN
E-2011

E-BUTT

HOMER CITY MINE
HELEN MINING COMPANY
ID-3600926
SCALE: 1 INCH = 50 FEET

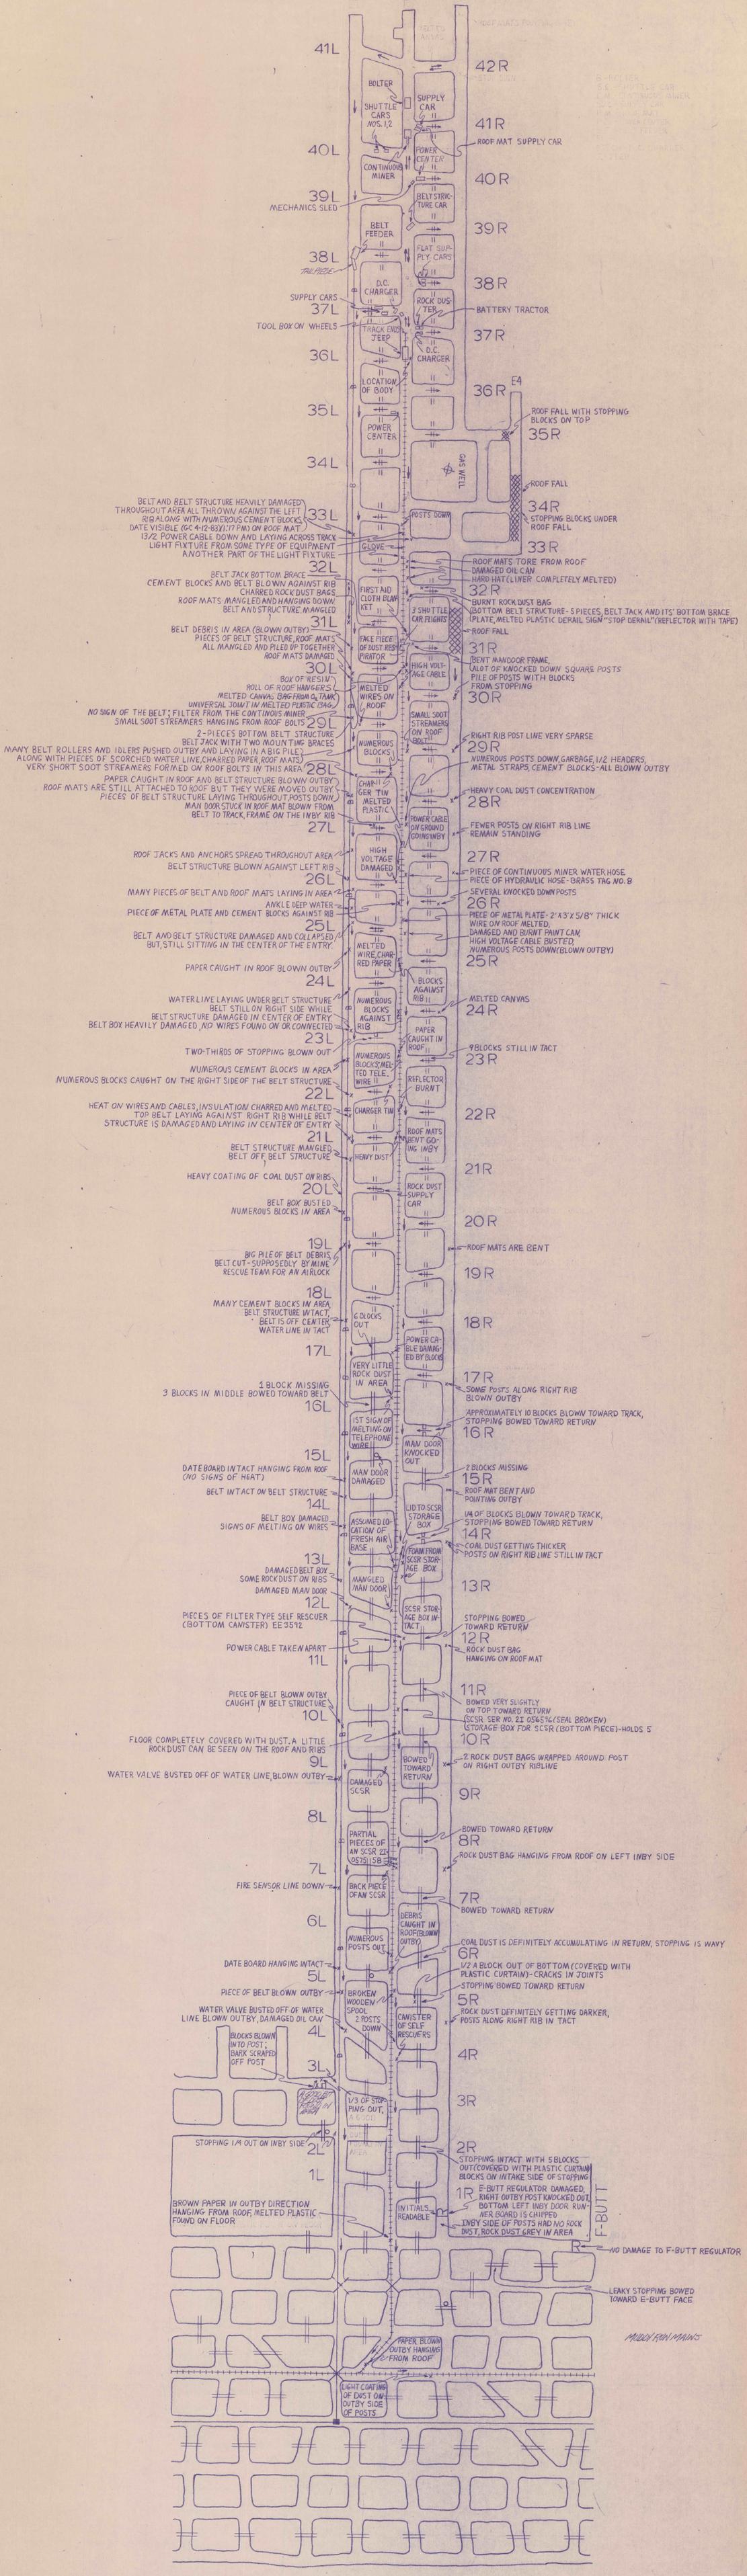
MECHANICS SLED
BOLT
SHUTTLE CARS NOS. 12
CONTINUOUS MINER
BOLT FEEDER
D.C. CHARGER
SUPPLY CARS
TOOL BOX ON WHEELS
TRACK END JEEP
LOCATION OF BODY
POWER CENTER
GAS WELL
ROCK DUST
BATTERY TRACTOR
D.C. CHARGER
ROOF MAT SUPPLY CAR
BOLT FEEDER
FLAT SUPPLY CARS
BOLT FEEDER
ROOF MAT SUPPLY CAR
ROOF FALL WITH STOPPING BLOCKS ON TOP
ROOF FALL
STOPPING BLOCKS UNDER ROOF FALL
ROOF MATS TORE FROM ROOF
DAMAGED OIL CAN
HARD HAT (LINER COMPLETELY MELTED)
BURNT ROCK DUST BAG
BOTTOM BELT STRUCTURE - 5 PIECES, BELT JACK AND ITS' BOTTOM BRACE (PLATE, MELTED PLASTIC DERAIL SIGN "STOP DERAIL" (REFLECTOR WITH TAPE)
BENT MAN DOOR FRAME
LADDER OF KNOCKED DOWN SQUARE POSTS
PILE OF POSTS WITH H BLOCKS FROM STOPPING
SMALL SOOT STREAMERS HANGING FROM ROOF BOLTS
NUMEROUS BLOCKS IN THIS AREA
CHAR-GER TIM MELTED PLASTIC
HIGH VOLTAGE CABLE ON GROUND GOING INBY
POWER CABLE ON ROOF MELTED
PIECE OF CONTINUOUS MINER WATER HOSE
PIECE OF HYDRAULIC HOSE - BRASS TAG NO. 8

SEVERAL KNOCKED DOWN POSTS
PIECE OF METAL PLATE - 2' X 3' X 5/8" THICK WIRE ON ROOF MELTED, DAMAGED AND BURNT PAINT CAN, HIGH VOLTAGE CABLE BUSTED, NUMEROUS POSTS DOWN (BLOWN OUTBY)
BLOCKS AGAINST RIB
PAPER CAUGHT IN ROOF BLOWN OUTBY
NUMEROUS BLOCKS AGAINST RIB
REFLECTOR BURNT
CHARGER TIM
ROOF MATS NOT GOING INBY
ROCK DUST SUPPLY CAR
ROOF MATS ARE BENT
ROOF MATS ARE BENT
APPROXIMATELY 10 BLOCKS BLOWN TOWARD TRACK, STOPPING BOWED TOWARD RETURN
MAM DOOR KNOCKED OUT
LID TO SCSR STORAGE BOX
FROM FROM SCSR STORAGE BOX
SCSR STORAGE BOX INTACT
STOPPING BOWED TOWARD RETURN
ROCK DUST BAG HANGING ON ROOF MAT
BOWED VERY SLIGHTLY ON TOP TOWARD RETURN (SCSR SER. NO. 21 056574 (SEAL BROKEN) STORAGE BOX FOR SCSR (BOTTOM PIECE) - HOLDS 5
BOWED TOWARD RETURN
2 ROCK DUST BAGS WRAPPED AROUND POST ON RIGHT OUTBY RIBLINE
BOWED TOWARD RETURN
ROCK DUST BAG HANGING FROM ROOF ON LEFT INBY SIDE
BOWED TOWARD RETURN
DEBRIS CAUGHT IN ROOF (BLOWN OUTBY)

COAL DUST IS DEFINITELY ACCUMULATING IN RETURN, STOPPING IS WAVY
1/2 A BLOCK OUT OF BOTTOM COVERED WITH PLASTIC CURTAIN - CRACKS IN JOINTS
STOPPING BOWED TOWARD RETURN
ROCK DUST DEFINITELY GETTING DARKER, POSTS ALONG RIGHT RIB IN TACT
BLOCKS BLOWN INTO POST; BARK SCRAPPED OFF POST
1/3 OF STOPPING OUT, A COOL AREA
STOPPING 1/4 OUT ON INBY SIDE
BROWN PAPER IN OUTBY DIRECTION HANGING FROM ROOF, MELTED PLASTIC FOUND ON FLOOR
INITIALS READABLE
INBY SIDE OF POSTS HAD NO ROCK DUST, ROCK DUST GREY IN AREA
NO DAMAGE TO F-BUTT REGULATOR
LEAKY STOPPING BOWED TOWARD E-BUTT FACE
MUD ON MAINS
LIGHT COATING OF DUST ON OUTBY SIDE OF POSTS
