Paul Smith Fatal Accident  
 Barnes-Tucker Company  
 Lancashire #15 Mine  
 Bakerston Pa  
 January 22, 1948  
 Scale 1"=20'

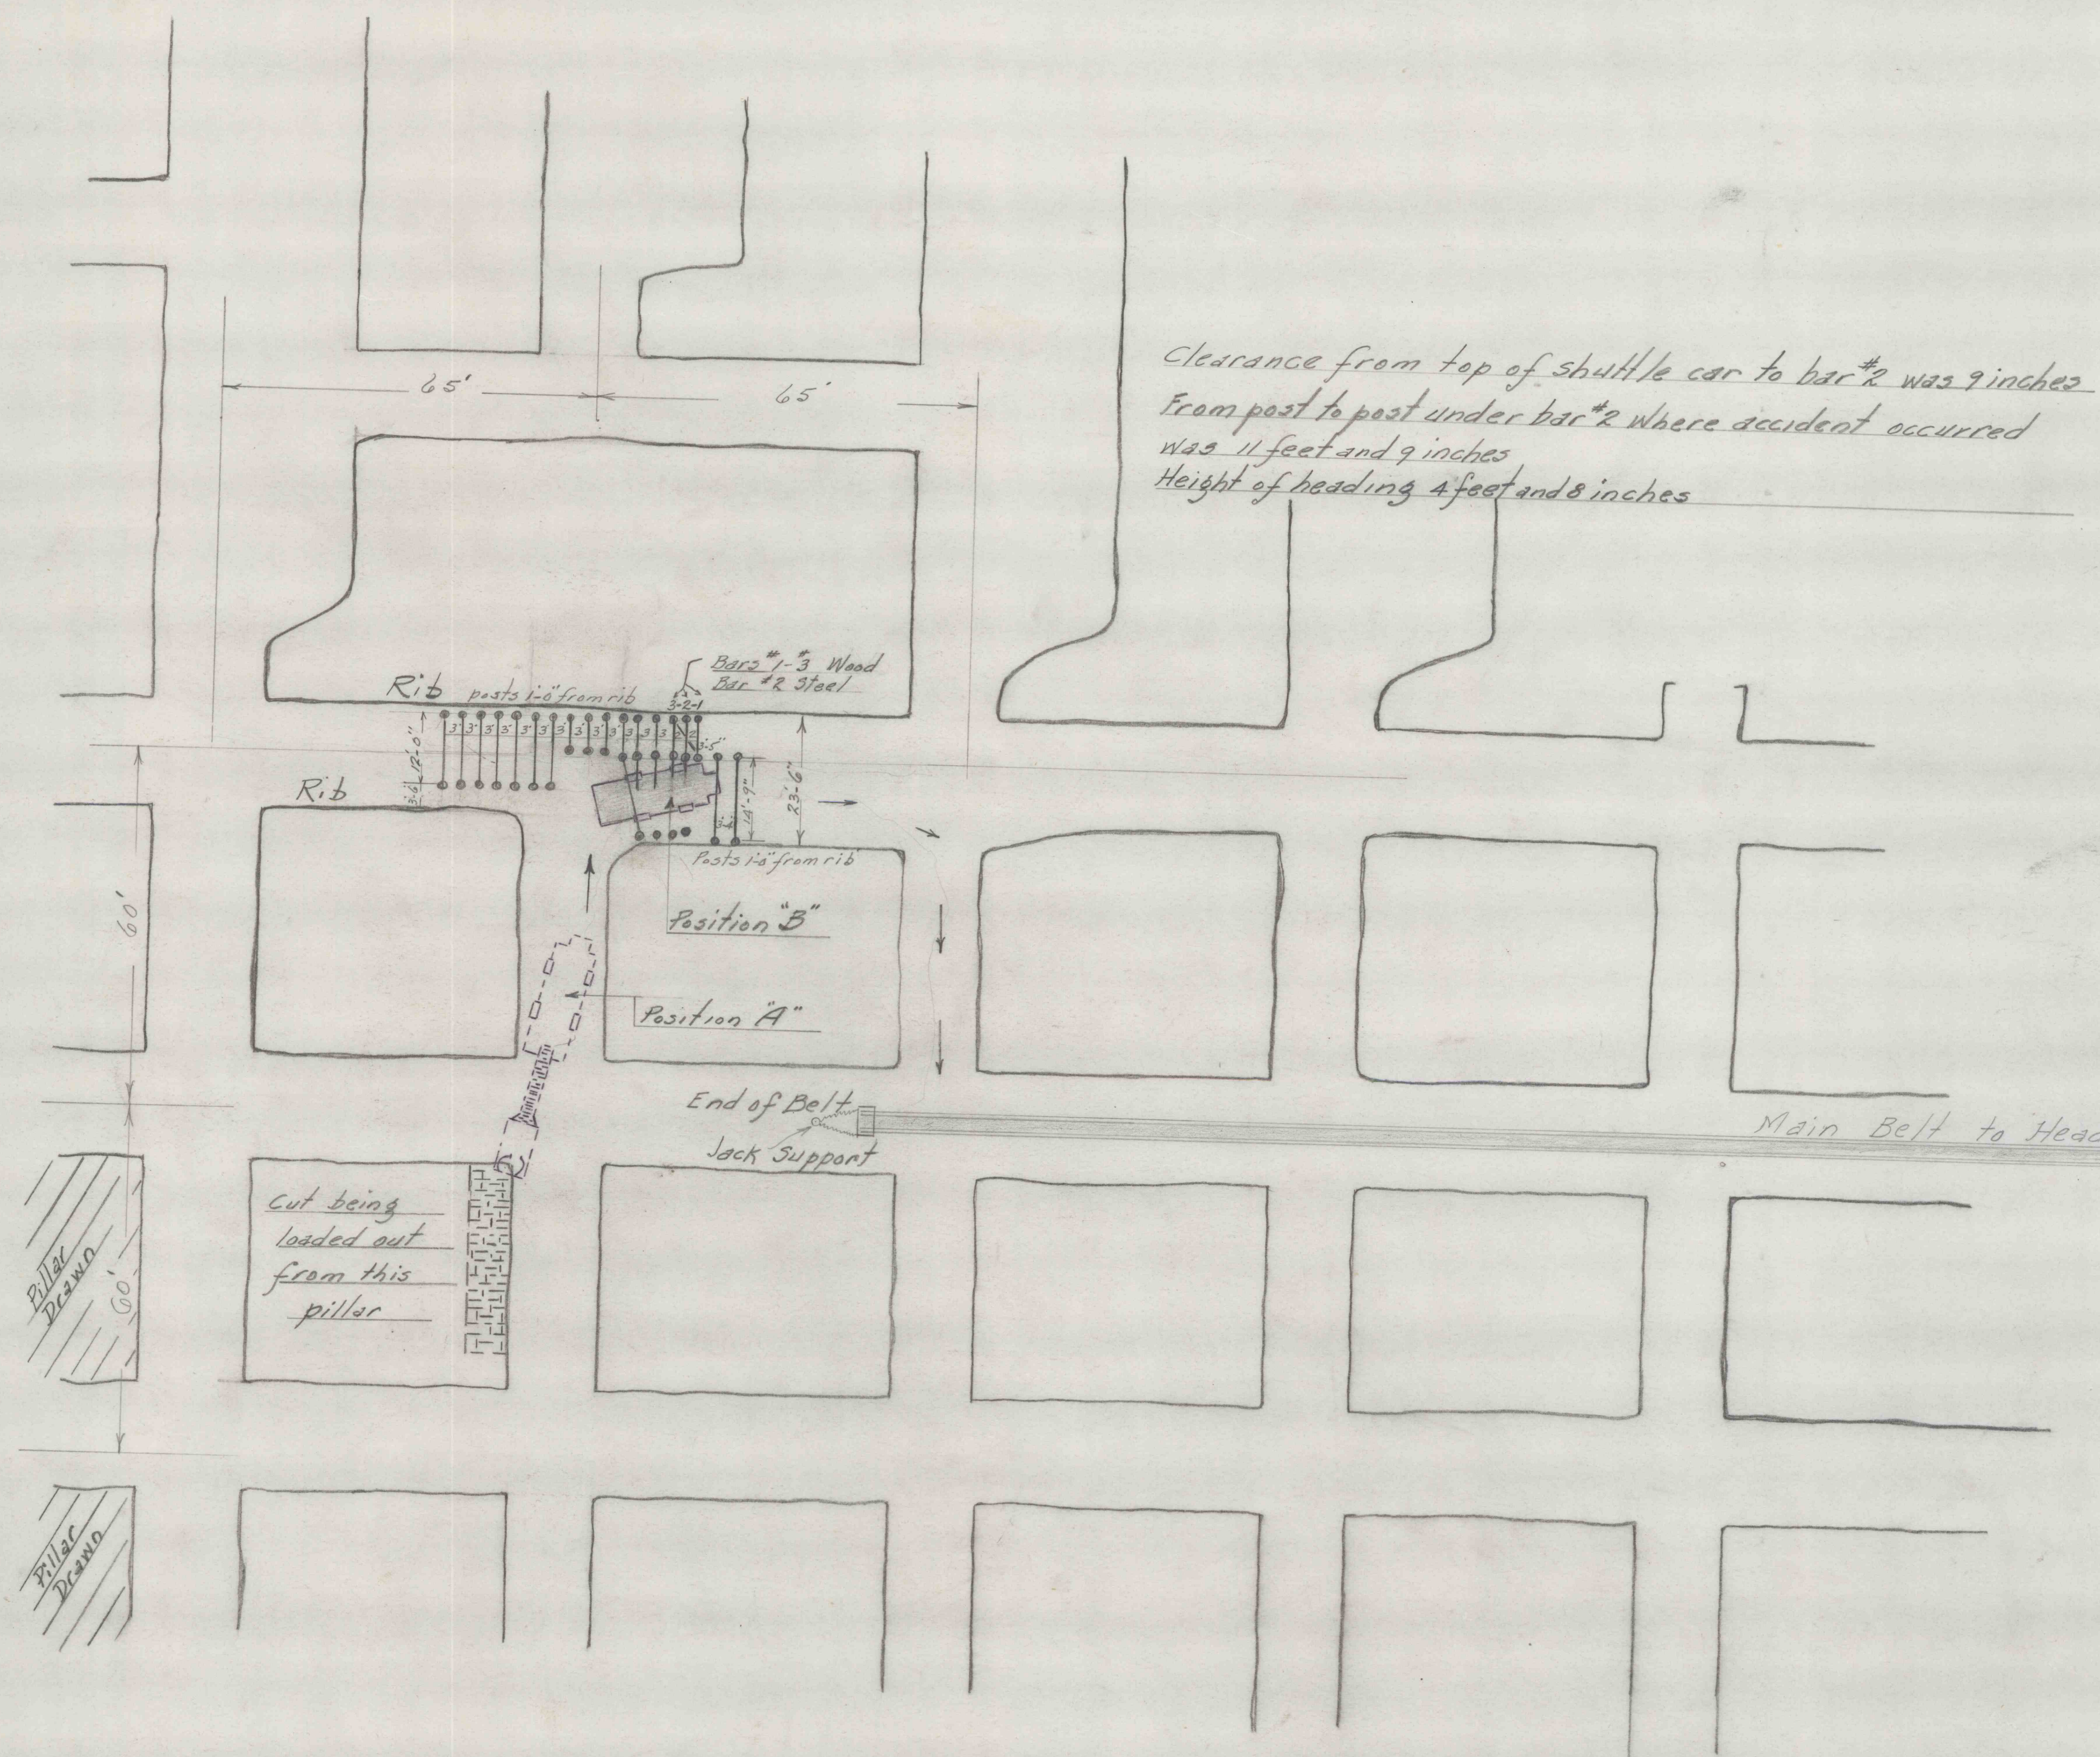
Clearance from top of shuttle car to bar #2 was 9 inches  
 From post to post under bar #2 where accident occurred  
 was 11 feet and 9 inches  
 Height of heading 4 feet and 8 inches

Shuttle car moves from position "A" where victim receives his load of coal from the Joy loading unit in B-12 heading pillars. He moves as arrows indicate to discharge on to main belt. Not following the runway as previously traveled being approximately 18 inches off the same, the cab side of the shuttle car struck the post supporting steel bar #9, the bar falls on the open cab in front of the victim. As shuttle car moves forward the steel bar becomes wedged between supports or posts of bars #1 and #3 pinning victim between bar and back of the cab. The victim reverses the car and moves back ward 3 feet and stops car, position "B". When discovered he was on his knees beside the shuttle car. Upon examination the mechanism of the car was found to be in good condition.
