MEARS ENTERPRISES, INC.

Clymer Refuse Disposal

EXHIBIT 6.2

ENVIRONMENTAL RESOURCES MAP

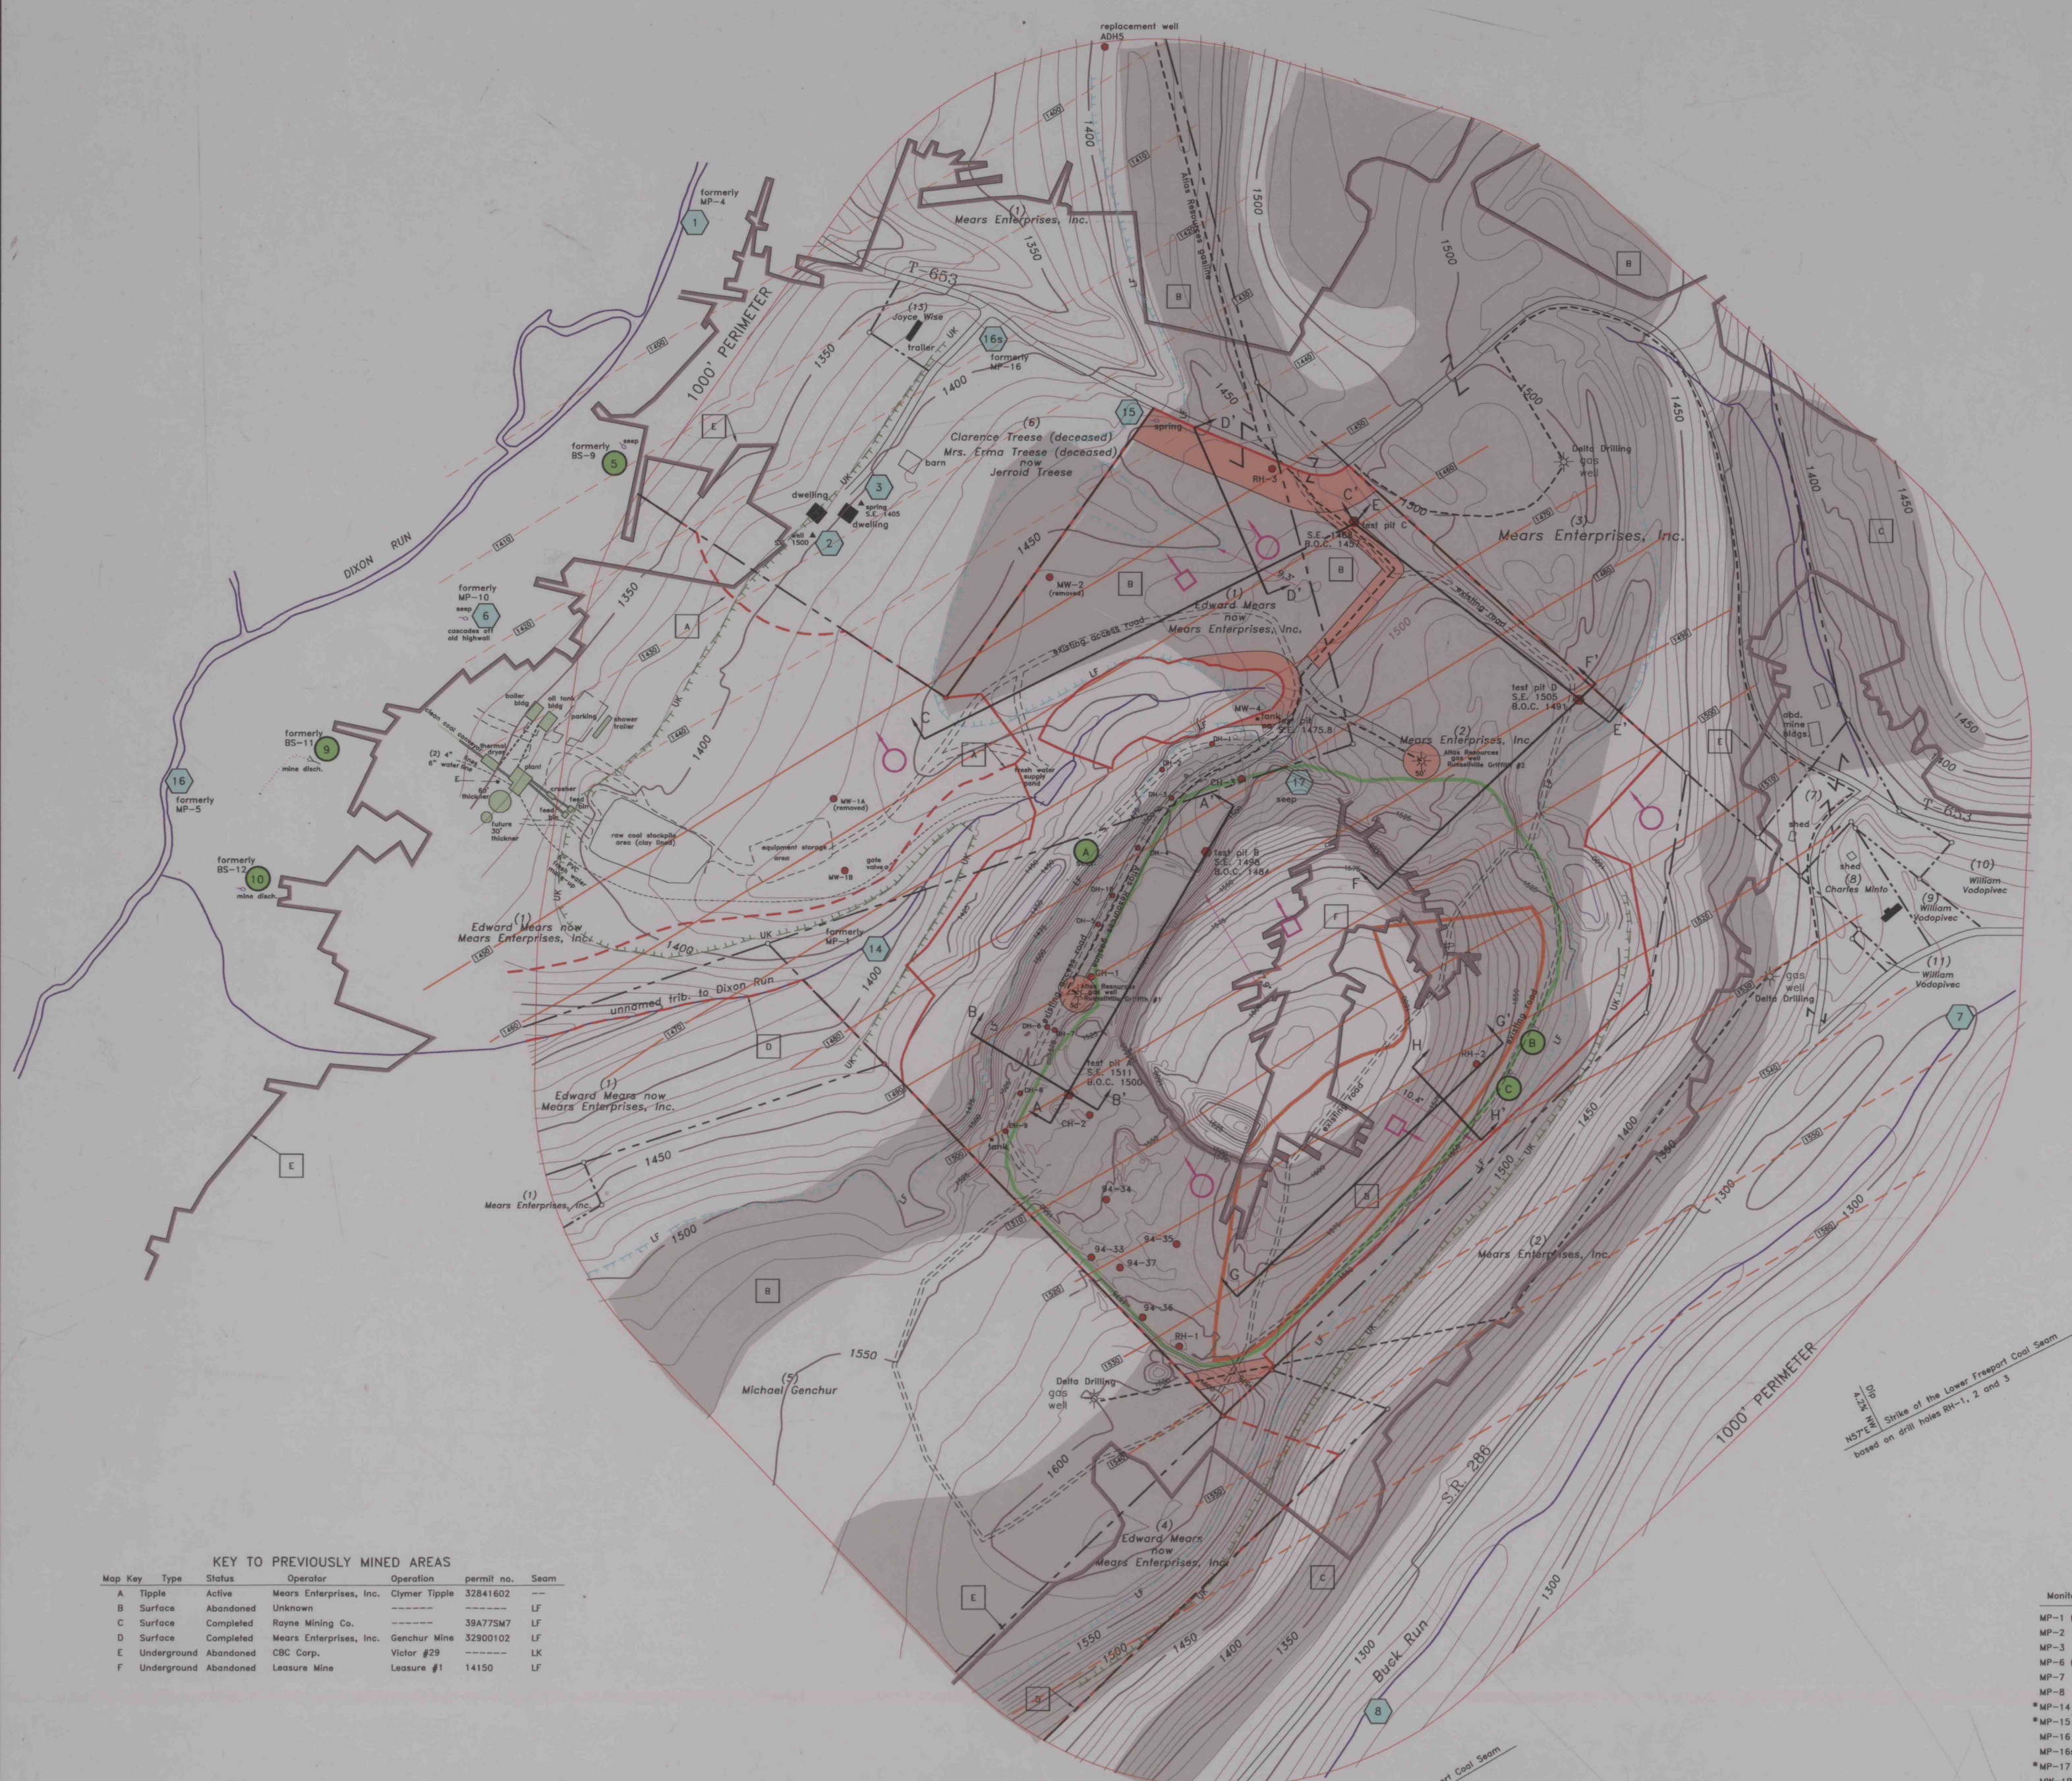
- EXISTING PERMIT AREA 79.6 acres
- BARRIER AREA
- VARIANCE AREA
- OCCUPIED DWELLING
- UNOCCUPIED STRUCTURE
- PROPERTY LINE
- KEY NO. TO PROPERTY OWNERS
- MAP KEY TO PREVIOUSLY MINED AREAS
- PREVIOUSLY SURFACE MINE AREA
- ABANDONED DEEP MINE EXTENT
- LIMIT OF REFUSE DISPOSAL 36.3 acs.
- BACKGROUND SAMPLE
- MONITORING POINT
- SLOPE MEASUREMENT
- TEST HOLE
- TEST PIT
- GEOLOGIC CROSS SECTION LINE
- LOWER FREEPORT COAL SEAM OUTCROP
- UPPER KITTANNING COAL SEAM OUTCROP
- STRUCTURE CONTOUR (LF SEAM)
- INFERRED STRUCTURE CONTOUR (LF SEAM)
- GROUNDWATER FLOW DIRECTION (REGIONAL)
- GROUNDWATER FLOW DIRECTION (LOCAL)
- PHASE I (NOW COMPLETED) DISPOSAL AREA TO BE REACTIVATED AND MODIFIED

Map Key	Type	Status	Operator	Operation	permit no.	Seam
A	Tipple	Active	Mears Enterprises, Inc.	Clymer Tipple	32841602	LF
B	Surface	Abandoned	Unknown			LF
C	Surface	Completed	Rayne Mining Co.		39A775M7	LF
D	Surface	Completed	Mears Enterprises, Inc.	Genchur Mine	32800102	LF
E	Underground	Abandoned	CBC Corp.	Victor #29		LK
F	Underground	Abandoned	Leasure Mine	Leasure #1	14150	LF

Monitoring Point	Surface Elev.	Description
MP-1 (formerly MP-4)	1245	Dixon Run - upstream
MP-2	1400	Trease supply - well
MP-3	1405	Trease supply - spring
MP-5 (formerly MP-10)	1295	spring - UK horizon
MP-7	1330	Buck Run - upstream
MP-8	1240	Buck Run - downstream
MP-14 (formerly MP-1)	1395	receiving stream - downstream
MP-15	1448	spring - LF horizon
MP-16 (formerly MP-5)	1235	Dixon Run - downstream
MP-16a (formerly MP-16)	1390	spring - UK horizon
MP-17	1500	LF deep mine discharge
MW-18	1438	monitoring well
MW-4	1475	monitoring well
