DETAILED ENLARGEMENT OF Nº 16 LEFT OFF Nº 2 DIP
MONROE C. M. CO. REVLOC, PA.

MARCH-13-41

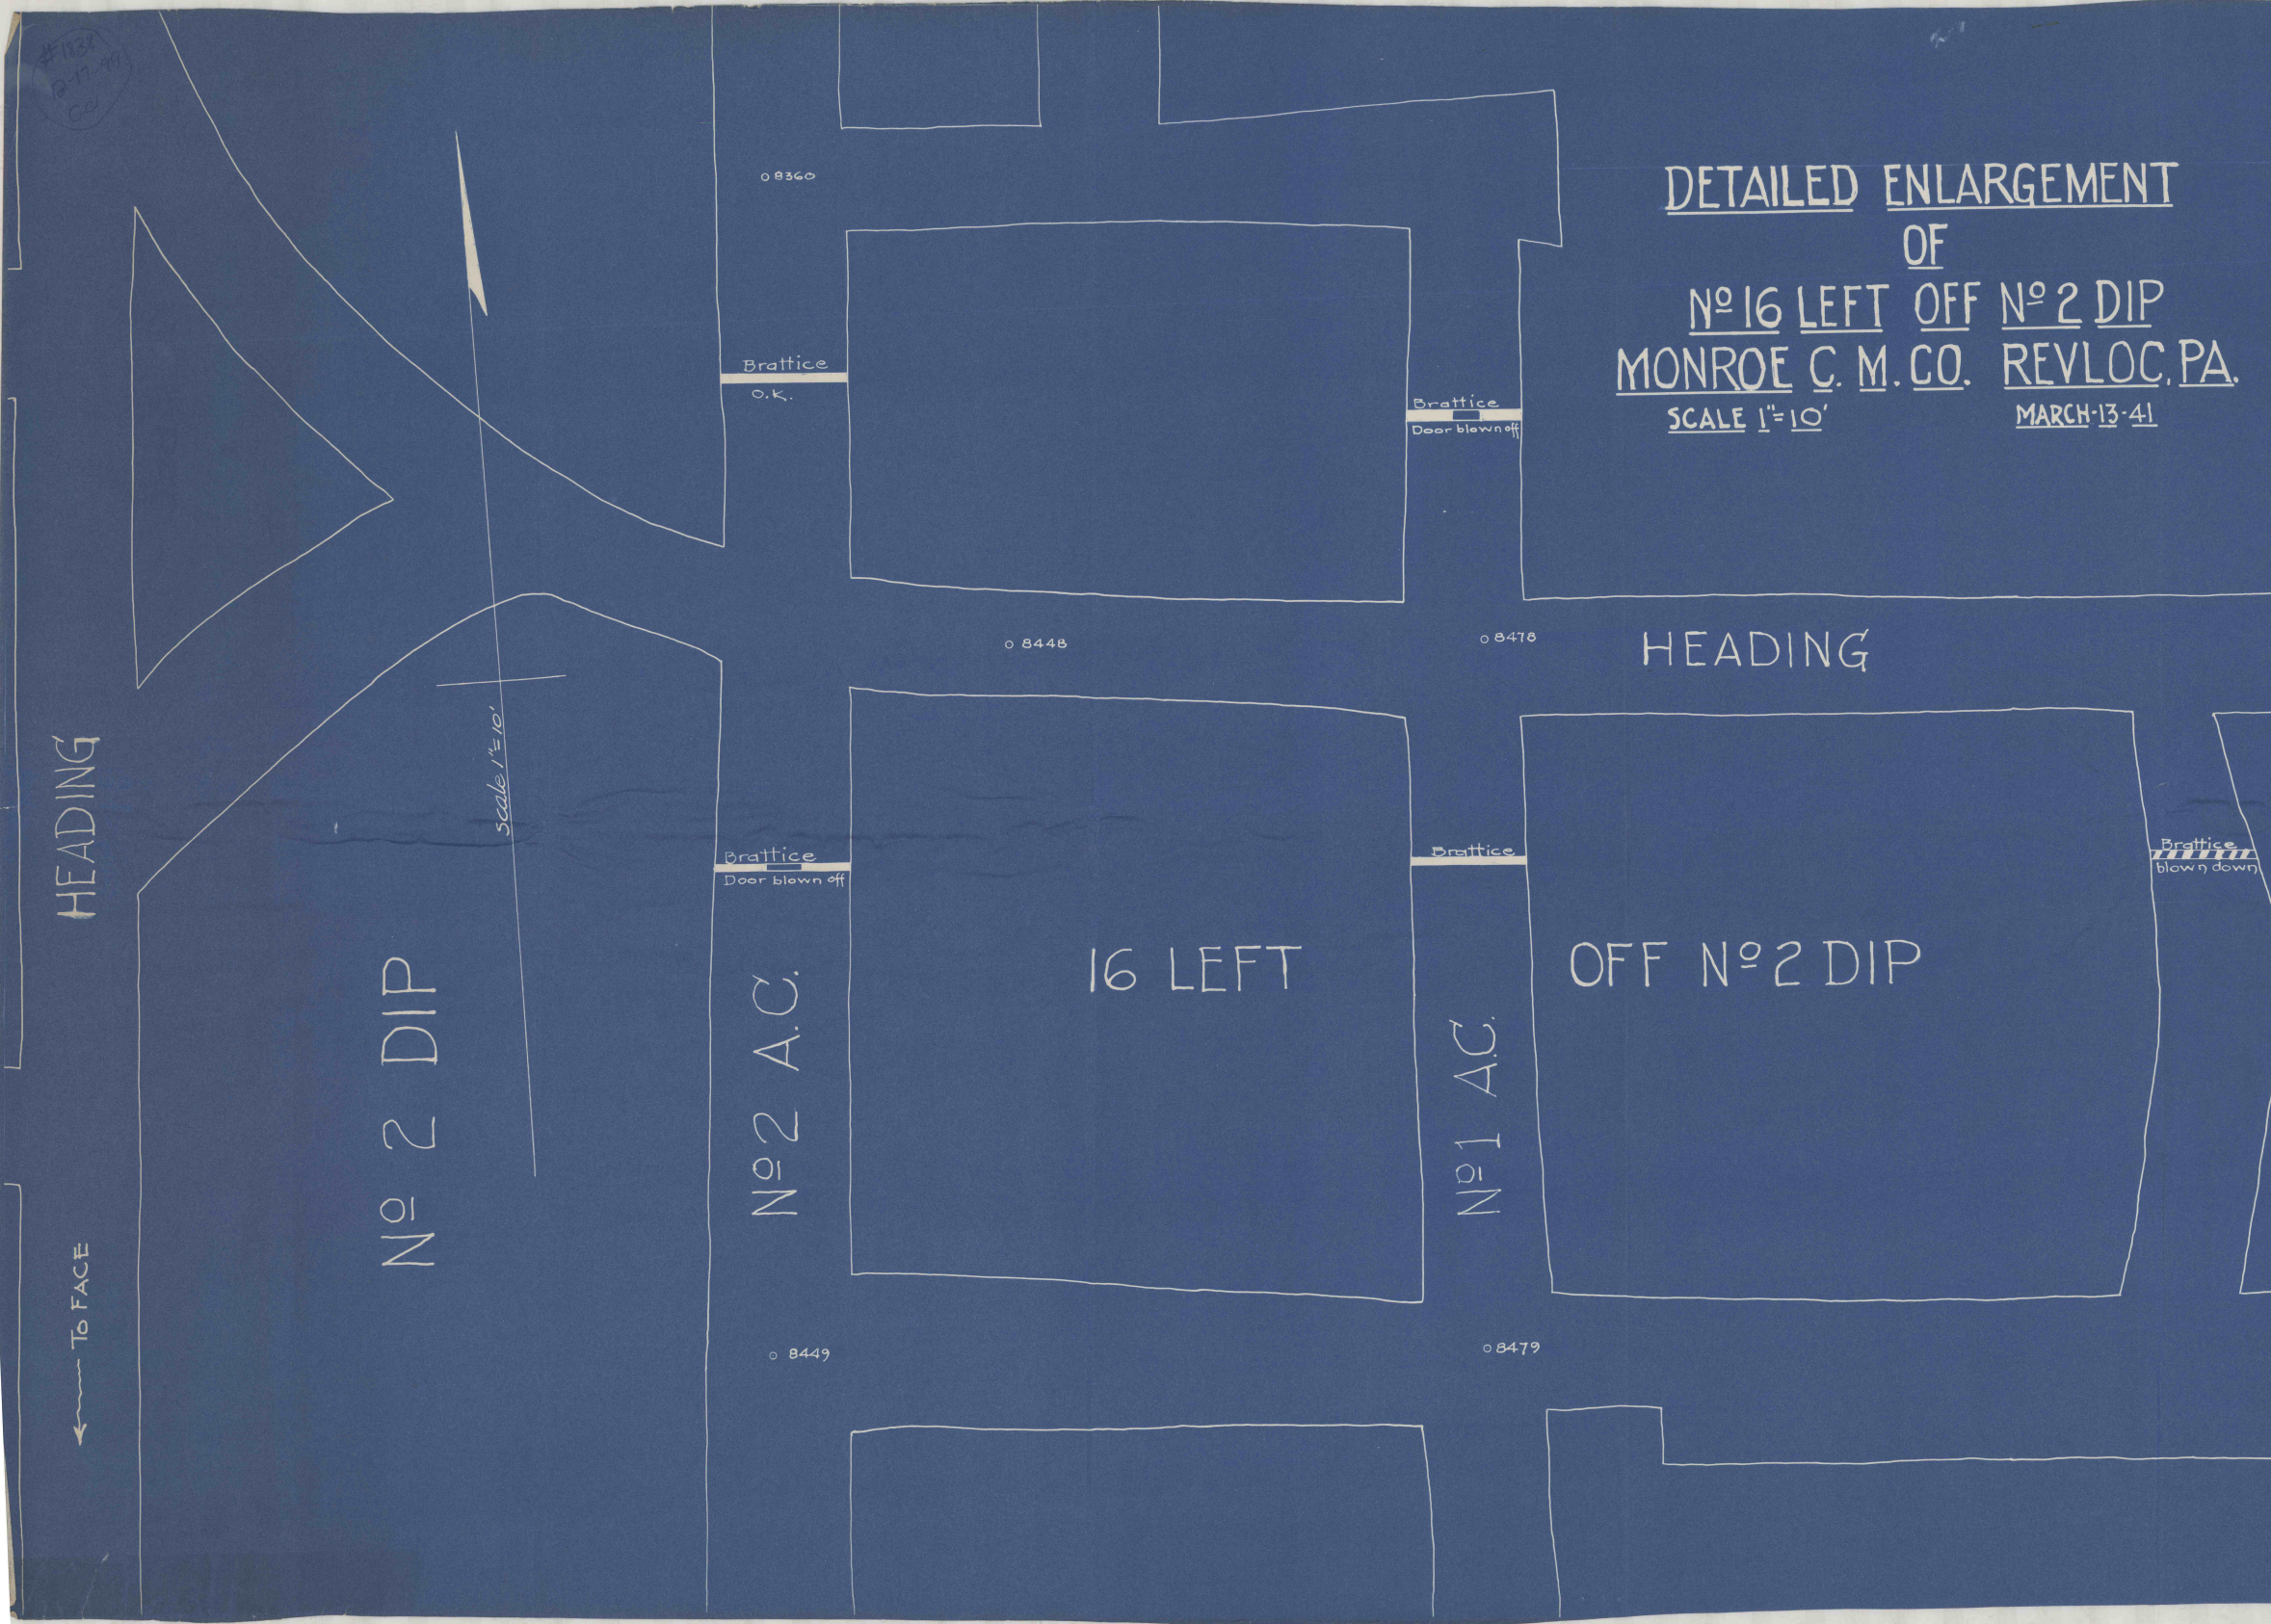
o 8360
Brattice
O.K.
Brattice
Door blown off
o 8448
o 8478
HEADING
HEADING
scale 1" = 10'
Brattice
Door blown off
Brattice
Brattice
blown down
Nº 2 DIP
Nº 2 A.C.
16 LEFT
Nº 1 A.C.
OFF Nº 2 DIP
To FACE
o 8449
o 8479

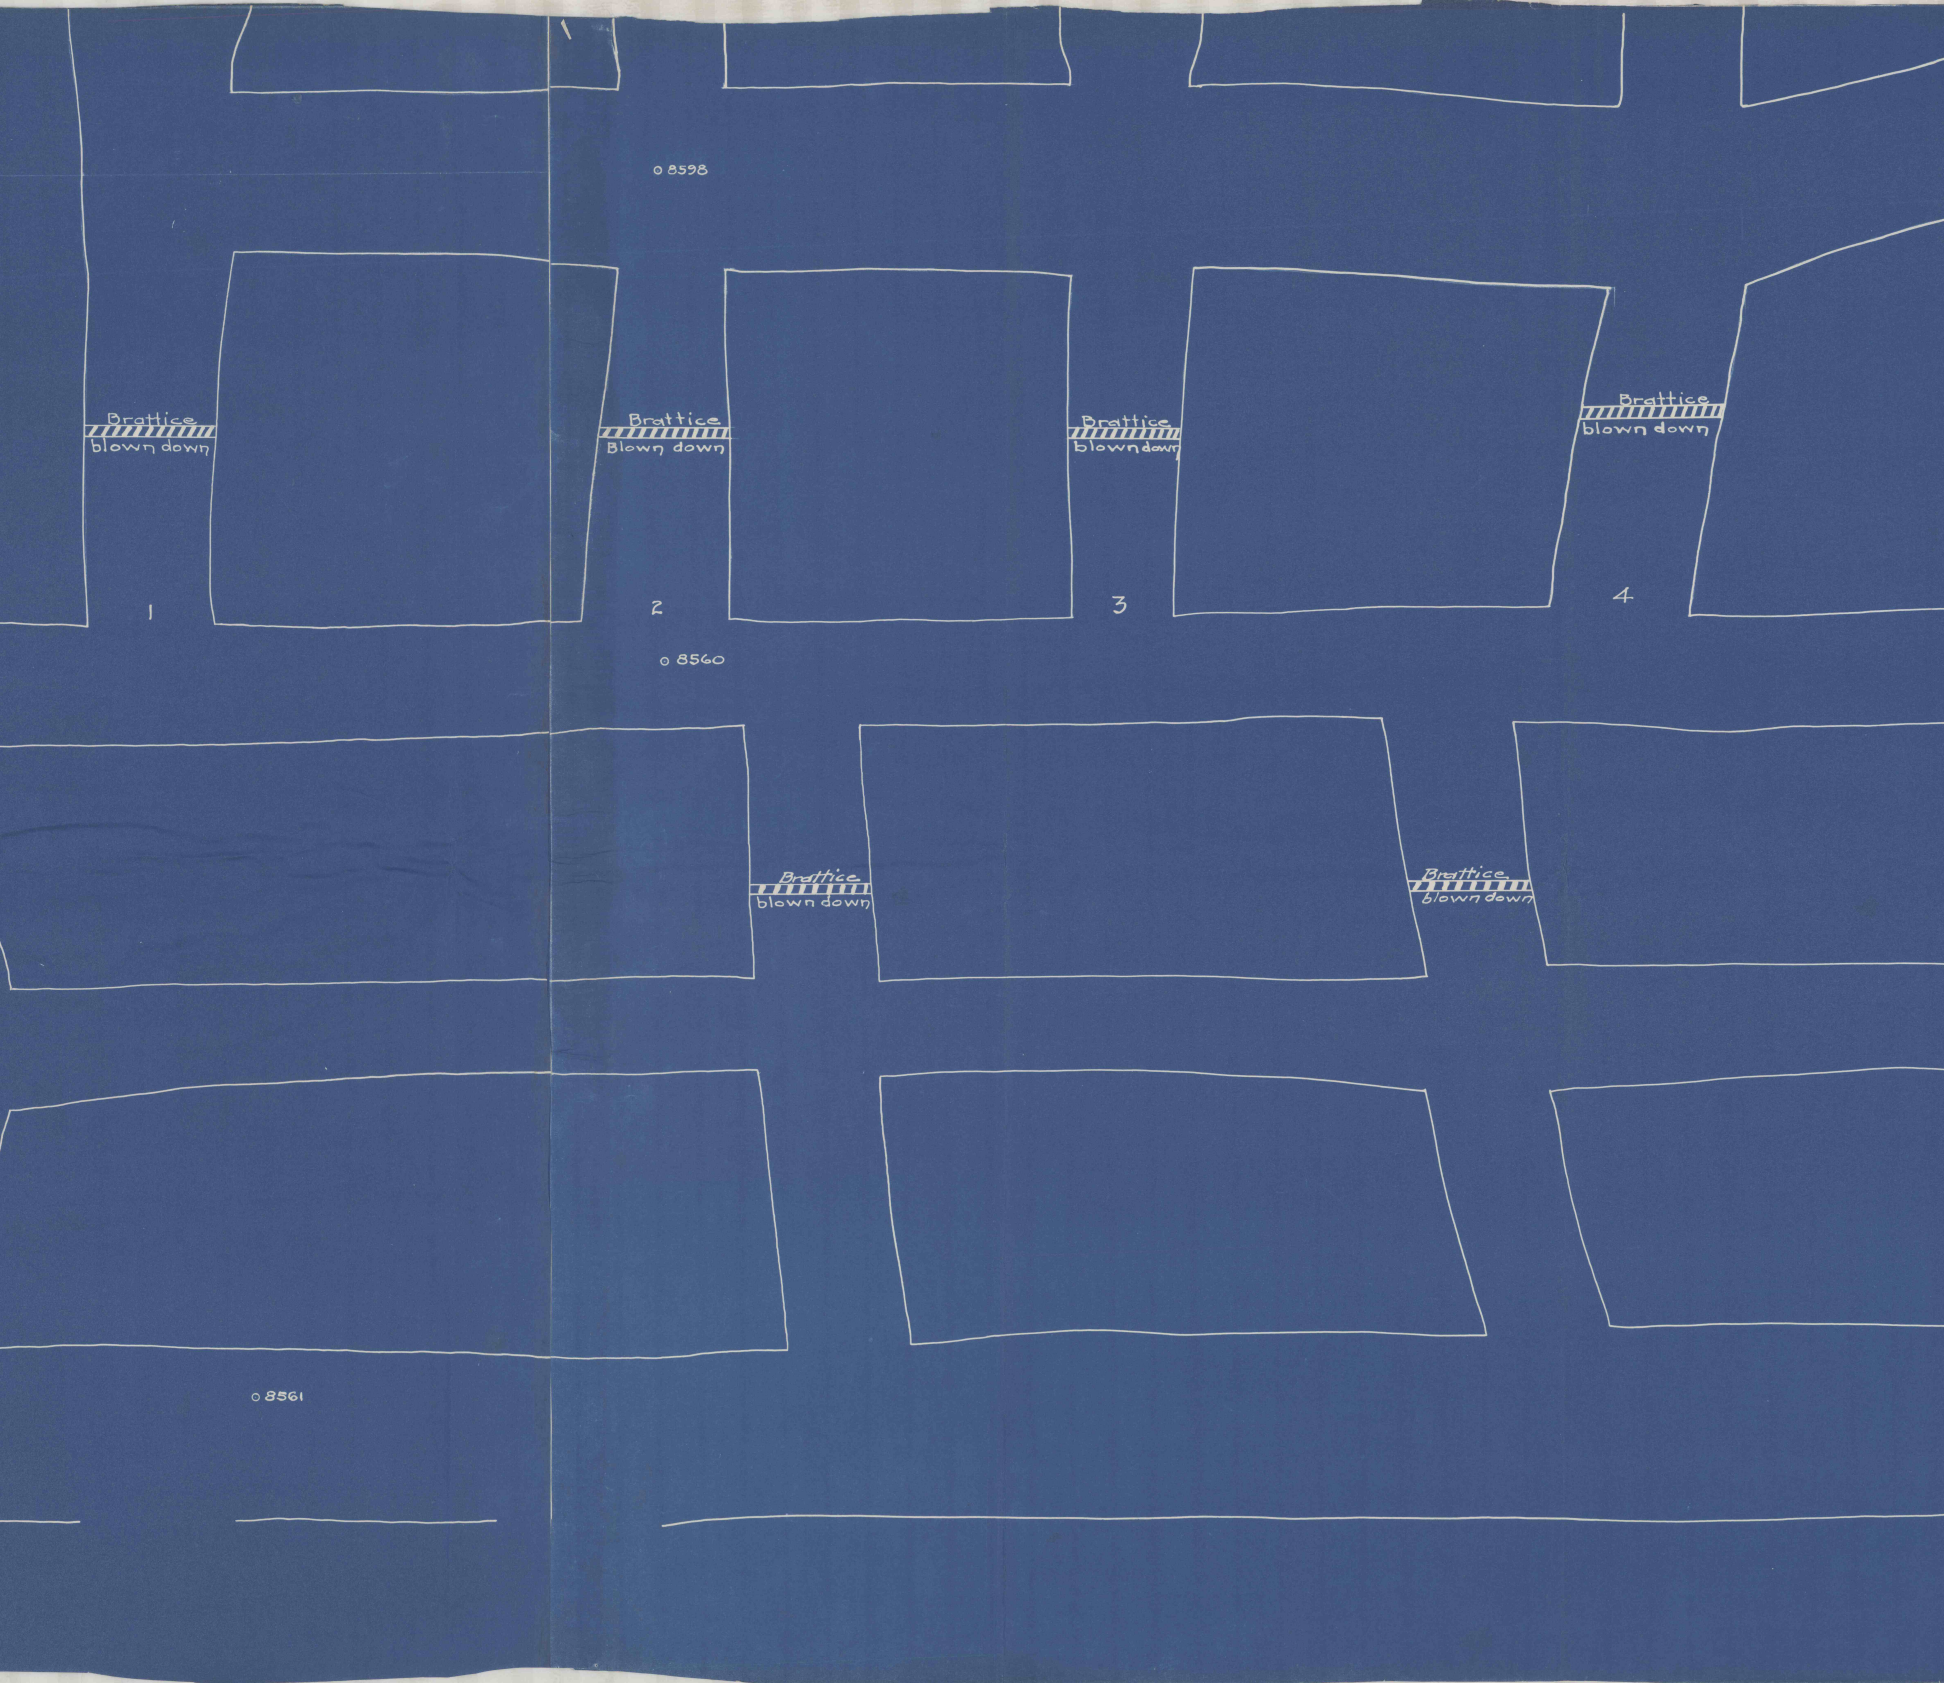
o 8598
Brattice blown down
Brattice Blown down
Brattice blown down
Brattice blown down
1
2
3
4
o 8560
Brattice blown down
Brattice blown down
o 8561

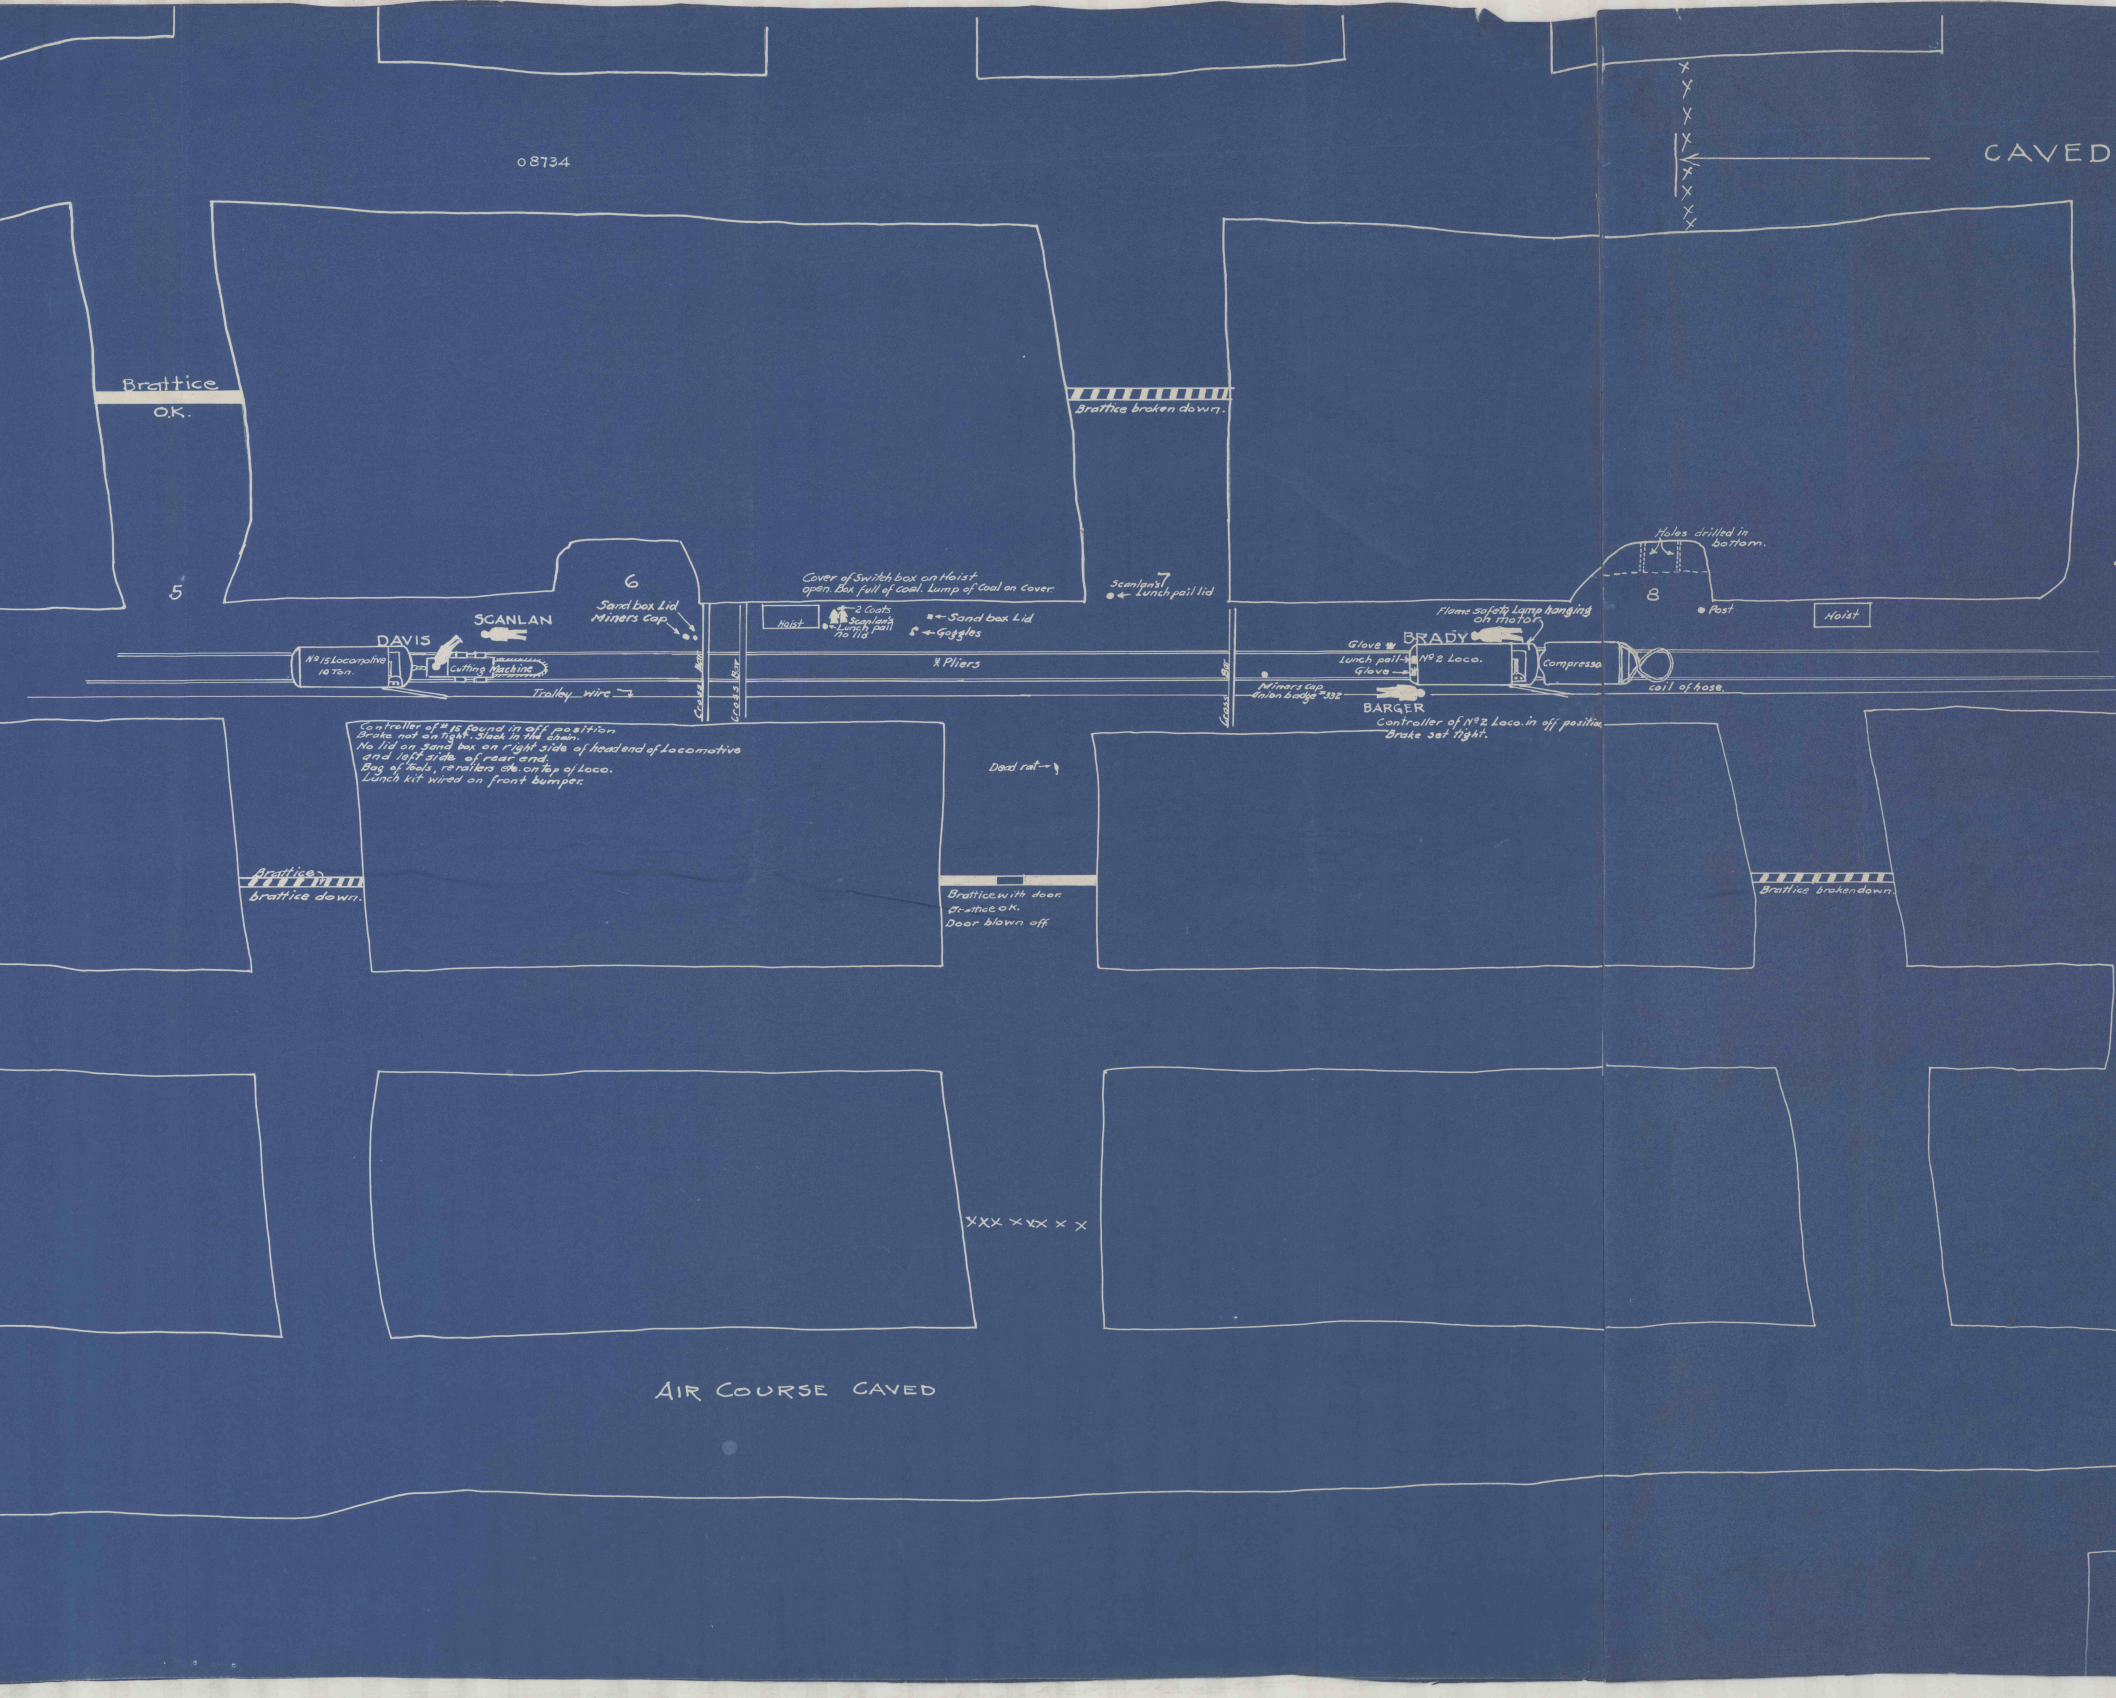
CAVED
Brattice
O.K.
Brattice broken down.
5
6
7
8
Holes drilled in bottom.
Cover of Switch box on Hoist open. Box full of coal. Lump of Coal on Cover.
Scanlan's Lunch pail lid
Sand box Lid
Miners Cap
SCANLAN
DAVIS
Nº 15 Locomotive 10 Ton.
Cutting Machine
Trolley wire
Cross Bar
Cross Bar
Hoist
2 Coats
Scanlan's Lunch pail no lid
Sand box Lid
Goggles
Pliers
Cross Bar
Flame safety Lamp hanging on motor
Glove
BRADY
Lunch pail
Nº 2 Loco.
Glove
Compresso
Miners cap Union badge #332
BARGER
coil of hose.
Post
Hoist
Dead rat
Brattice
brattice down.
Brattice with door.
Brattice OK.
Door blown off.
Brattice broken down.
XXX XXX X X
AIR COURSE CAVED

Controller of #15 found in off position
Brake not on tight. Slack in the chain.
No lid on sand box on right side of head end of Locomotive
and left side of rear end.
Bag of Tools, rerailers etc. on top of Loco.
Lunch kit wired on front bumper.

Controller of Nº 2 Loco. in off positio
Brake set tight.

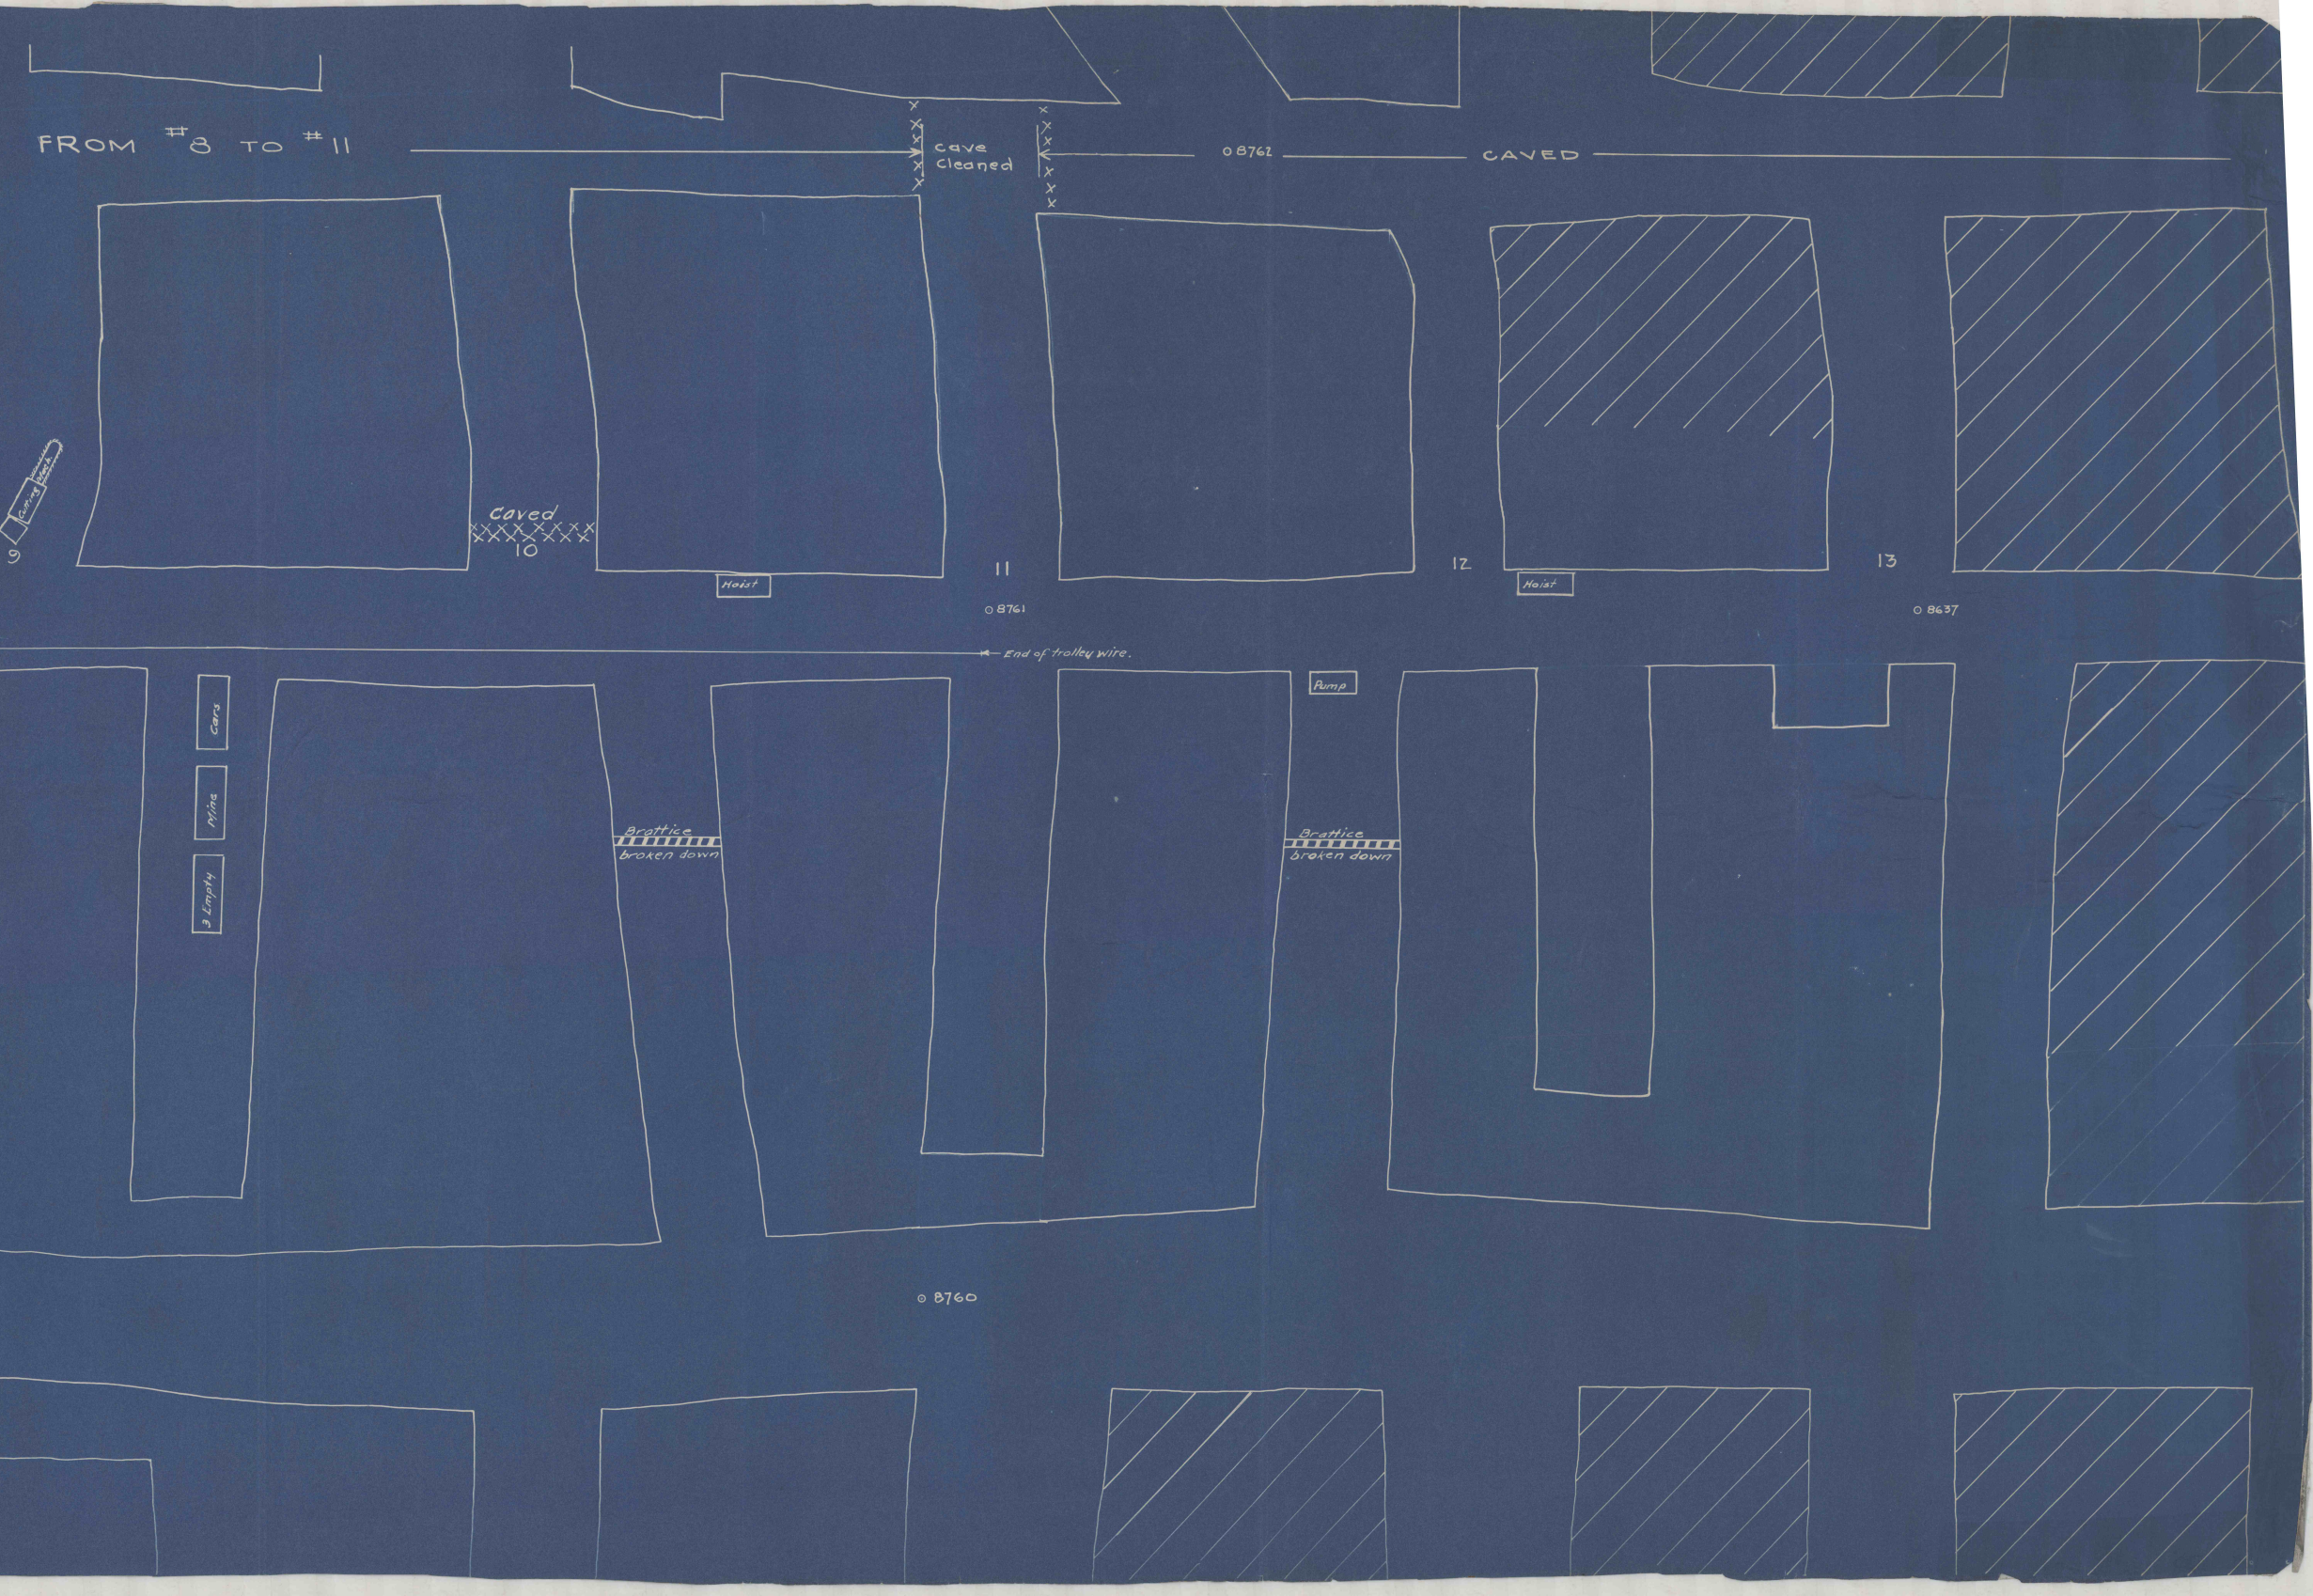
FROM #8 TO #11
cave cleaned
o 8762
CAVED
Cutting Mach.
9
Caved
10
11
12
13
Hoist
Hoist
o 8761
o 8637
End of trolley wire.
Pump
Cars
Mine
3 Empty
Brattice broken down
Brattice broken down
o 8760
