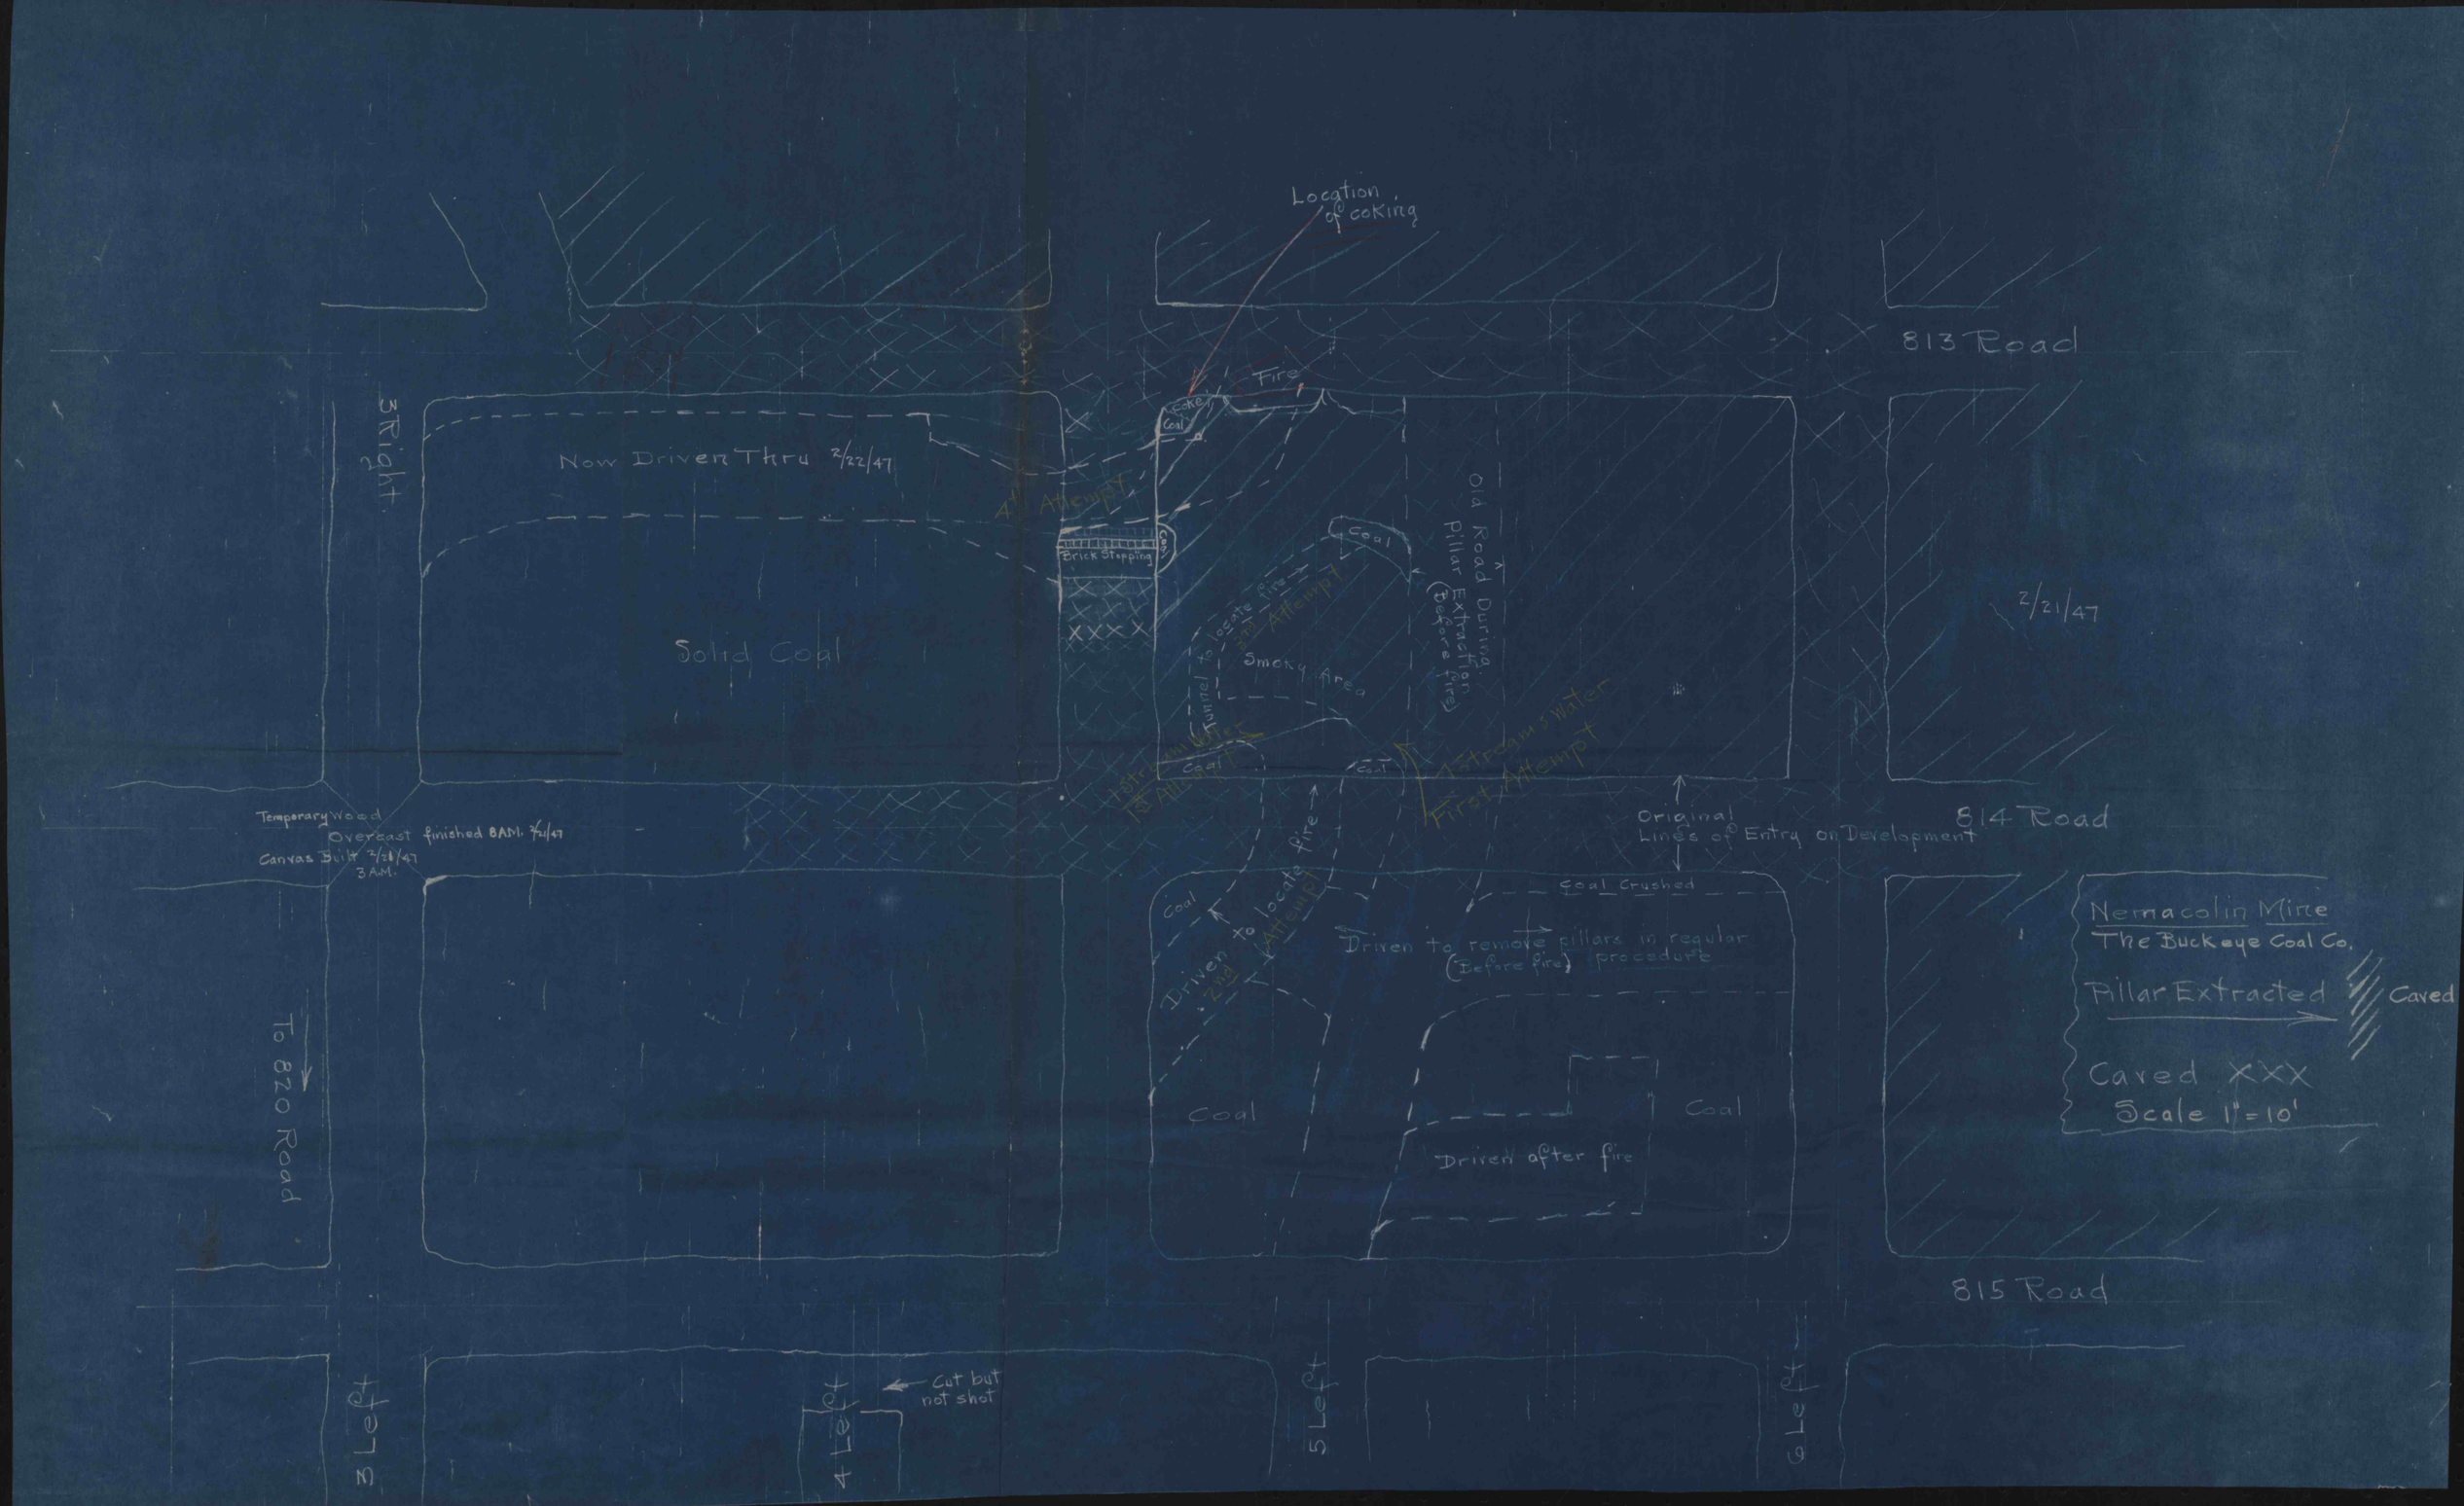
Location of coking
813 Road
Fire
Coke
Coal
3 Right
Now Driven Thru 2/22/47
4th Attempt
Brick Stopping
Coal
Old Road During Pillar Extraction (Before fire)
Coal
Tunnel to locate fire
3rd Attempt
Smoky Area
Solid Coal
2/21/47
Coal
Coal
1st Attempt
First Attempt
Temporary Wood
Overcast finished 8 A.M. 2/21/47
Canvas Built 2/21/47 3 A.M.
Original Lines of Entry on Development
814 Road
Coal
Driven to locate fire
2nd Attempt
Coal Crushed
Driven to remove pillars in regular procedure (Before fire)
Nemacolin Mine
The Buckeye Coal Co.
Pillar Extracted
Caved
Caved XXX
Scale 1" = 10'
To 820 Road
Coal
Coal
Driven after fire
815 Road
3 Left
4 Left
Cut but not shot
5 Left
6 Left
