·SECOND·FLOOR·STEEL·FRAMING·
SCALE 1/8" = 1'-0"
·FIRST·FLOOR·PLAN·
SHEET No. 4.
MCH. 1941
REINFORCING AND REPAIRS HIGH-SCHOOL BUILDING FOR THE SHENANDOAH SCHOOL DISTRICT SHENANDOAH, SCHUYLKILL Co. PA.
AUSTIN L. REILLY. REGISTERED ARCHITECT
54-55 BENNETT BLDG. WILKES-BARRE. PA.

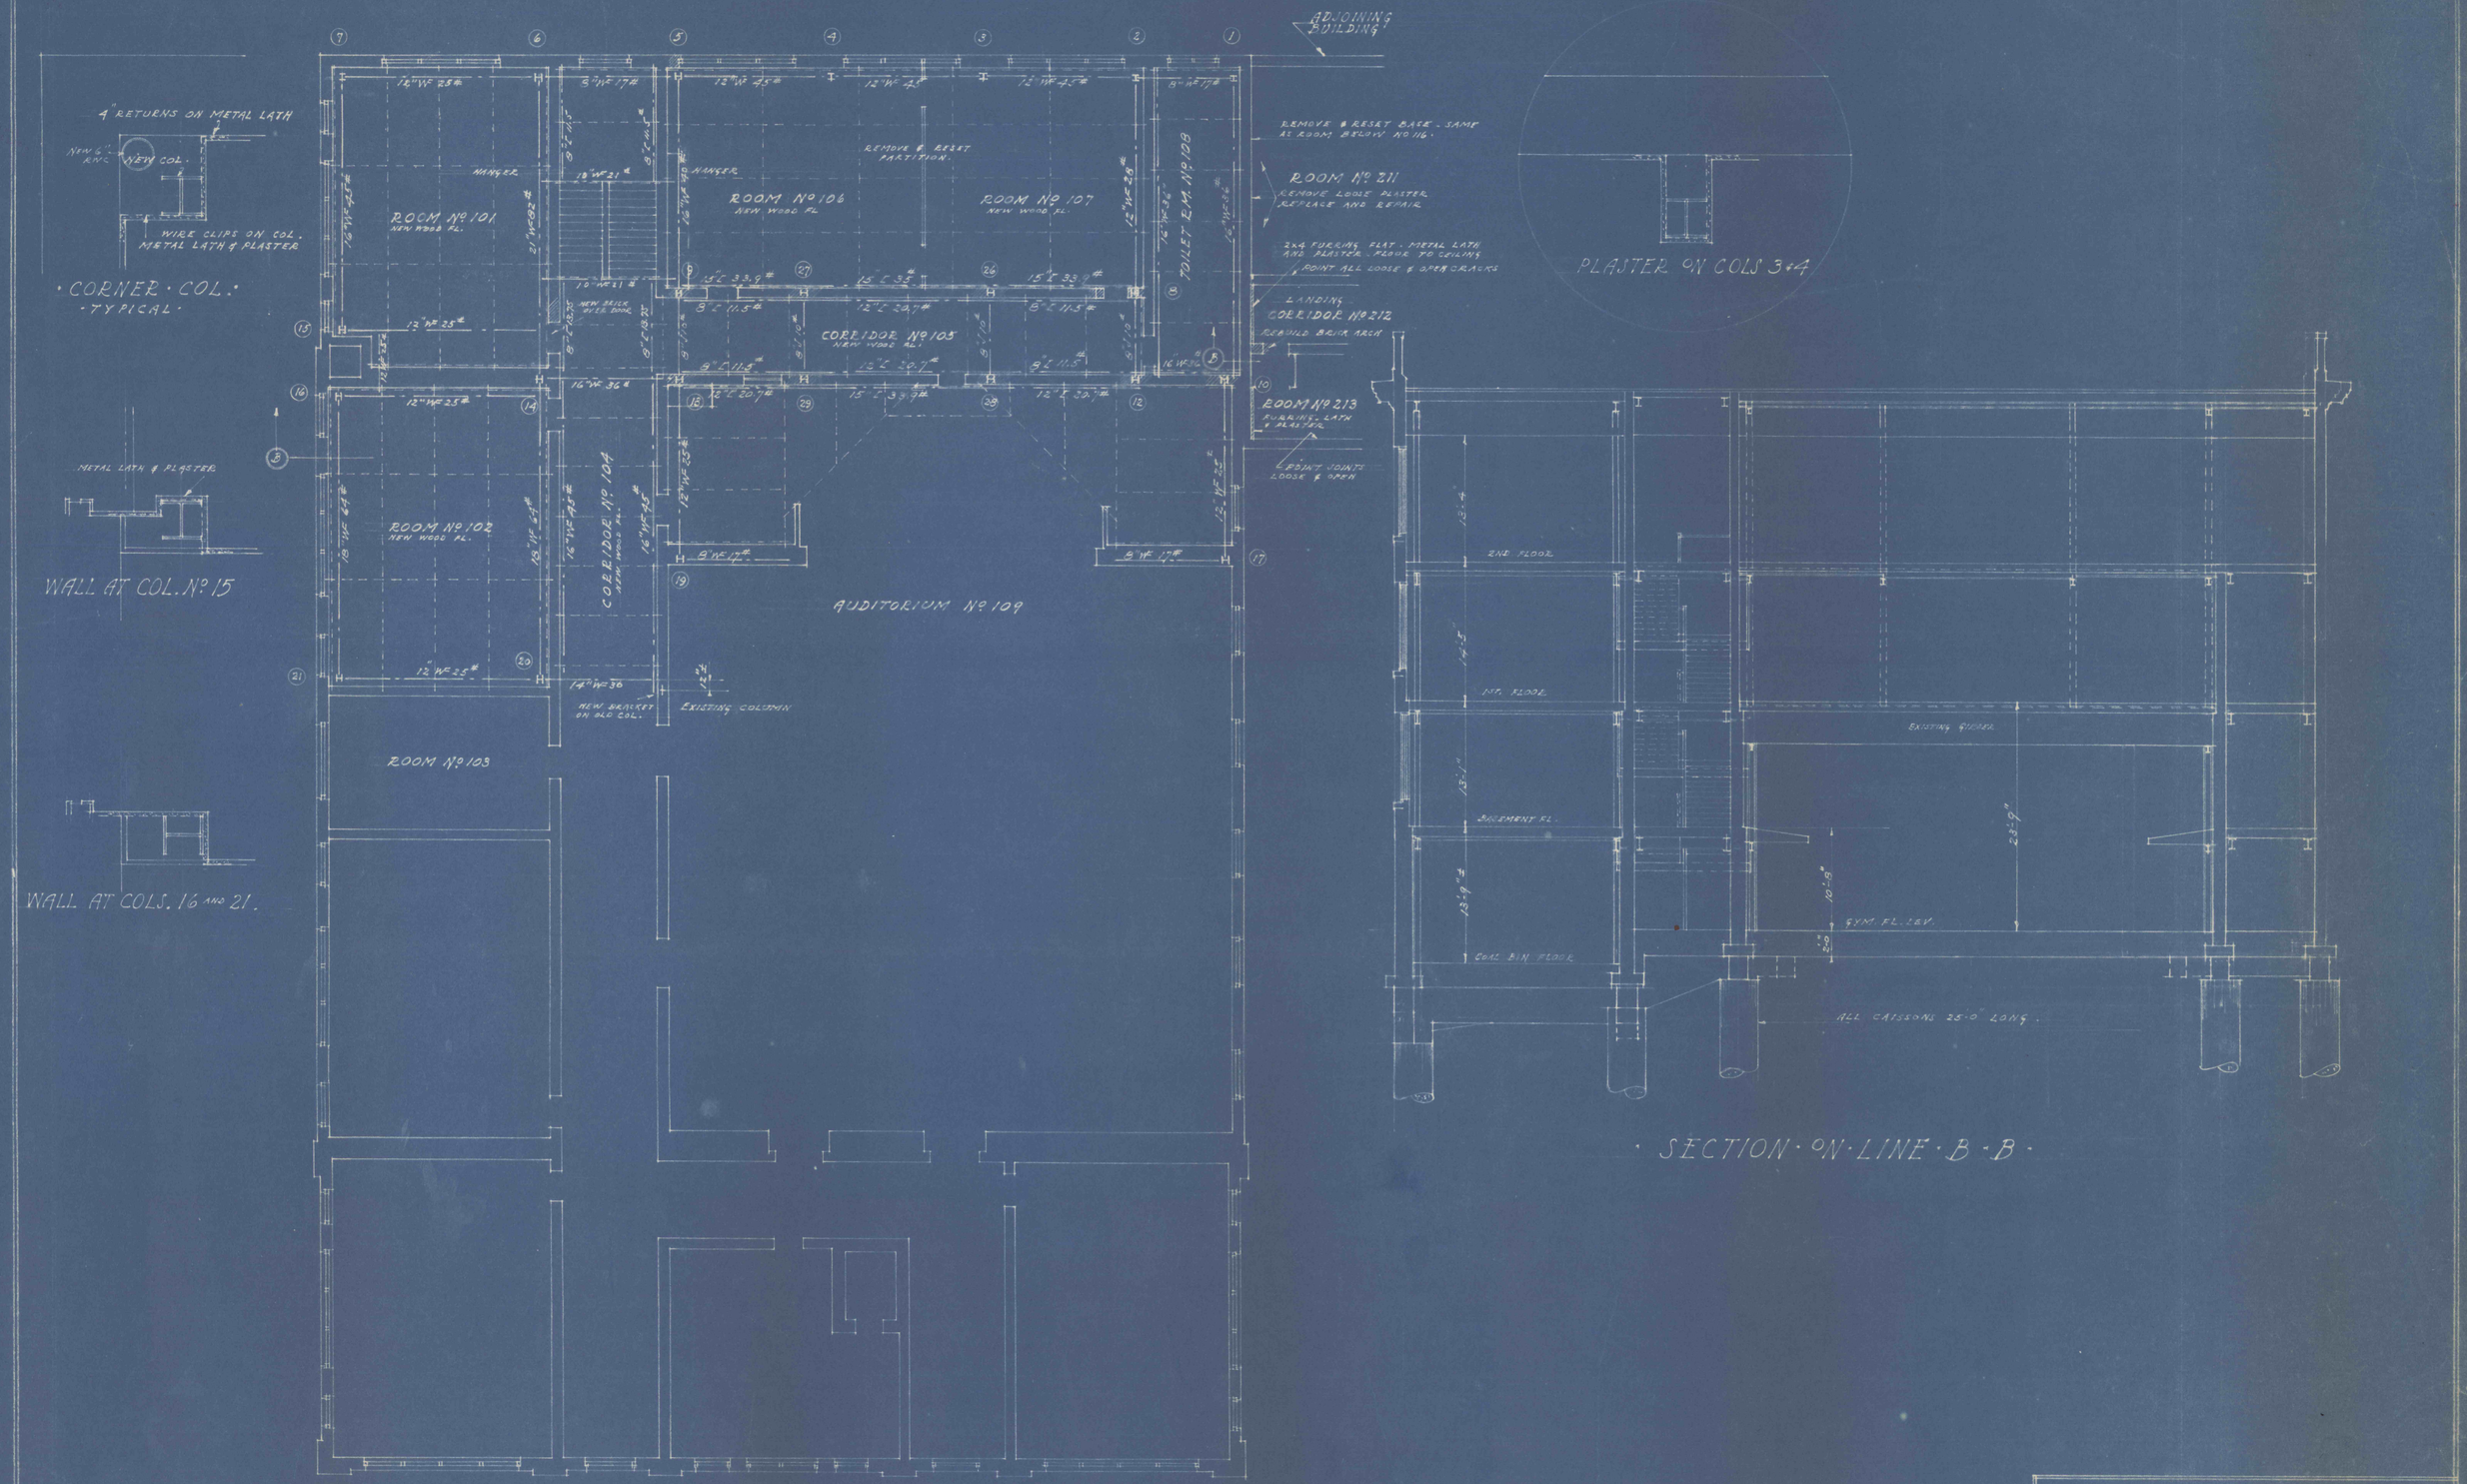
4" RETURNS ON METAL LATH
NEW COL.
WIRE CLIPS ON COL. METAL LATH & PLASTER
·CORNER·COL.·
·TYPICAL·
METAL LATH & PLASTER
WALL AT COL. No. 15
WALL AT COLS. 16 AND 21.
ADJOINING BUILDING
ROOM No. 101
NEW WOOD FL.
HANGER
ROOM No. 106
NEW WOOD FL.
REMOVE & RESET PARTITION.
ROOM No. 107
NEW WOOD FL.
TOILET RM. No. 108
NEW BRICK OVER DOOR
CORRIDOR No. 105
NEW WOOD FL.
ROOM No. 102
NEW WOOD FL.
CORRIDOR No. 104
NEW WOOD FL.
AUDITORIUM No. 109
NEW BRACKET ON OLD COL.
EXISTING COLUMN
ROOM No. 103
REMOVE & RESET BASE - SAME AS ROOM BELOW No. 116.
ROOM No. 211
REMOVE LOOSE PLASTER REPLASTER AND REPAIR
2x4 FURRING FLAT - METAL LATH AND PLASTER - FLOOR TO CEILING
POINT ALL LOOSE & OPEN CRACKS
LANDING
CORRIDOR No. 212
REBUILD BRICK ARCH
ROOM No. 213
RUBBING LATH & PLASTER
POINT JOINTS LOOSE & OPEN
PLASTER ON COLS 3 & 4
2ND FLOOR
1ST. FLOOR
EXISTING GIRDER
BASEMENT FL.
GYM. FL. LEV.
COAL BIN FLOOR
ALL CAISSONS 25'-0" LONG.
·SECTION·ON·LINE·B·B·
·FIRST·FLOOR·PLAN·
