DRISCOLL MINING COMPANY

MAP TO ACCOMPANY REQUEST FOR RUTHORIZATION TO MINE WITHIN THE SAFETY ZONE ESTABLISHED BY ACT #729 OF THE GENERAL ASSEMBLY.

SHOWING A PART OF THE WORKINGS OF DRISCOLL NO.4 MINE, FORMERLY VINTON NO.6 MINE, UNDER AND NEAR THE NORTH BRANCH OF BLACKLICK CREEK, IN THE "S" OR LOWER KITTANNING COAL BED.

LOCATED IN BLACKLICK TOWNSHIP, CAMBRIA COUNTY AND BUFFINGTON TO WNSHIP, INDIANA COUNTY, PENNSYLVANIA.

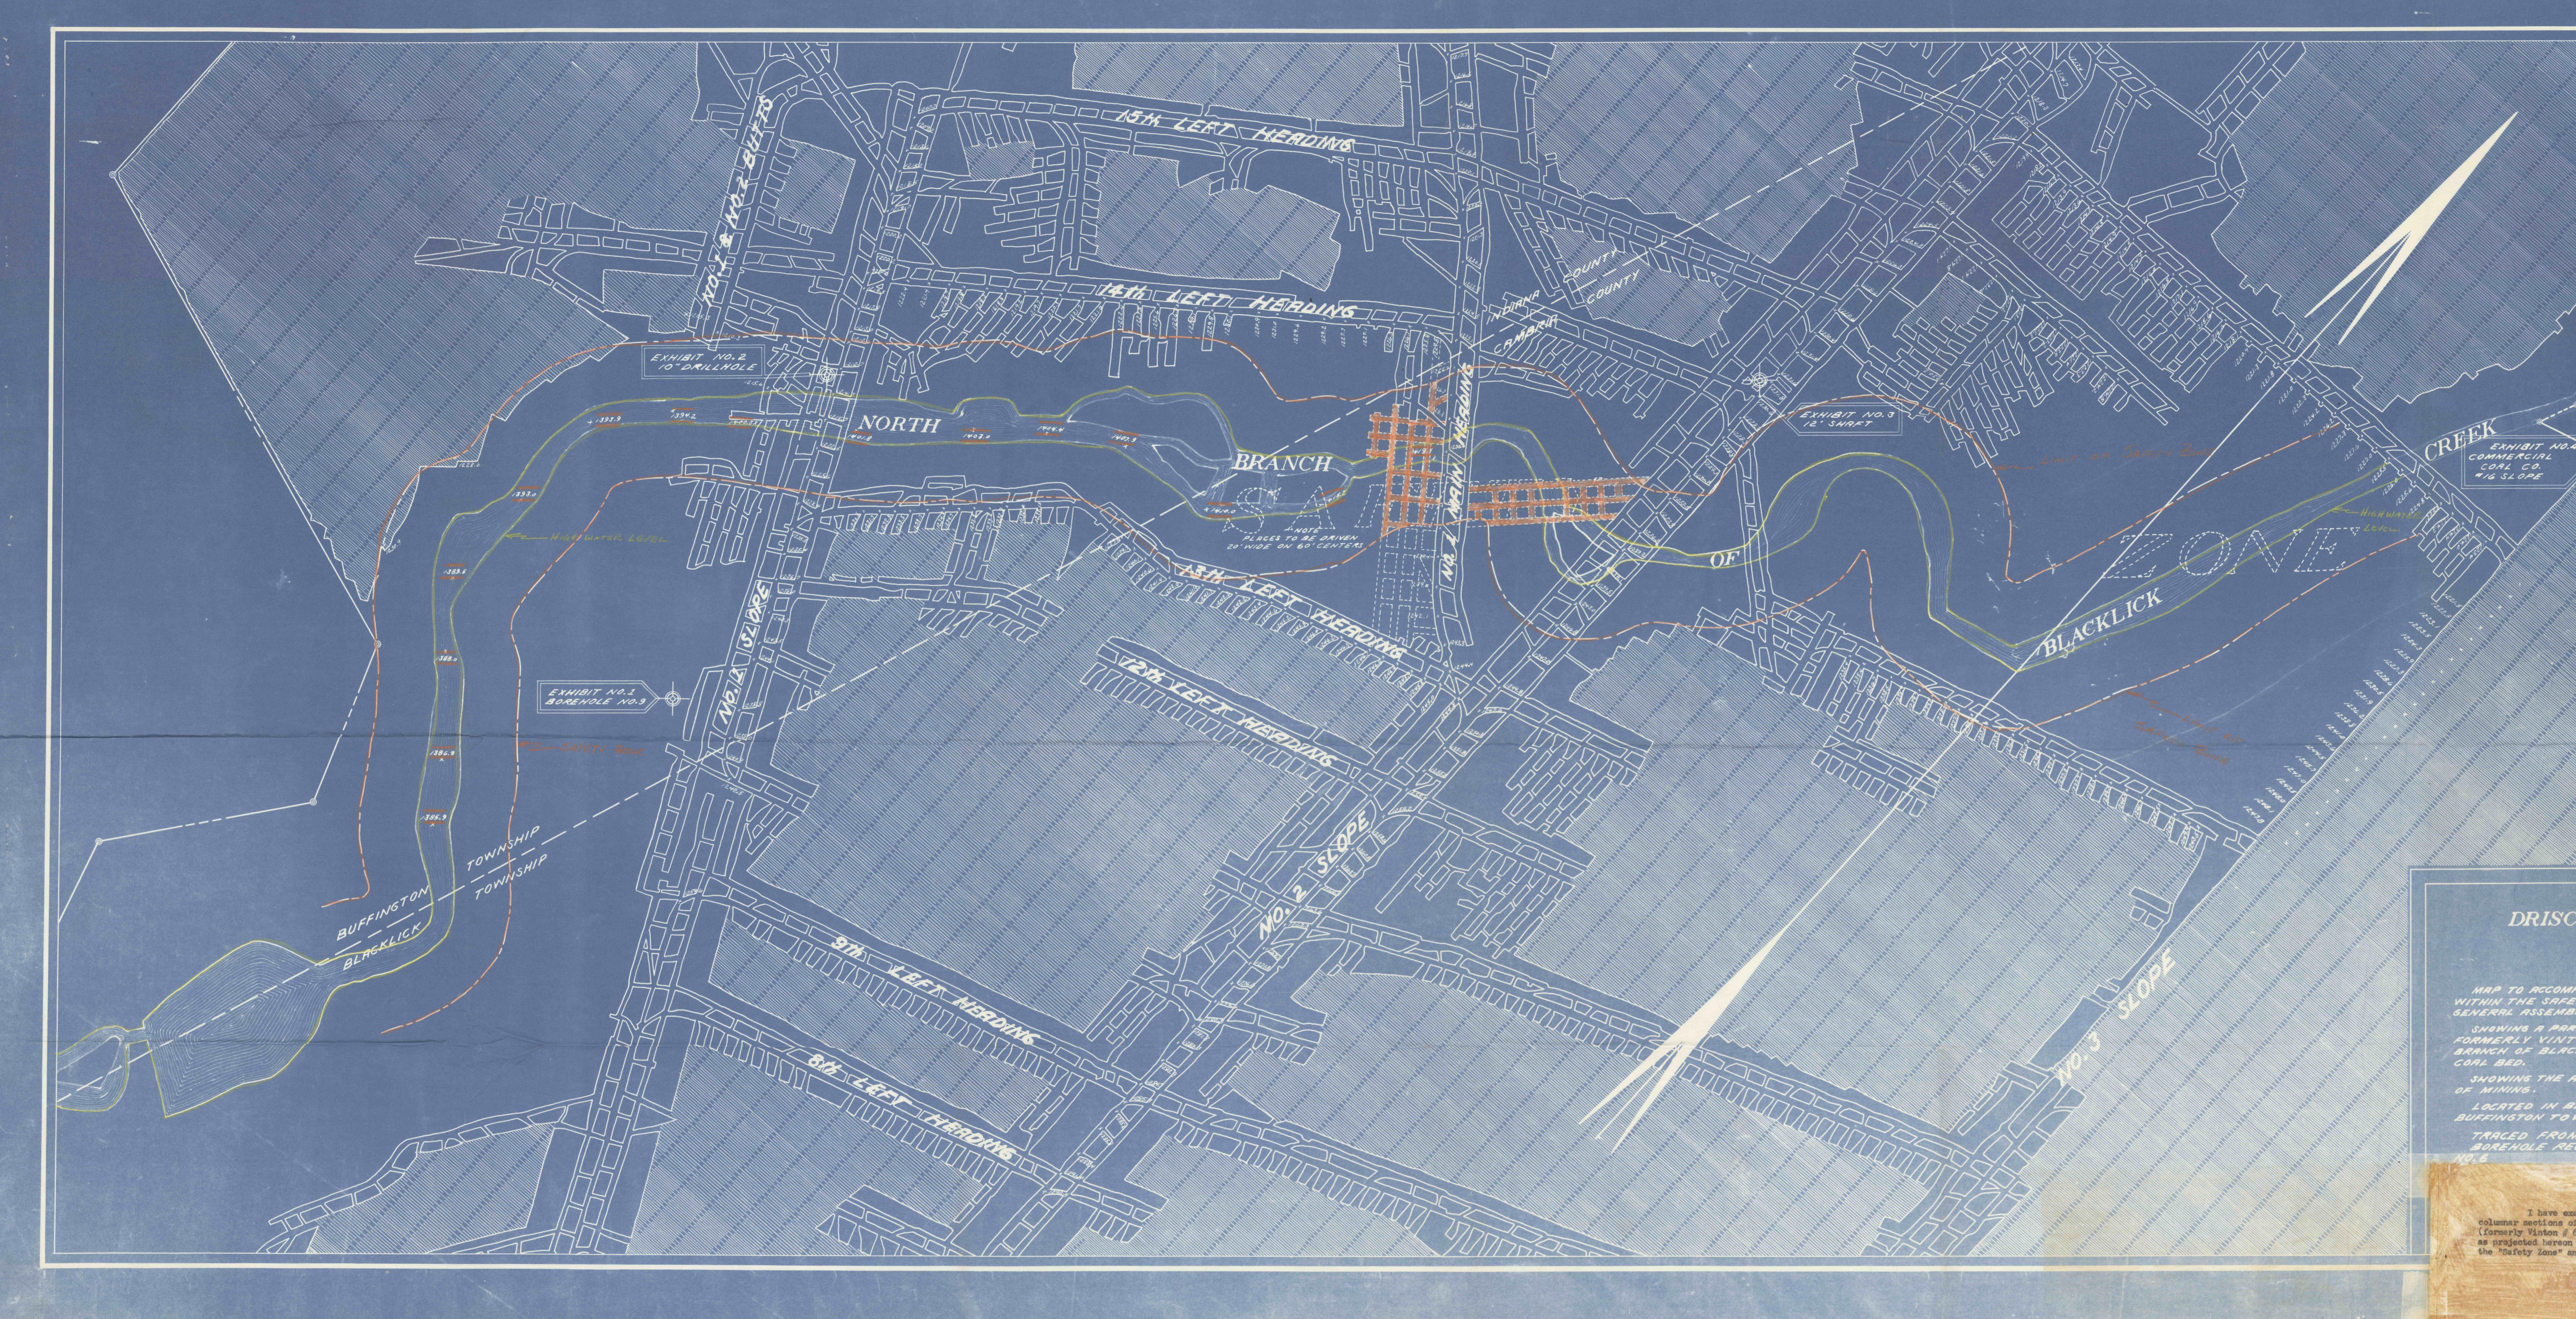
SHOWING THE AREA TO BE MINED, AND THE PLANNED METHOD OF MINING.

TRACED FROM THE VINTON NO.6 200' MINE TRACING. BOREHOLE RECORDS TAKEN FROM THE FILES OF VINTON

I have carefully examined the mine map and the strata of several drill holes of the Vinton Colliery Mine No. 6, situate in Blacklick and Buffington Townships, Indiana County, Pennsylvania, and to the best of my knowledge and belief, feel that the mining of the coal seam as indicated, will not sufficiently disturb the overlying strata to be hazardous.

I have examined this mine map, together with attached columnar sections of the overlying strata, of Driscoll # 4 Mine (formerly Vinton # 6 Mine) and it is my opinion that the mining as projected hereon will not create an unusual condition within the "Safety Zone" and the plan is hereby approved for owner.
