Eureka No. 5 Workings.

PUNXS. C. M. CO.
 Eureka No. 6. (partial map)

Showing workings in vicinity of Mahoning Creek and Eureka No. 5.
 Scale 1"=100'
 Punxsutawney, Pa., Aug. 10, 1917. H.M. Kanarr Engr.

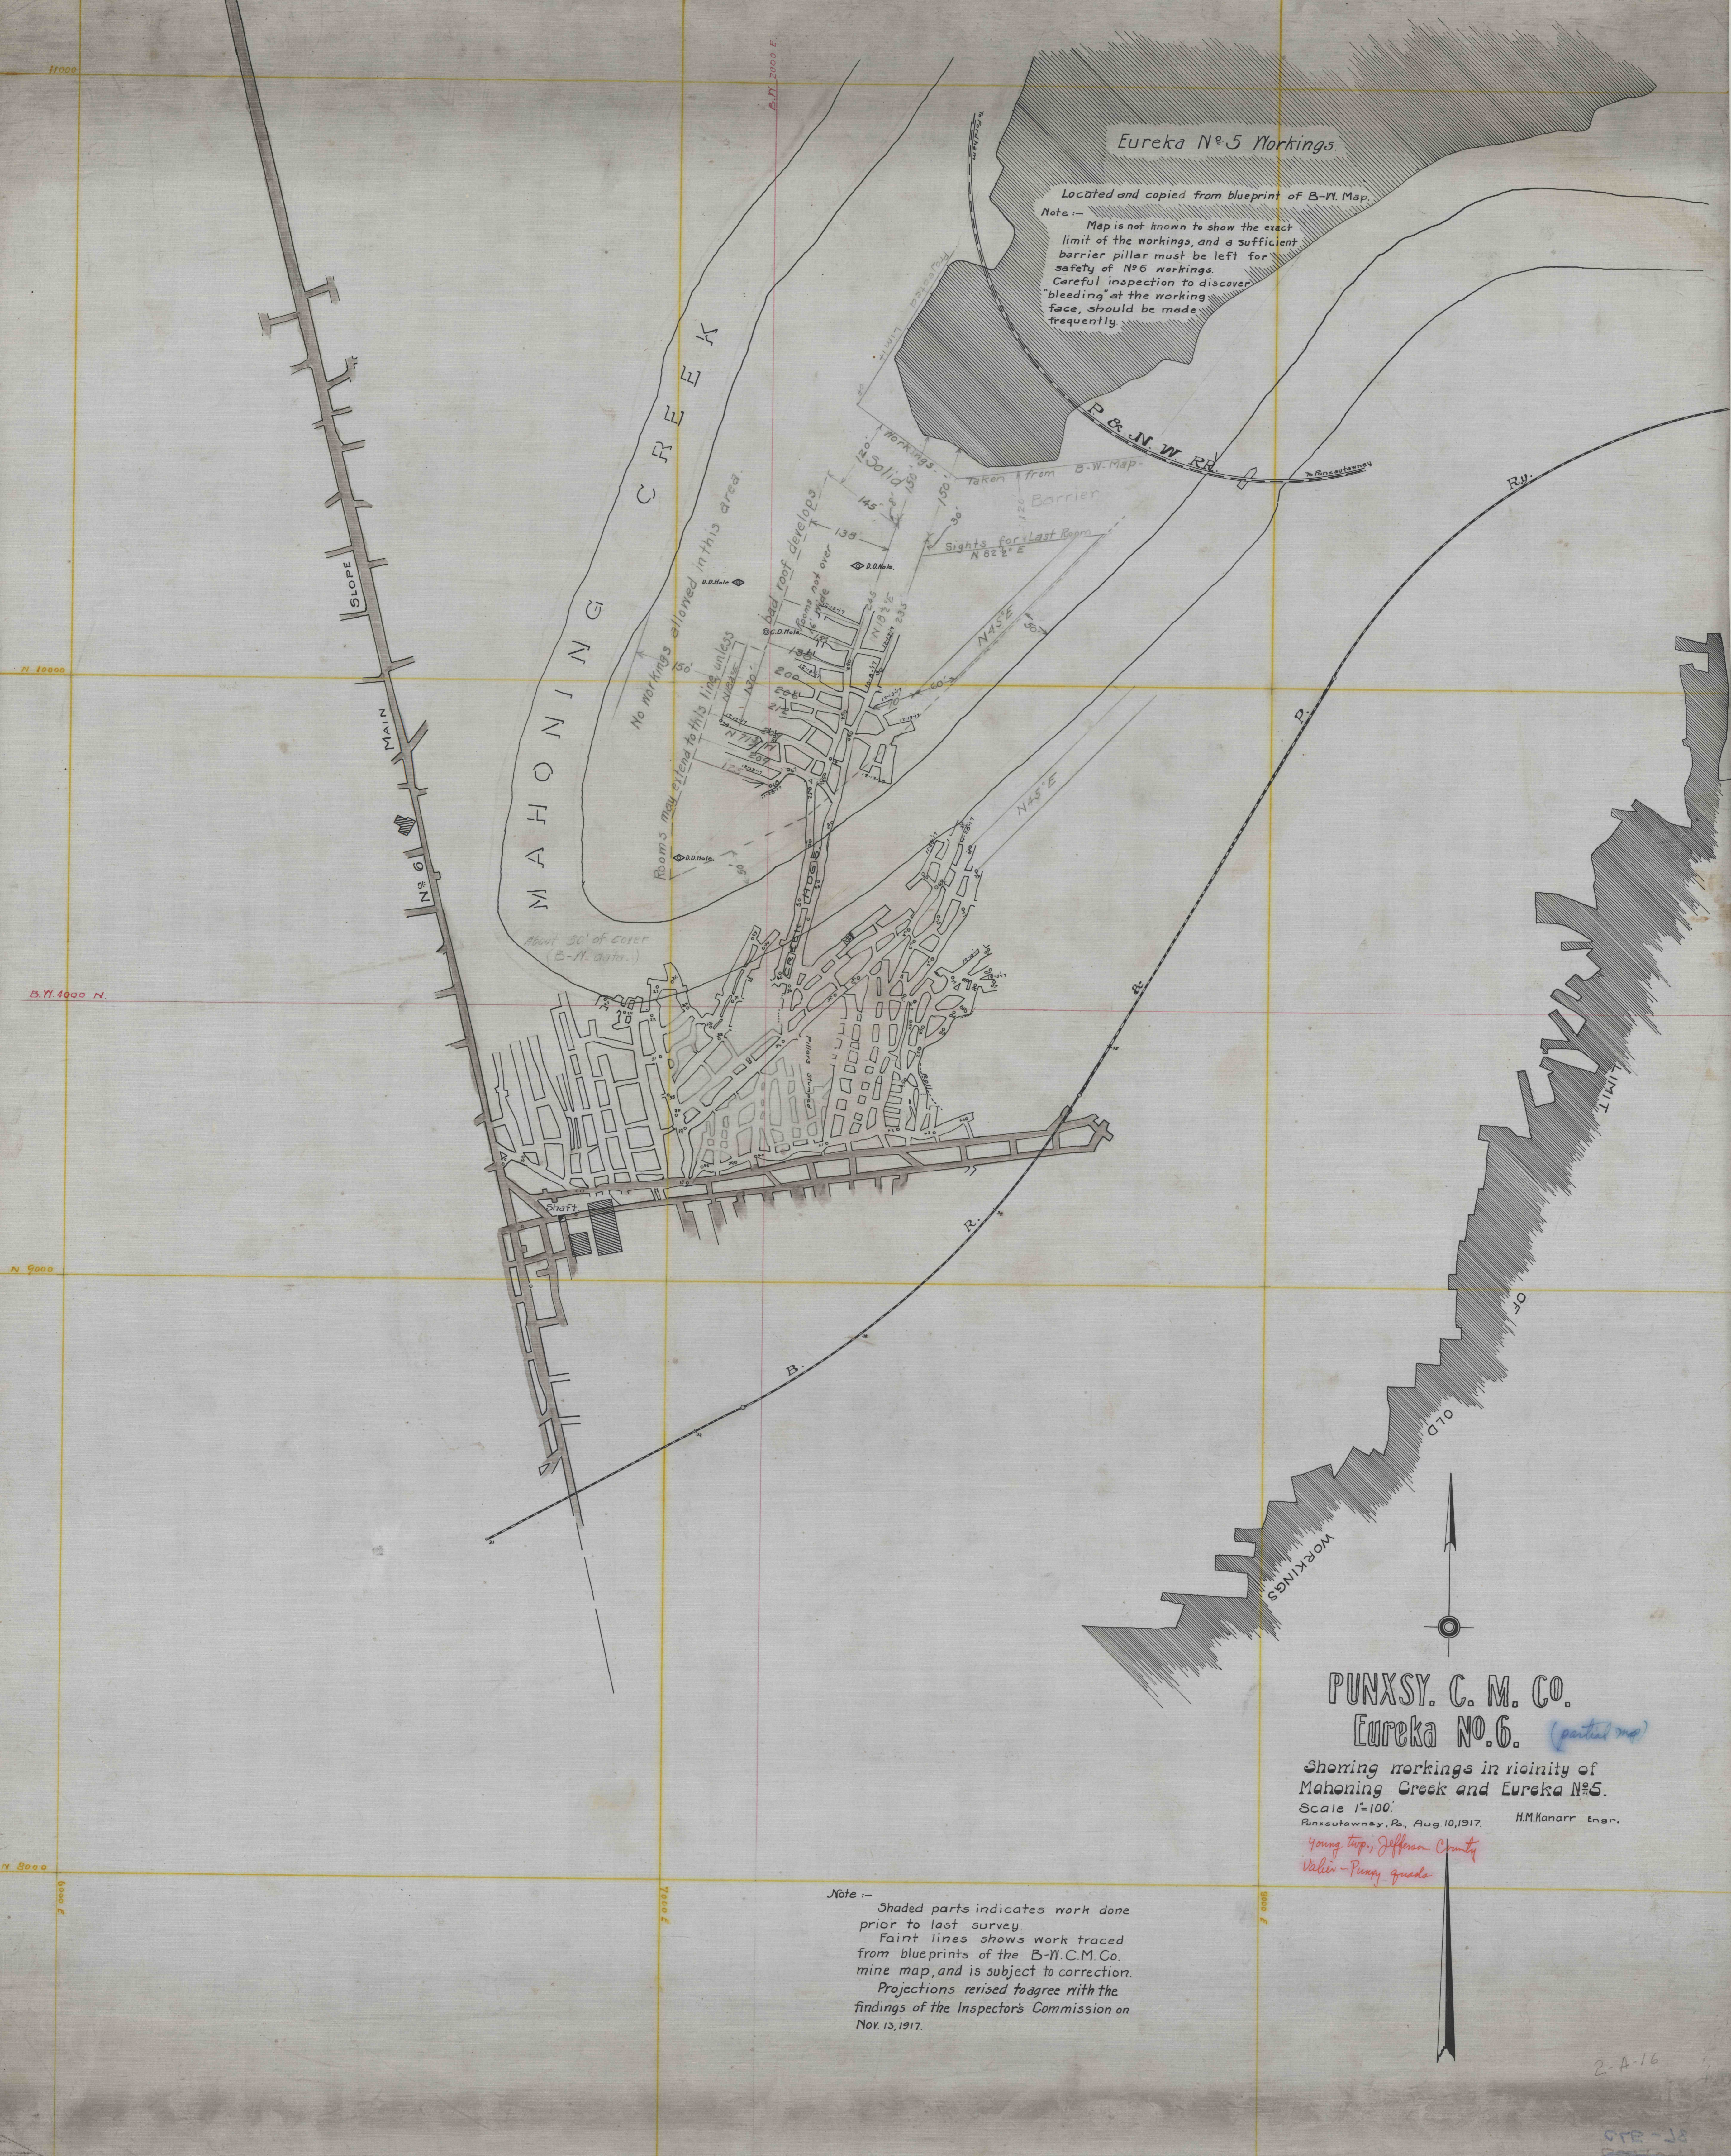
2-A-16

Located and copied from blueprint of B-W. Map.
 Note: - Map is not known to show the exact limit of the workings, and a sufficient barrier pillar must be left for safety of No. 6 workings. Careful inspection to discover "bleeding" at the working face, should be made frequently.

No workings allowed in this area.
 Rooms may extend to this line unless
 bad roof develops
 Ramp out over
 Sights for Last Room
 N 82 1/2° E

About 30' of cover
 (B-W. data.)

Note: - Shaded parts indicates work done prior to last survey. Faint lines shows work traced from blueprints of the B-W.C.M. Co. mine map, and is subject to correction. Projections revised to agree with the findings of the Inspector's Commission on Nov. 13, 1917.
