CRESCENT REFRACTORIES CO.

ENV. No. 41
SHEET No. 148
50-3-350

MAP SHOWING RIGHT OF WAY ACROSS
LANDS OF THE ROARING RUN STONE CO.,
SITUATED IN PIKE TWP. CLEARFIELD CO., PA.

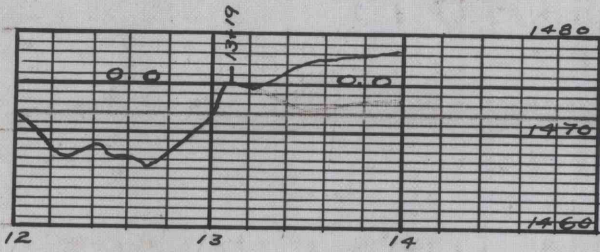
PROFILE CRES. REF. CO.
VER. 1" = 20'
HOR. 1" = 100'

13+69 = ϕ of BOTH TRACKS AT INTERSECTION

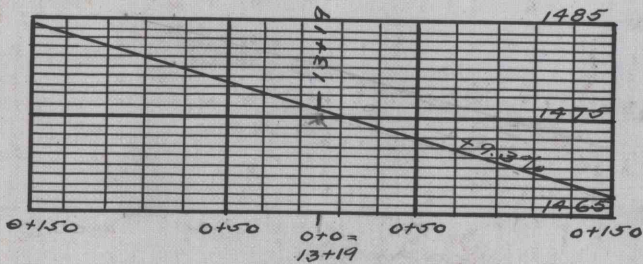
PROFILE ROARING RUN STONE CO.
SCALE VER. 1" = 20'
HOR. 1" = 100'
