BOUCHER-CORTRIGHT COAL CO.
 MAP OF
 OPERATION ON 'D' SEAM
 Beavertown, Cambria Co., Pa.
 Scale 1"=400' - Gardner M. Sicker - June 2, 1917.
 Mining Engineer
 Johnstown, Pa.

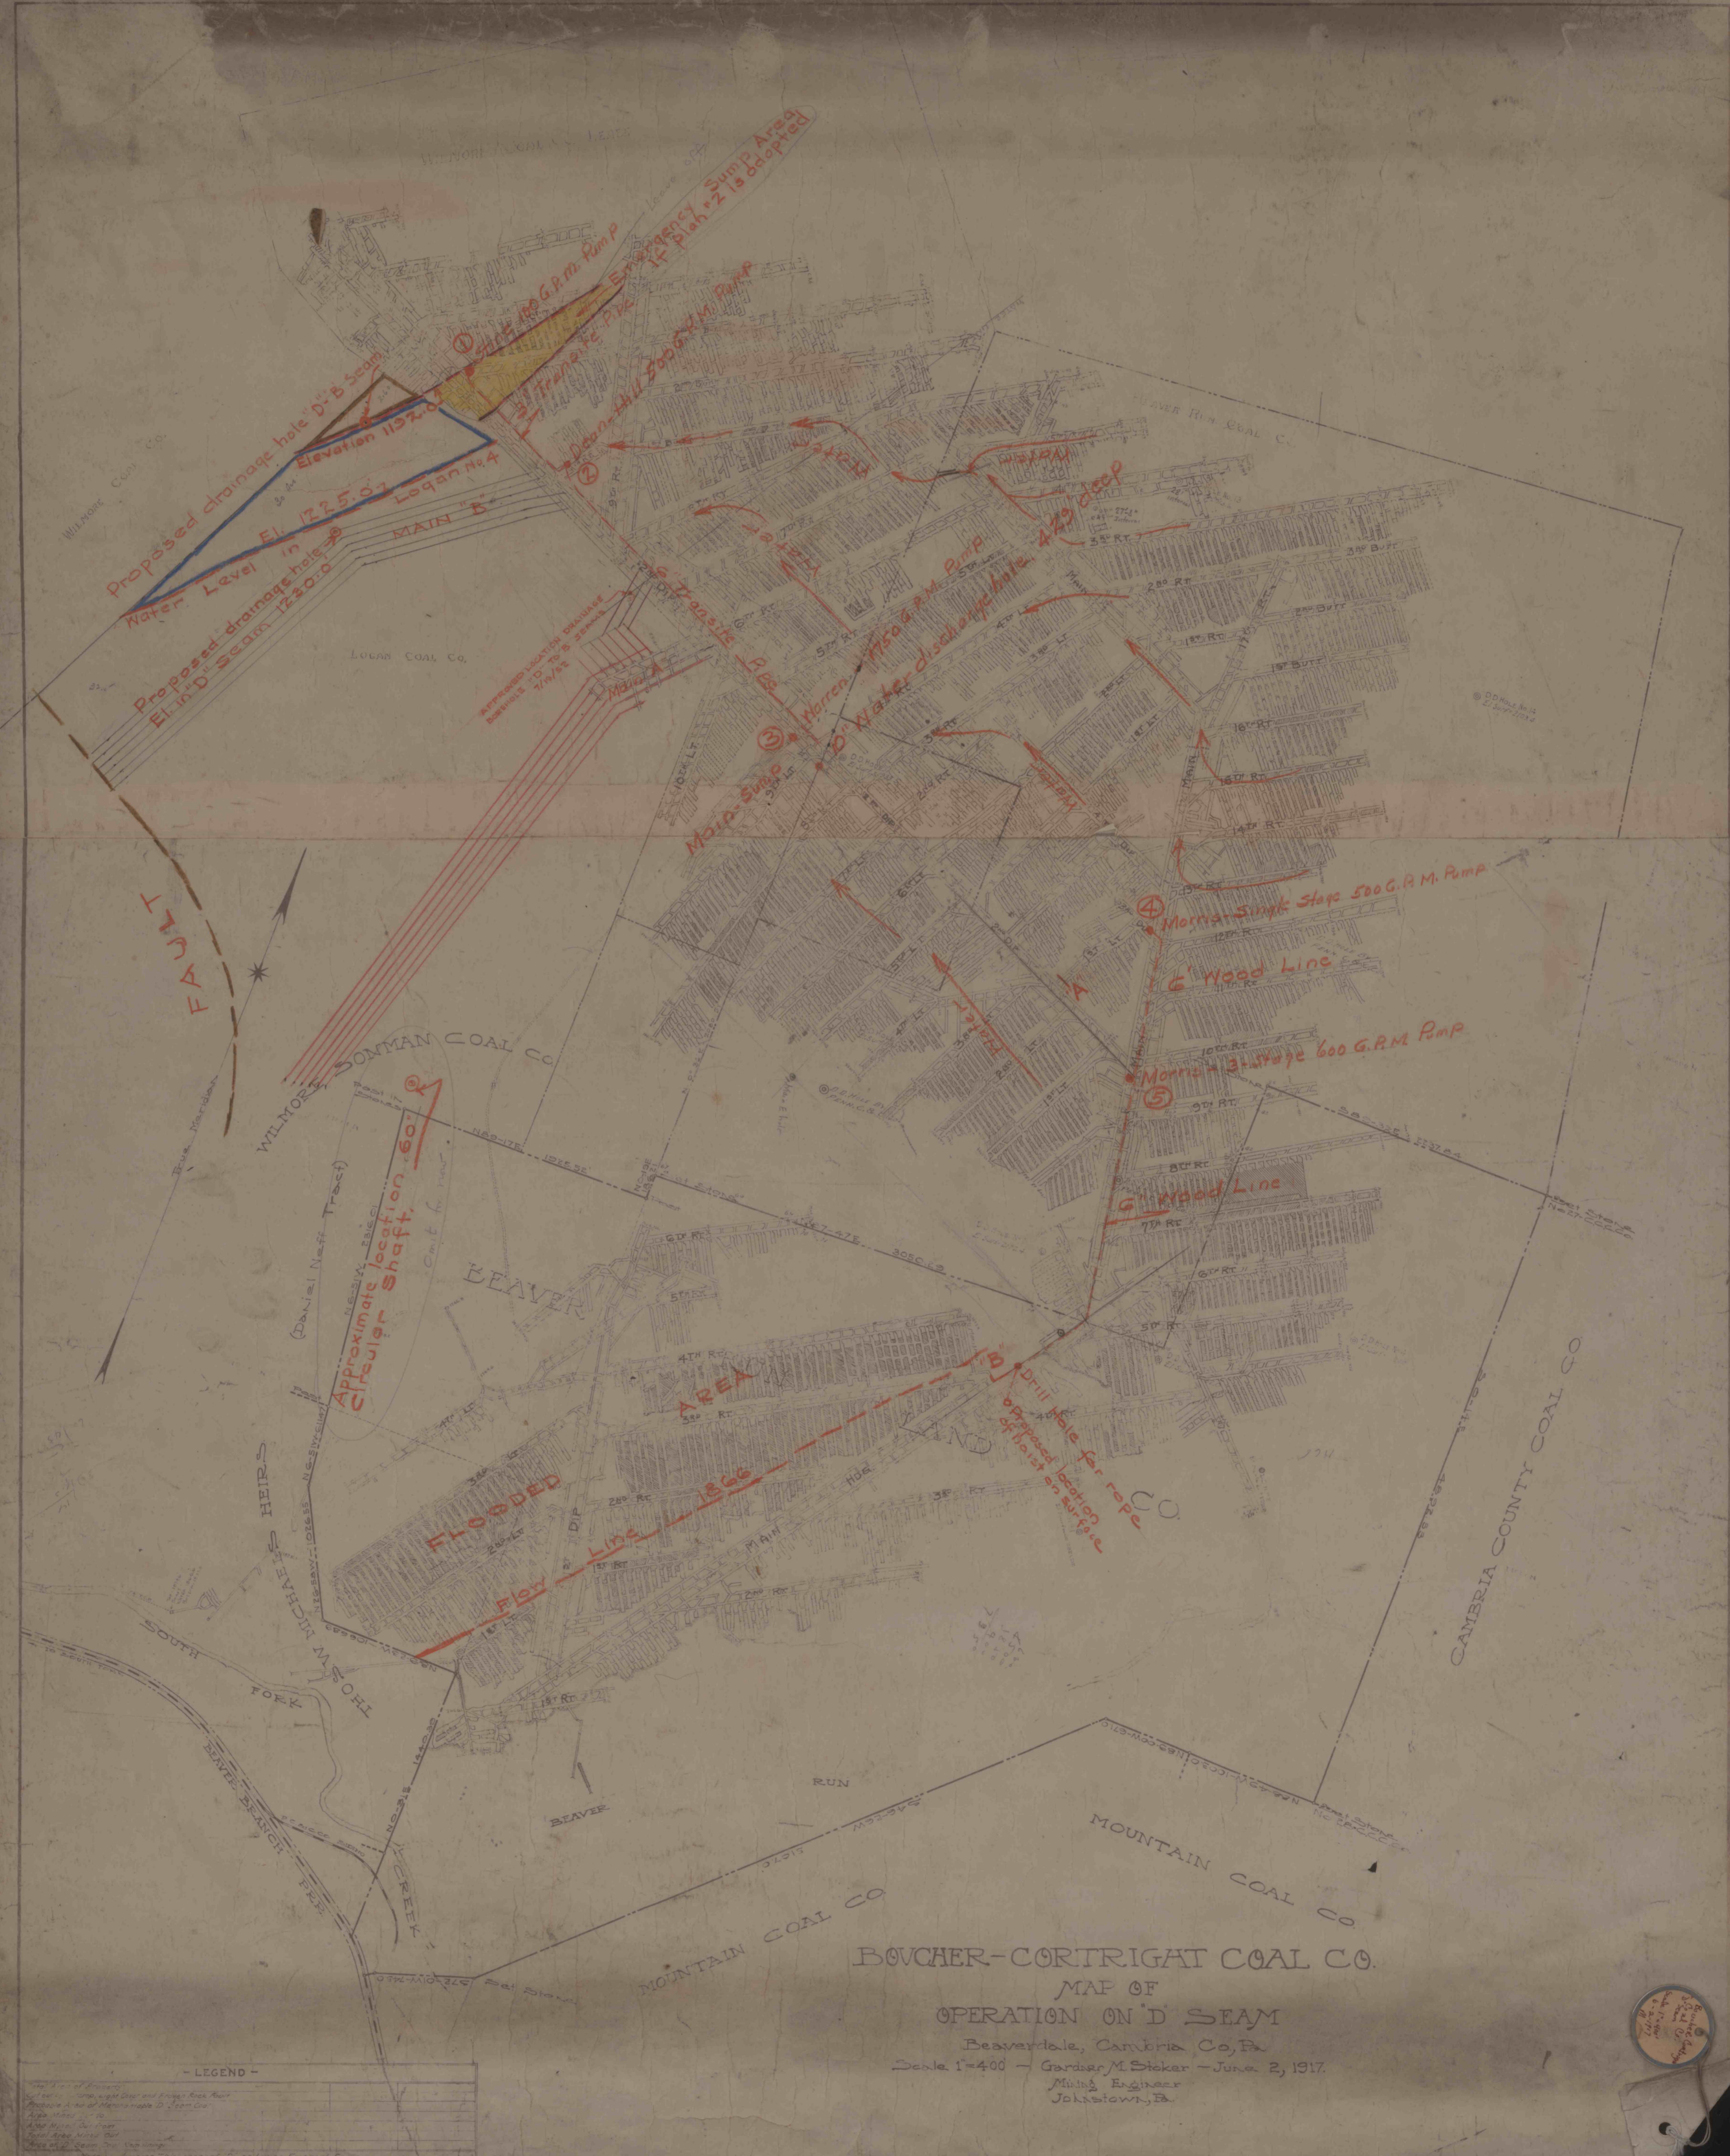
Proposed drainage hole 'D' B Seam
 Elevation 1132.0
 Water Level in 'D' Seam 1225.0
 Logan No. 4
 MAIN B

Approximate location 60' Circular Shaft

FLOODED AREA
