STEVE SUMAK
 FATAL ACCIDENT
 BARNES & TUCKER CO.
 OLD NO. 10 MINE
 BARNESBORO, PA.

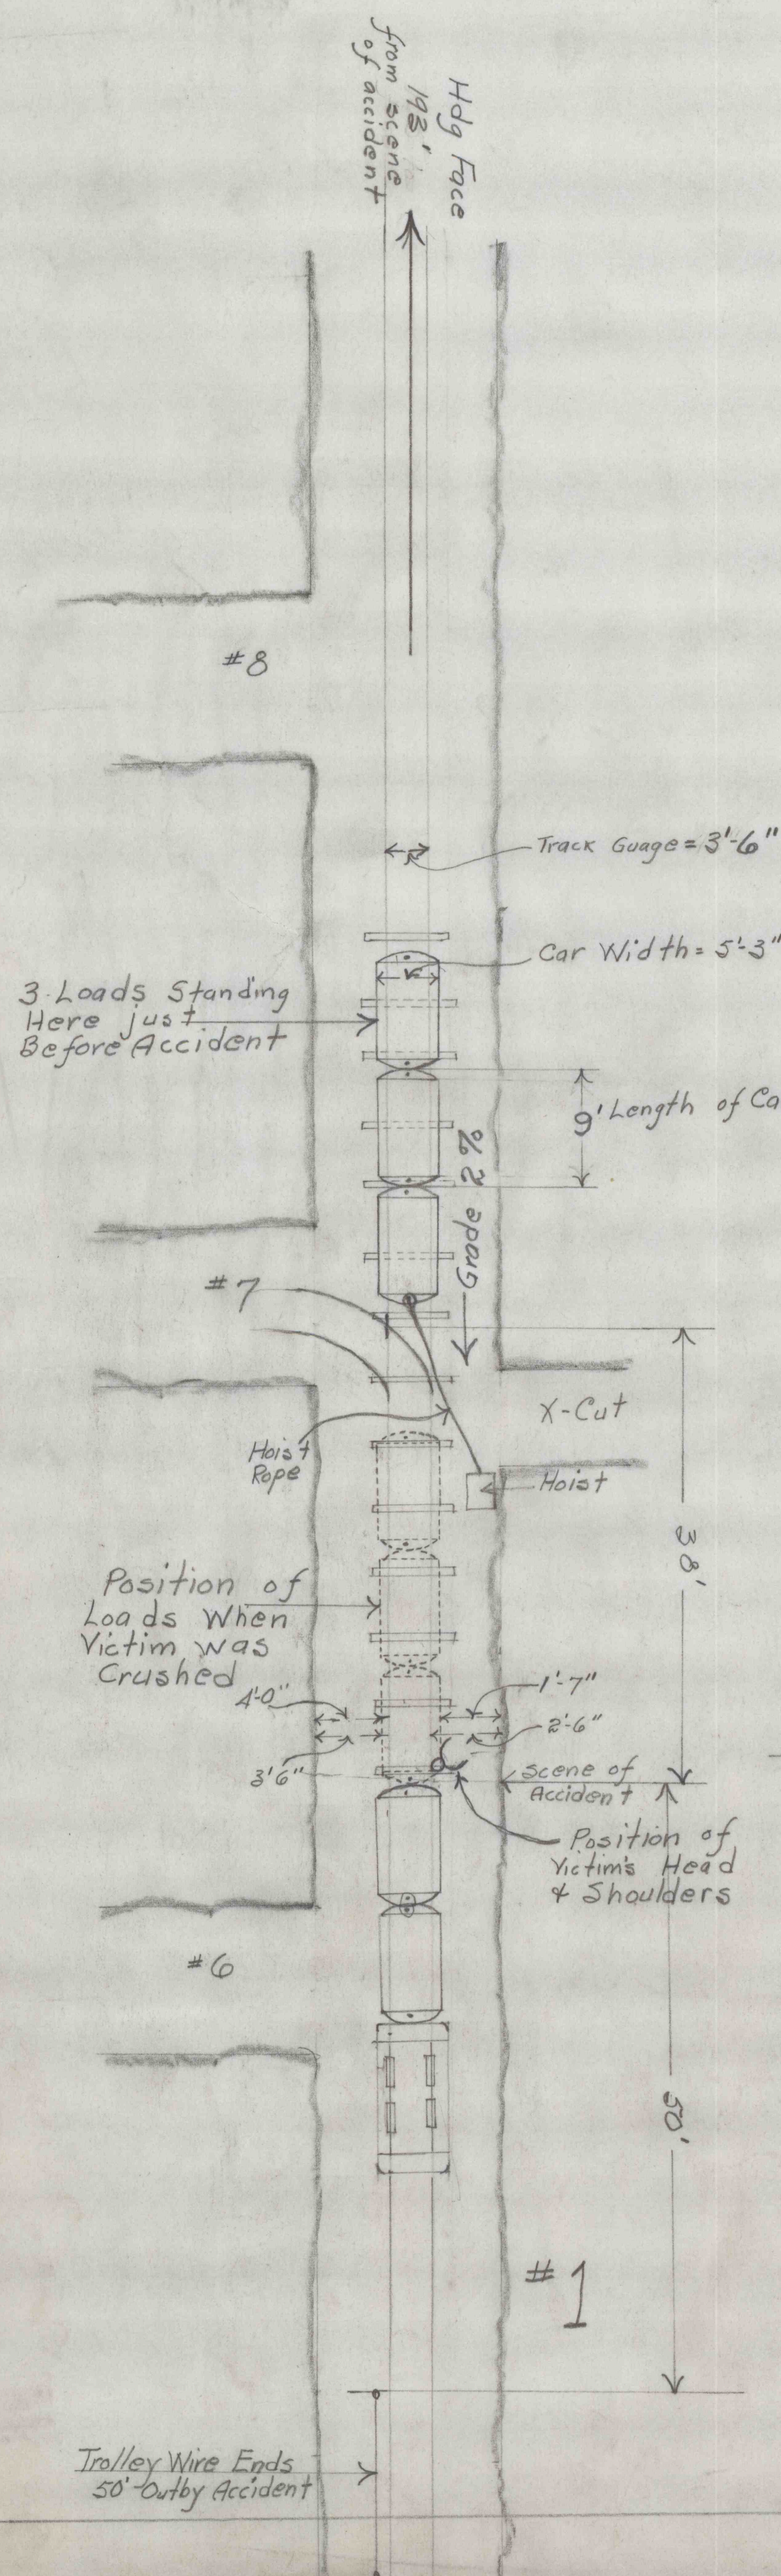
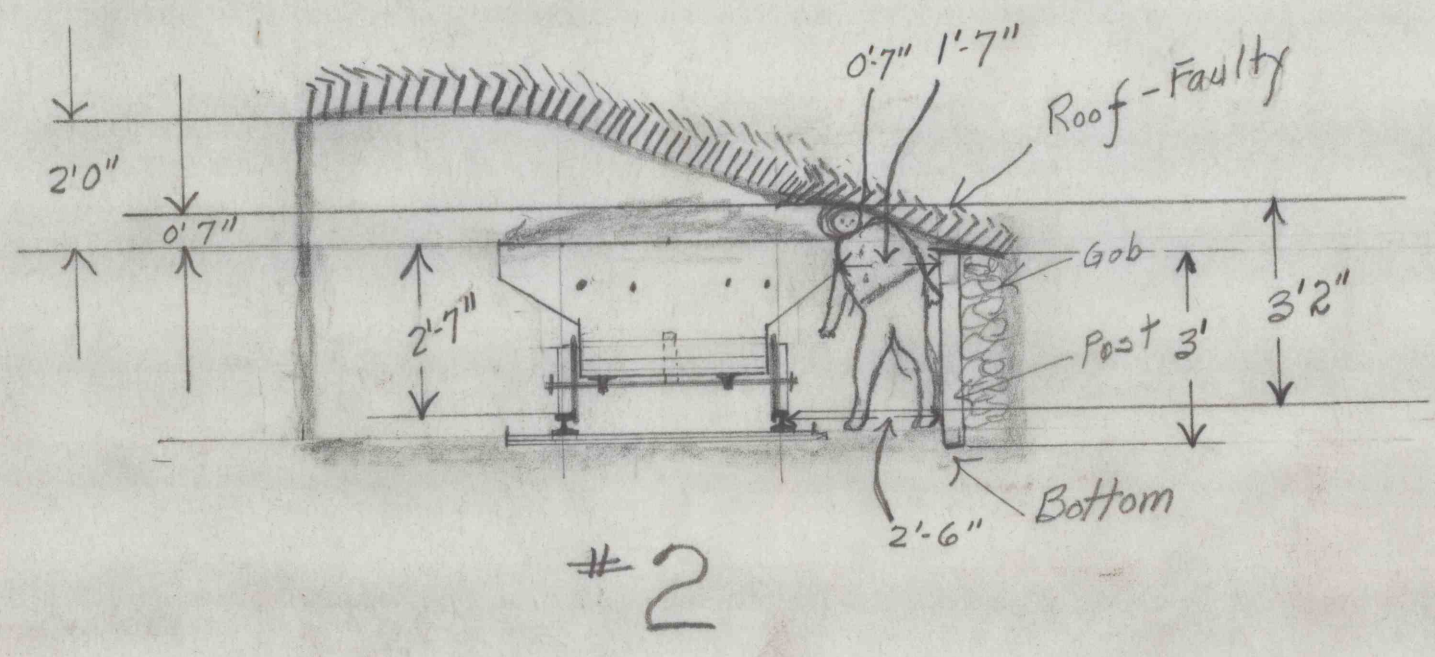
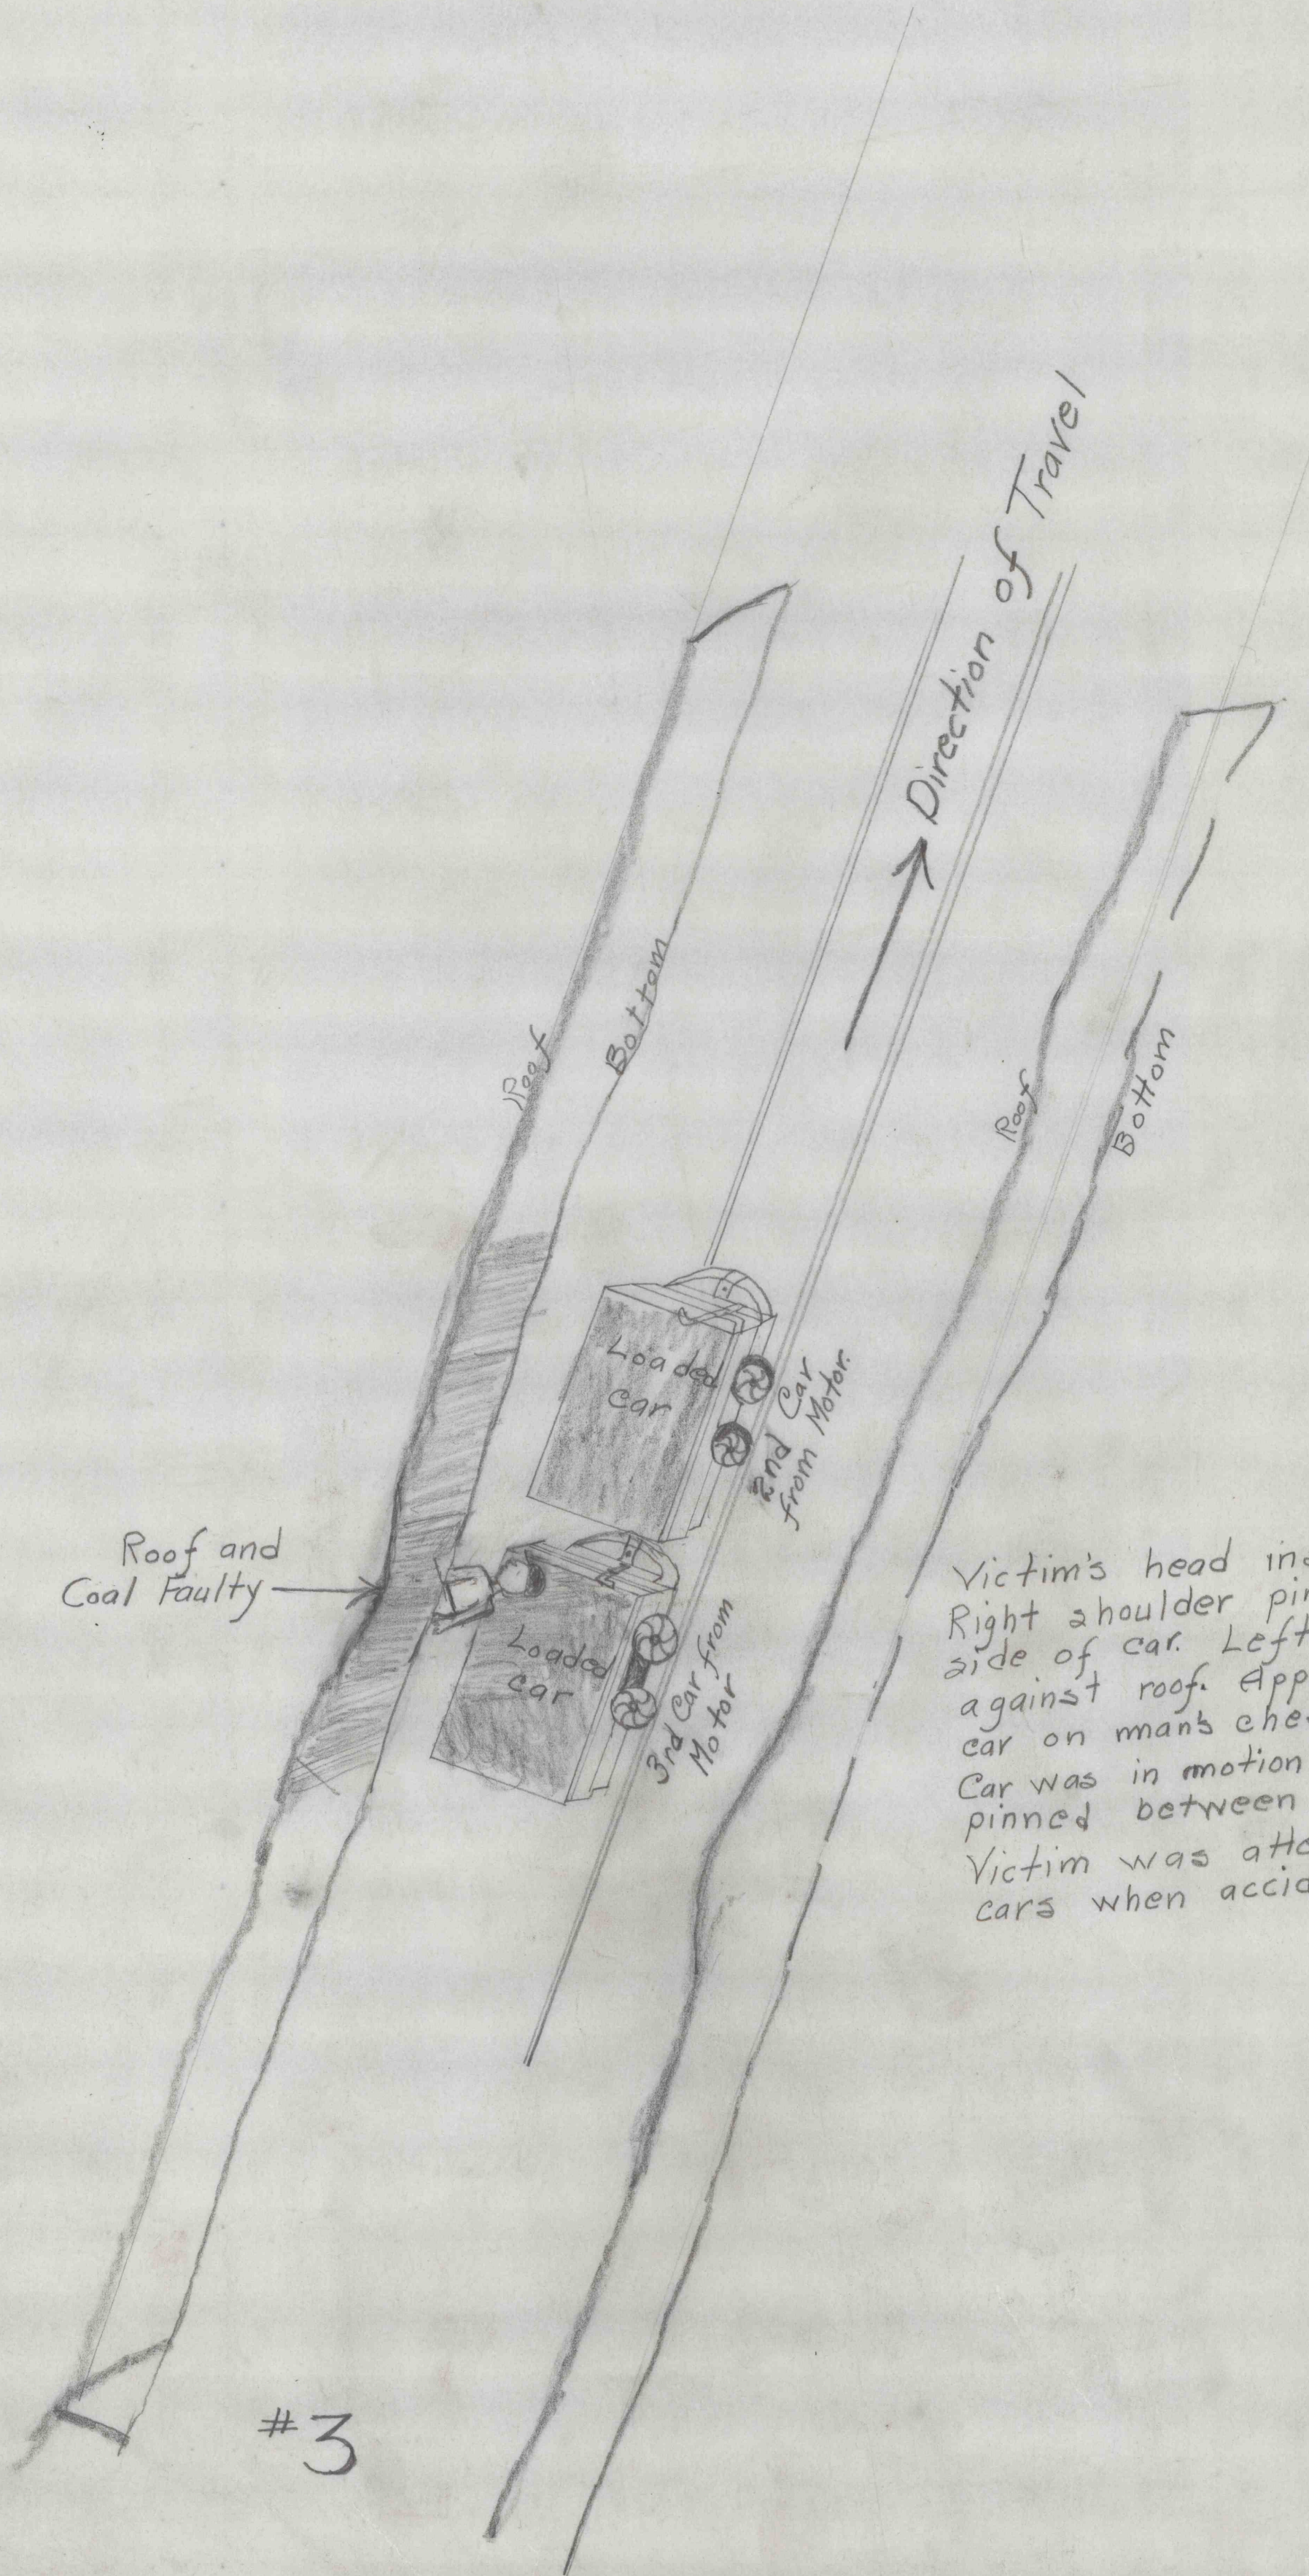
Scale 1" = 10' in #1
 1" = 3' in #2
 1" = 5' in #3
 March 9, 1942

Victim's head inside car as shown. Right shoulder pinned against left side of car. Left shoulder caught against roof. Apparently force of car on man's chest caused injury. Car was in motion when man got pinned between roof and car. Victim was attempting to couple cars when accident occurred.
