Date of Injuries Sept. 25, 1937.

ROCK FALL ACCIDENTS  
 CONVEYOR ROOM PILLAR  
 BARNES COAL NO. 15,  
 BAKERTON, CAMBRIA CO., PA.  
 S.C. 1" = 4 FT. Sept. 29, '37

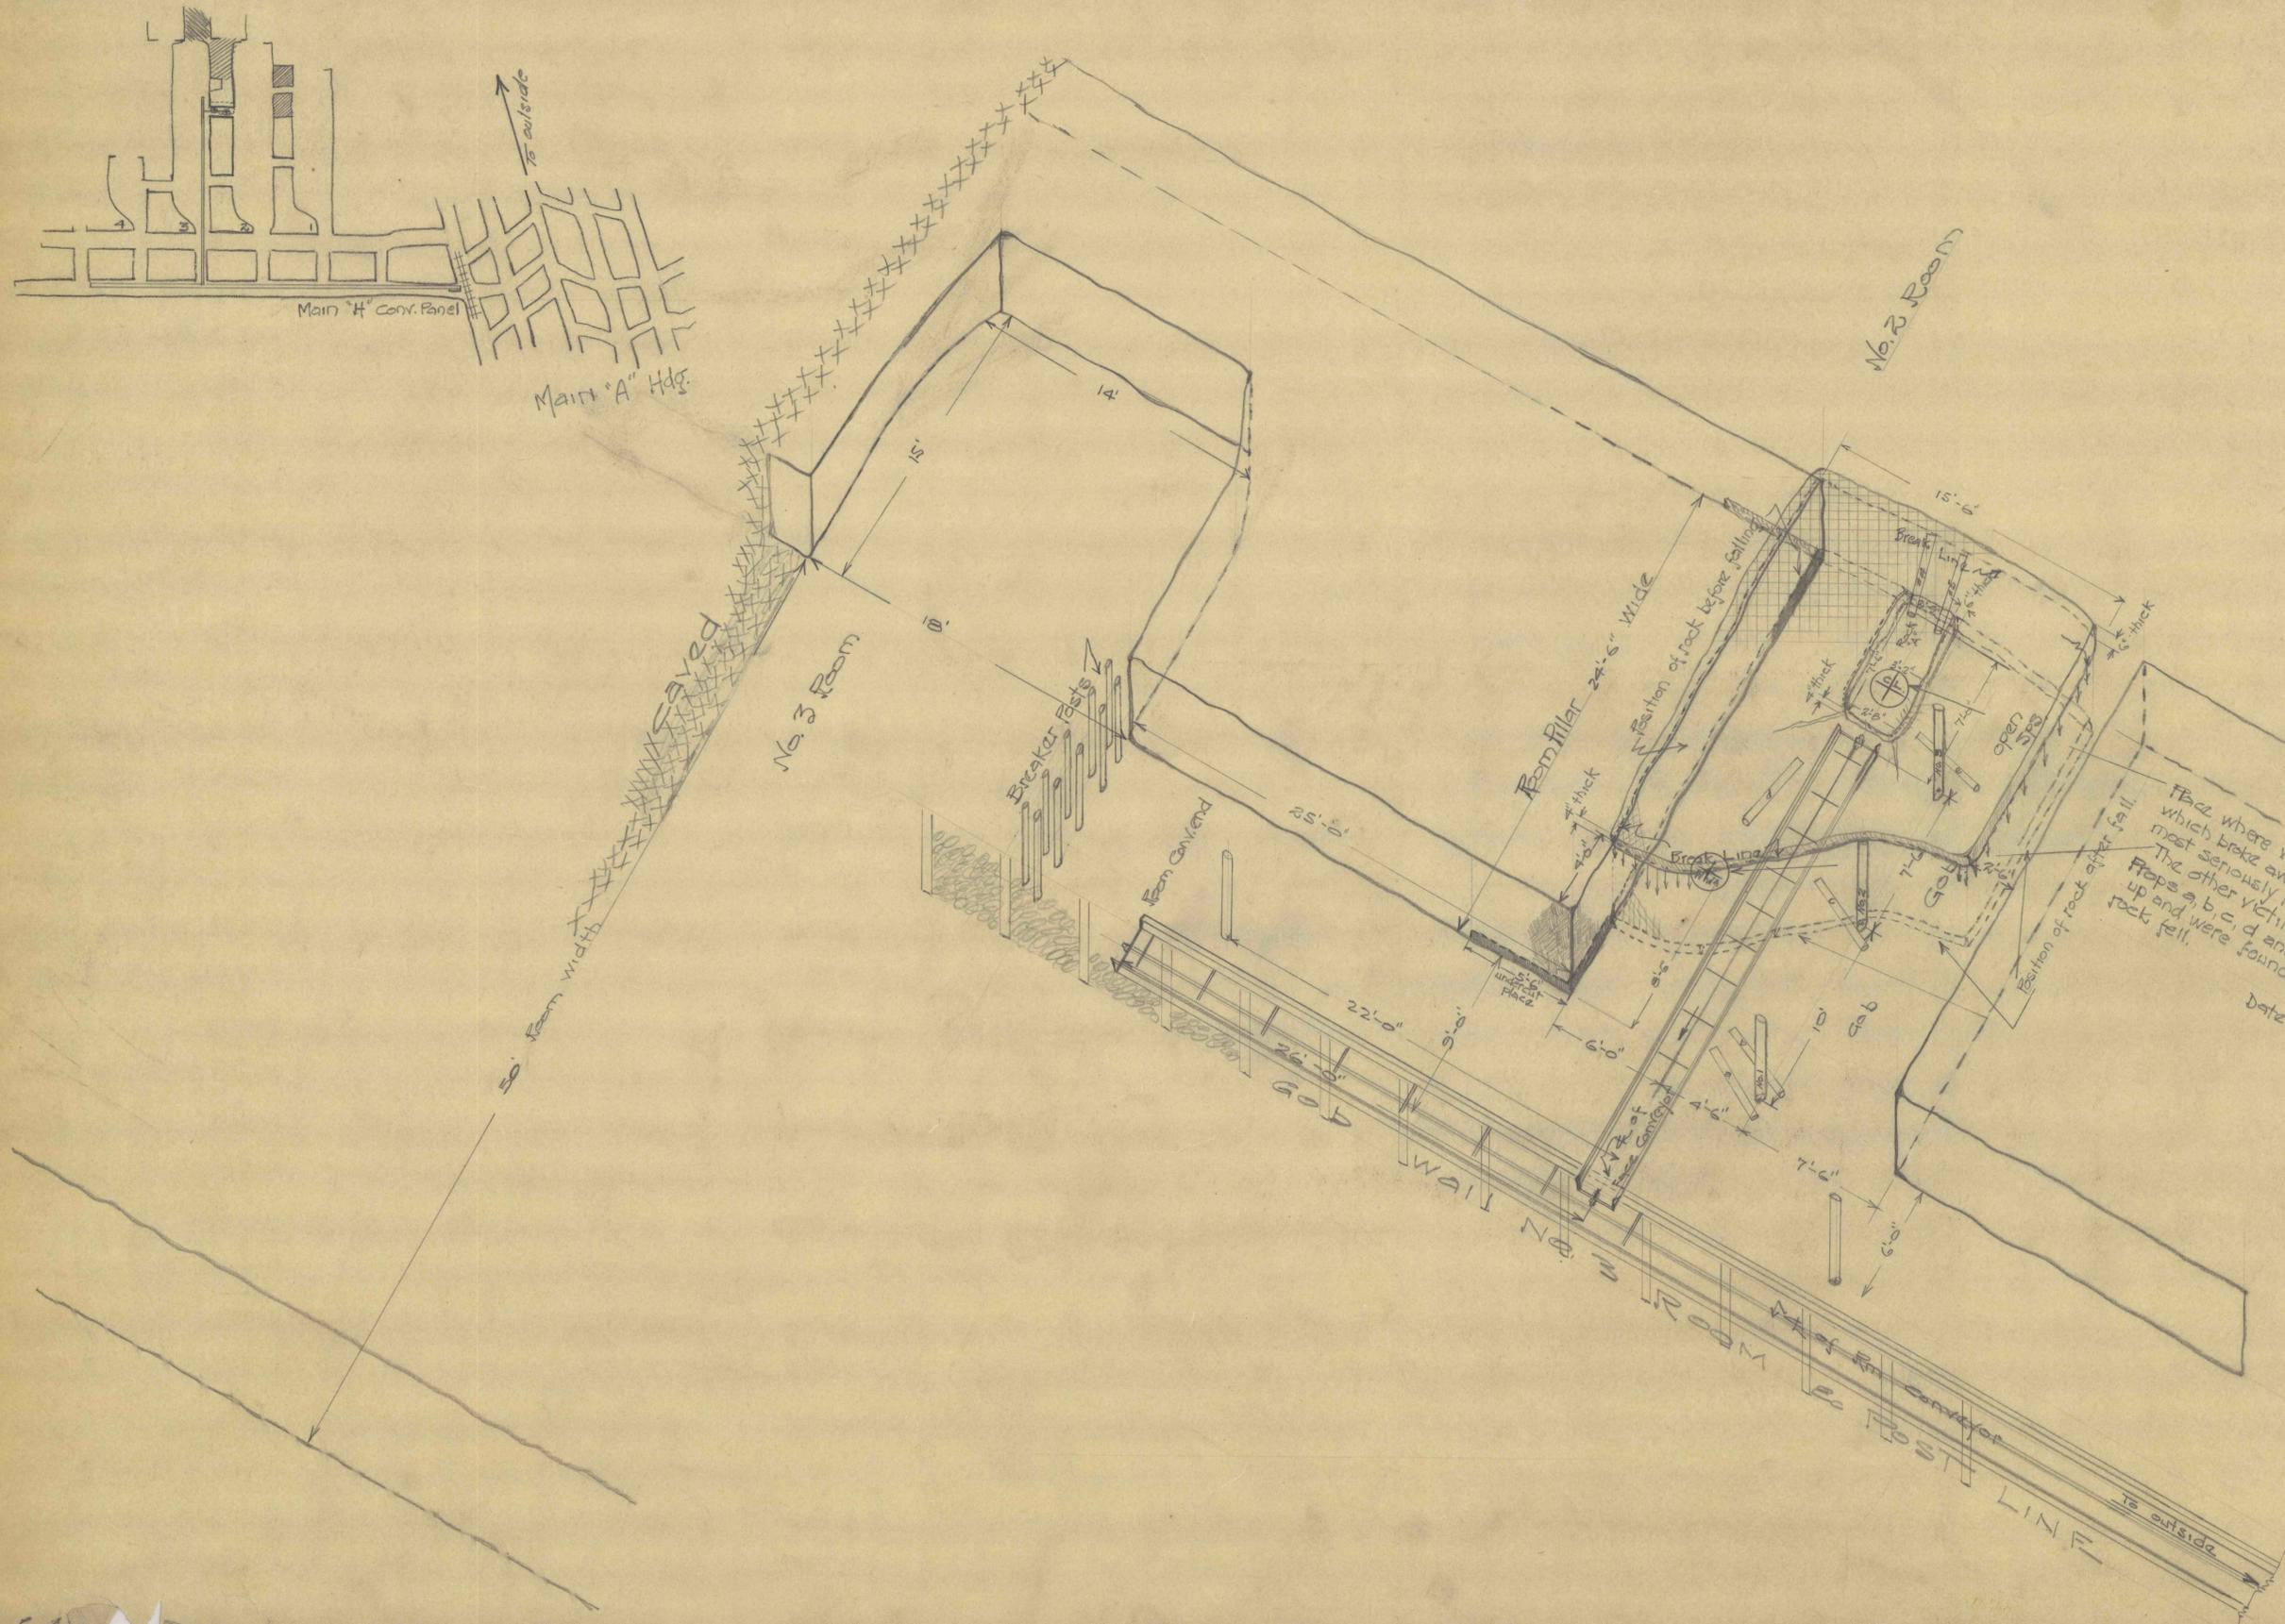
Place where victim was caught, under rock slab 'A' which broke away from main slab (24'-6" x 15'-6"). C.L. was most seriously hurt. The other victims W.W. was caught where shown. Props a, b, c, d and e were being prepared for setting up and were found in the position shown, after the rock fell.
