Position of victim between face and cutting machine

Barnes-Tucker Co,  
#15 Mine, Bakerton, Pa.  
Fatal Accident of  
John Stislow  
April 21, 1945

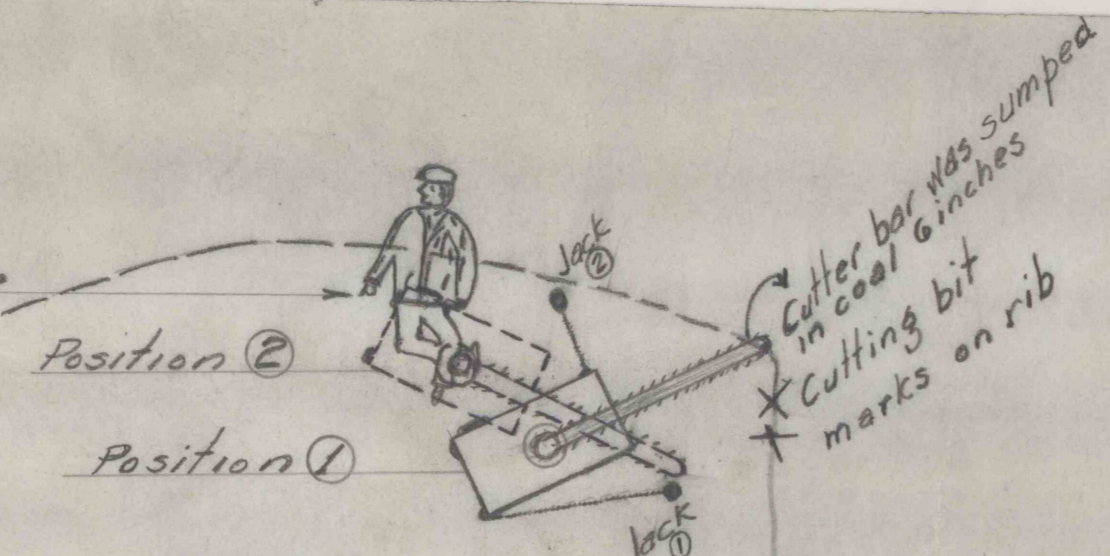
Cutter was sumping machine into right side of the face as shown in position 1. He misjudged the distance to coal, causing the cutter bar to jump striking the rib at 1'-5" and 3'-0" from corner of face and marked X then struck jack (j-1) which was set in place, the jack did not fall down, but forced the machine toward the face coming into position 2 catching the victim, who was at the controller and friction gear, between the machine and room face

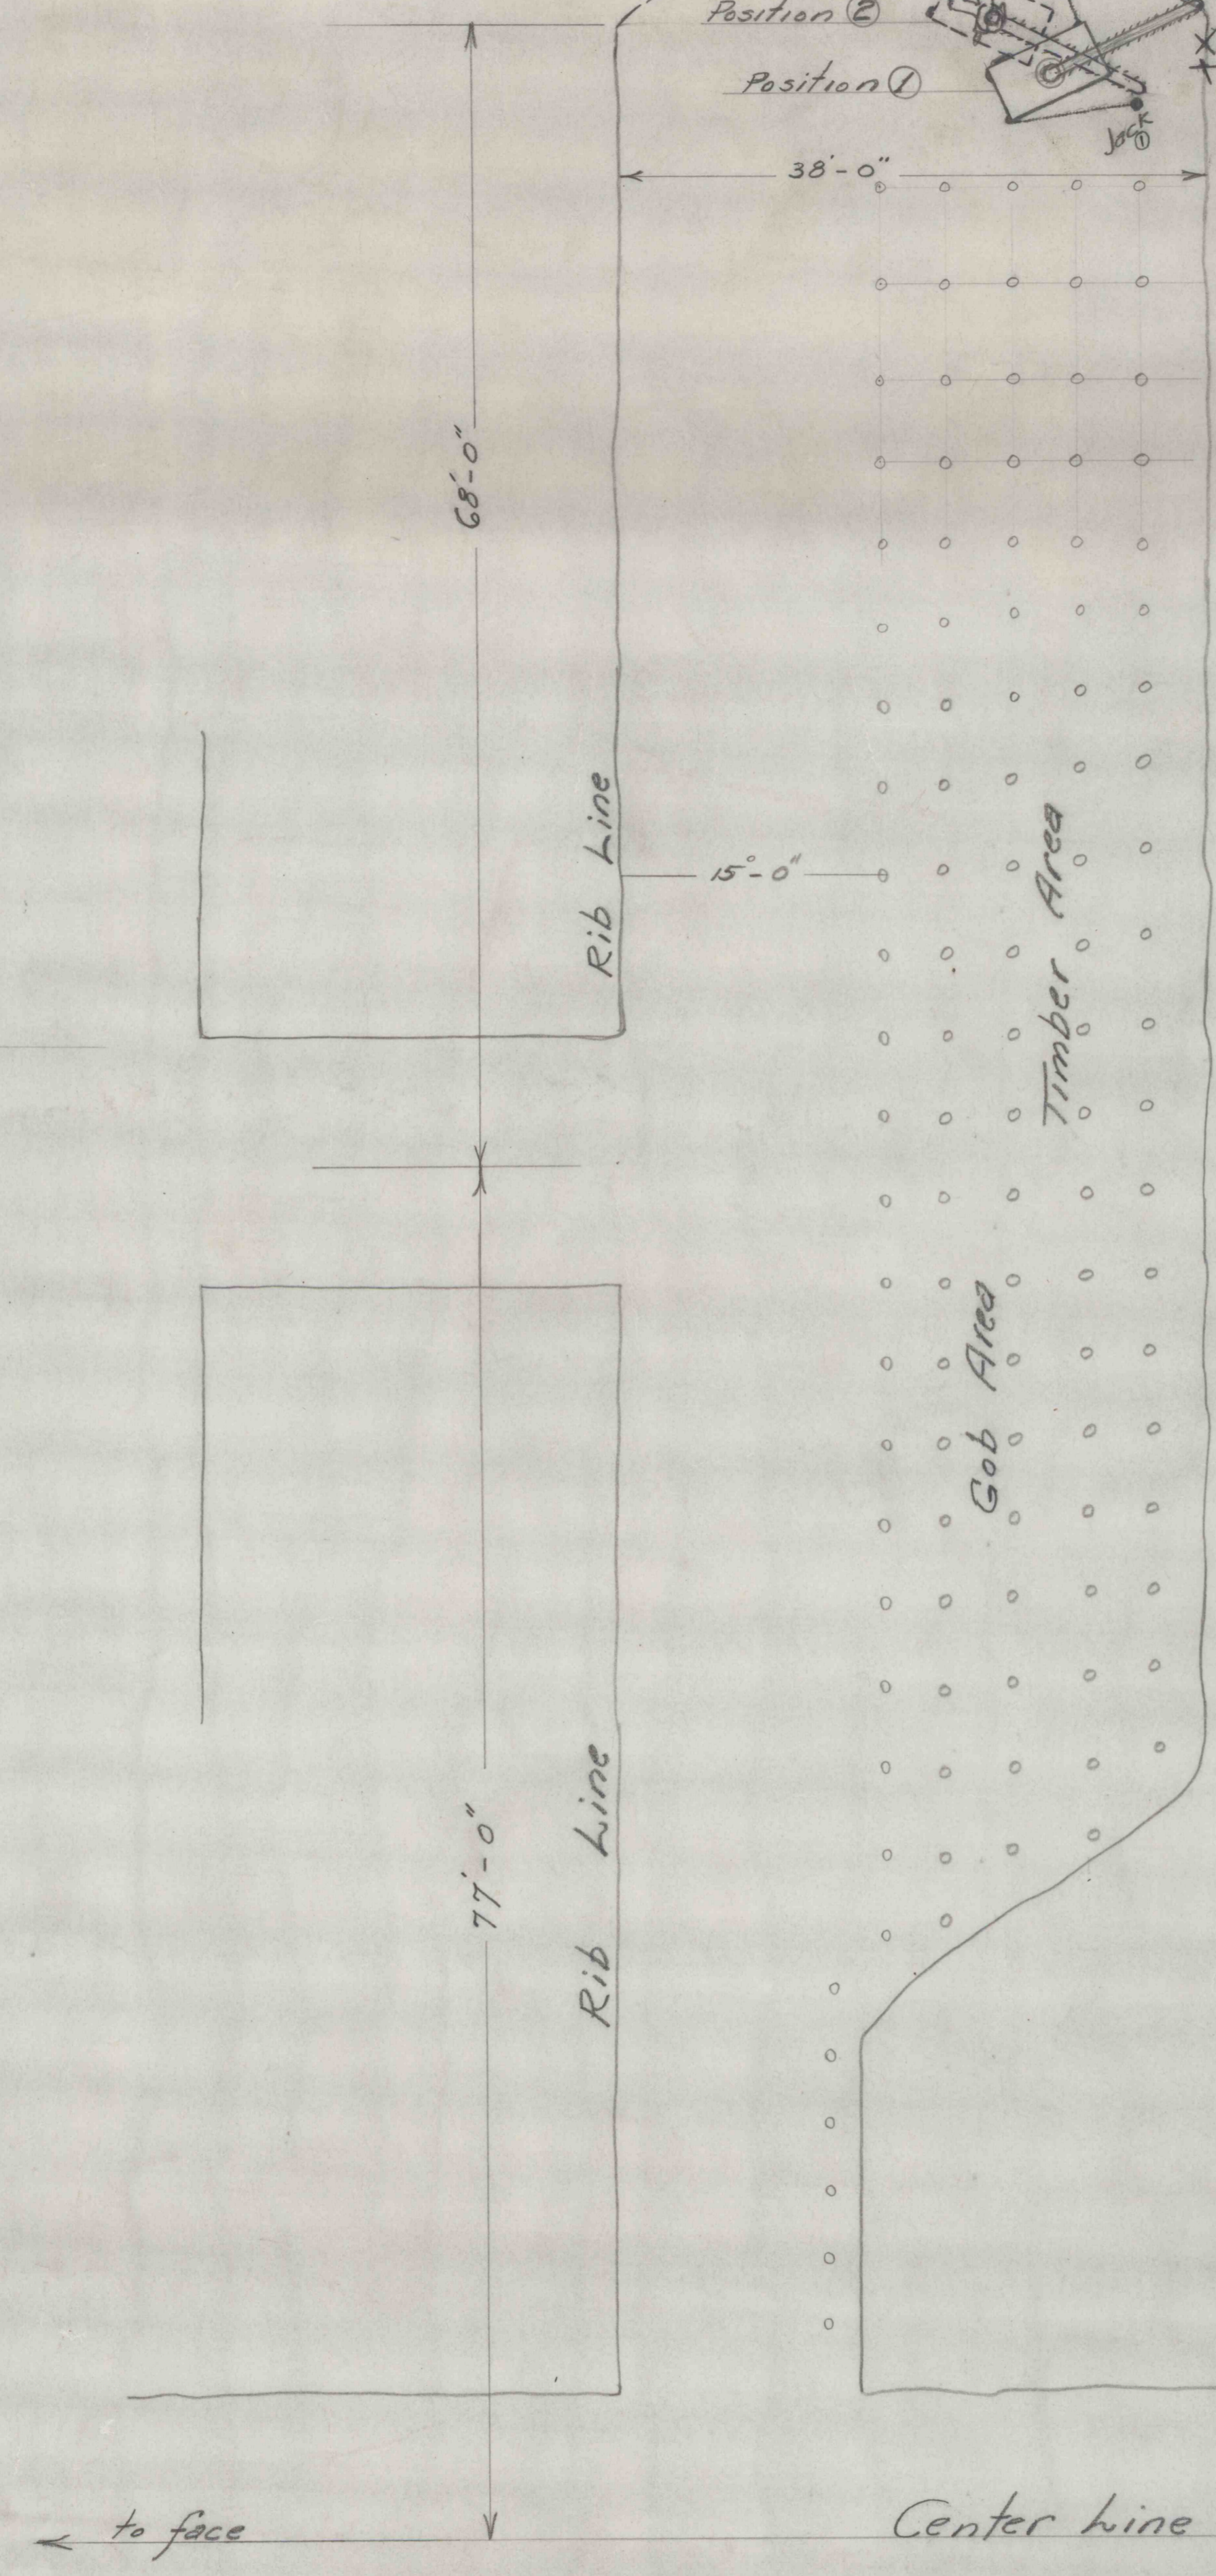
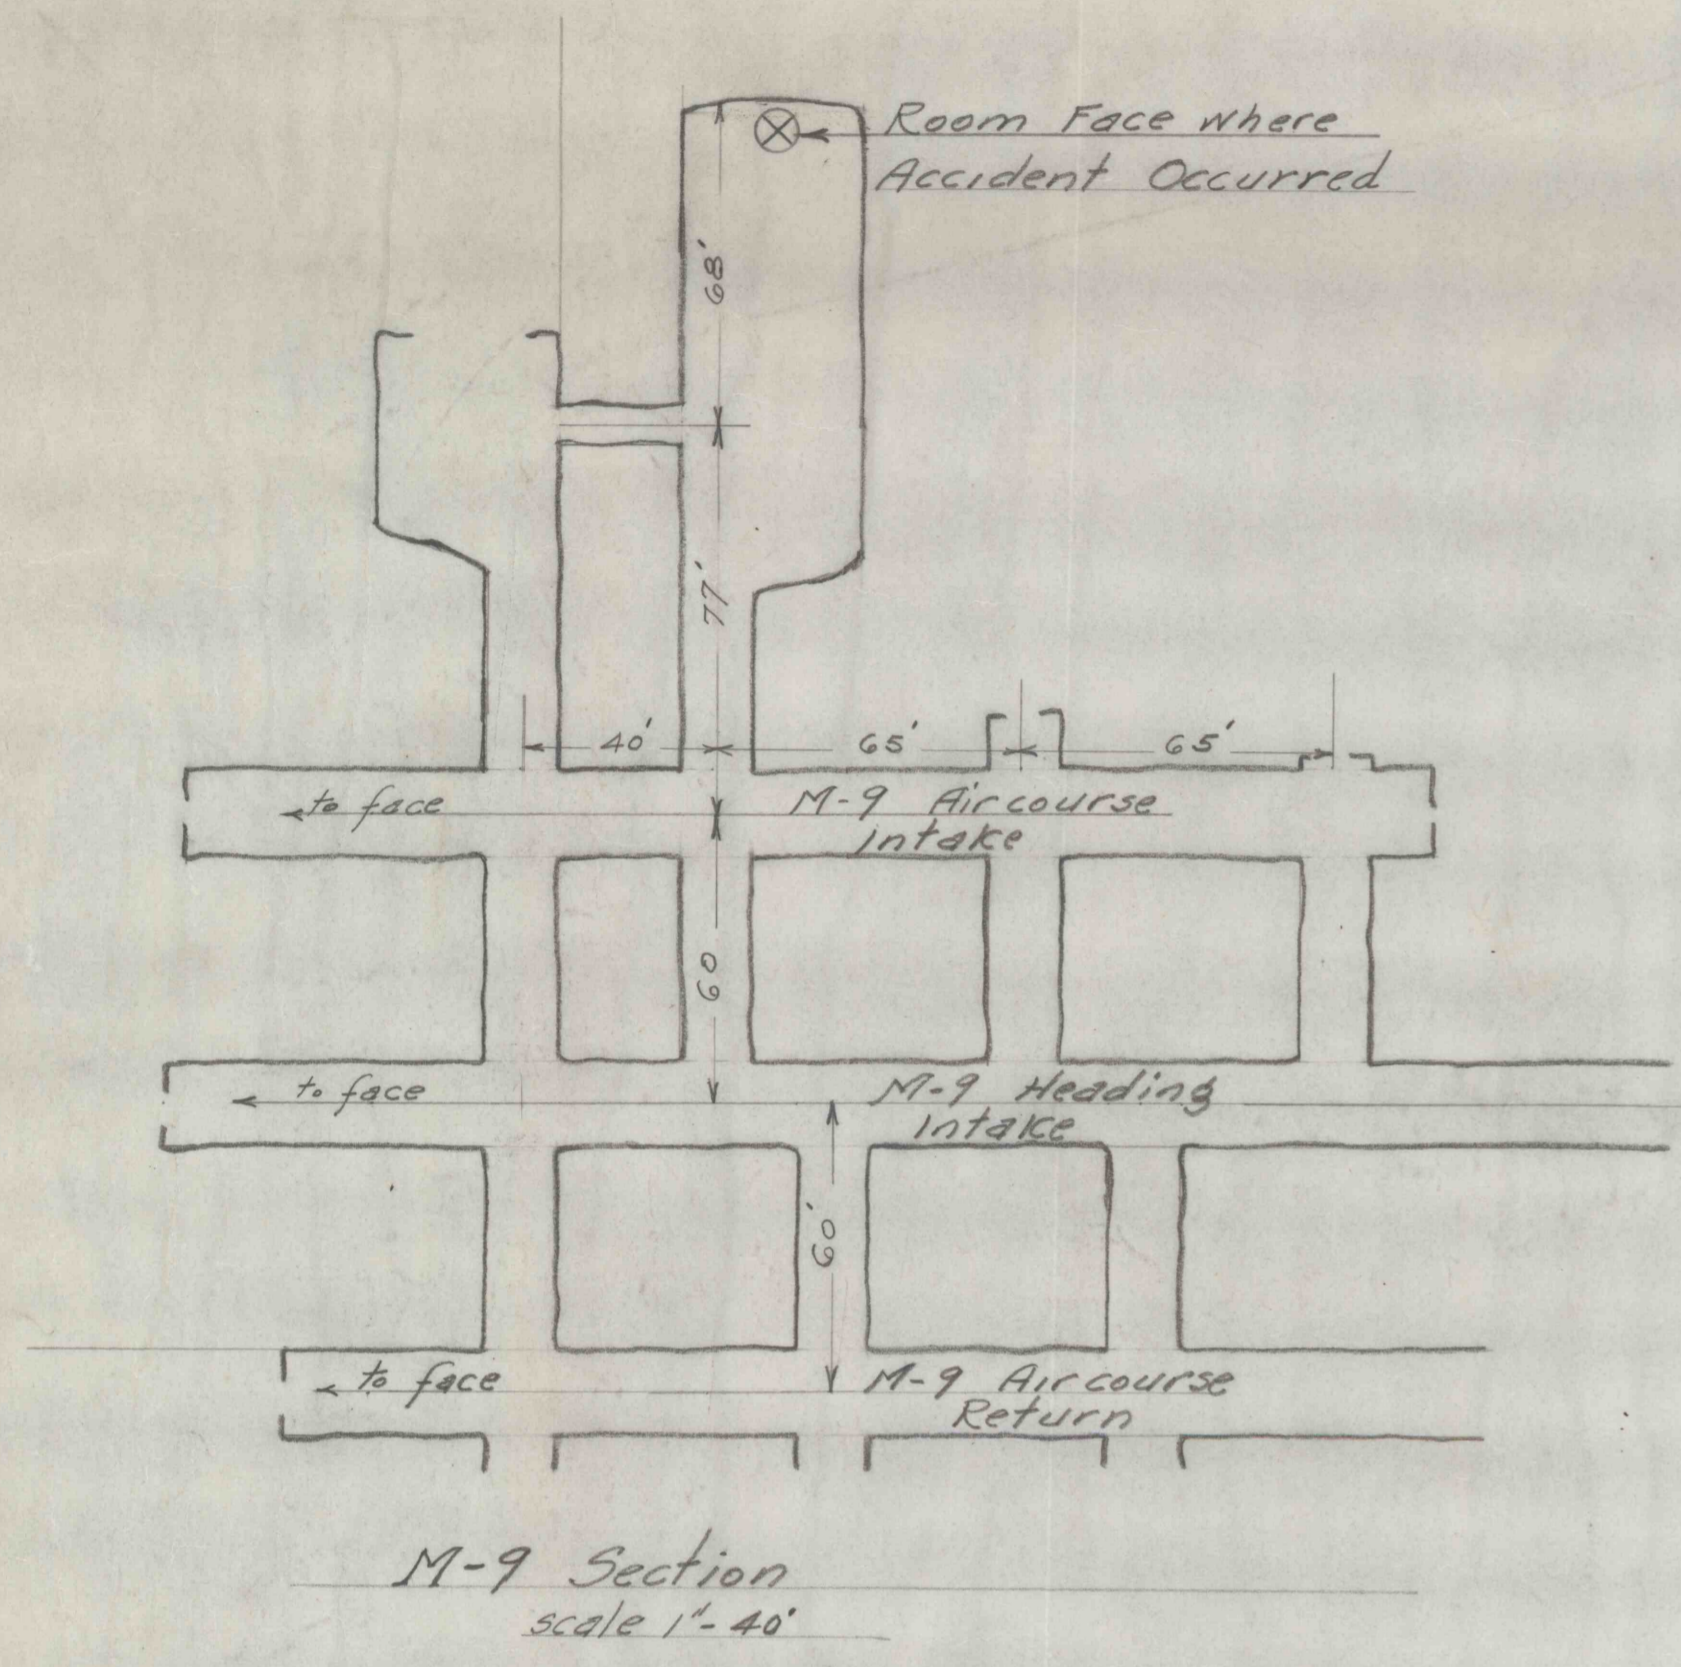
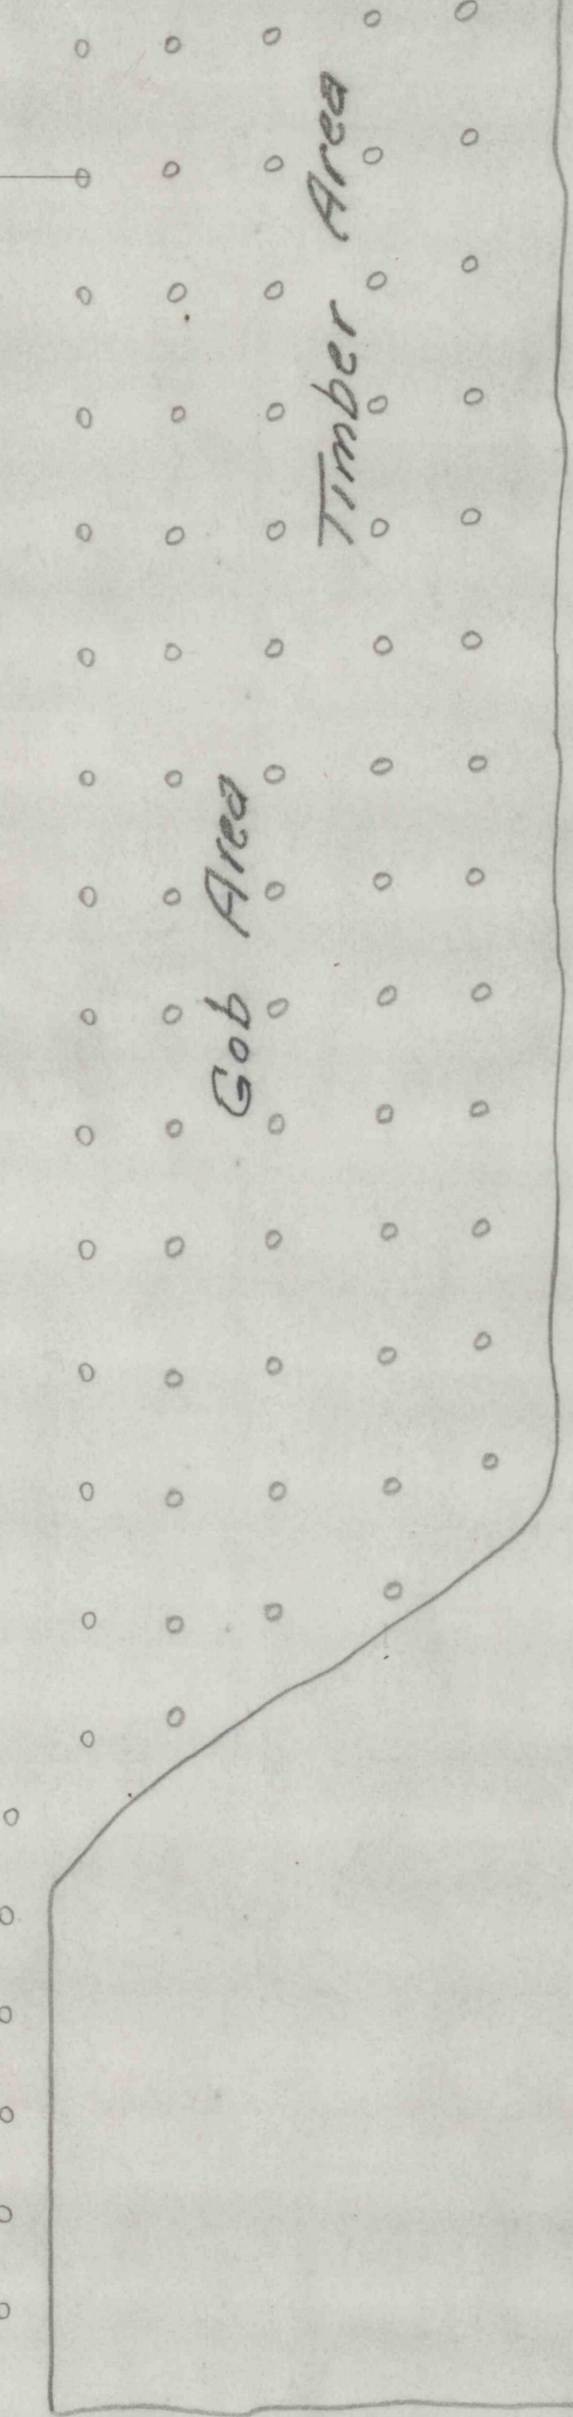
Center line of M-9 Aircourse  
scale 1/8"

Rib line
