PINE TWP. COAL CO., INC.
 HELLWOOD PA.
 PROJECTIONS FOR HIGHWALL MECHANICAL MINING
 Date - 8-2-59
 Scale - 1" = 100'
 REVISED - 10-15-59
 SUDDENLY MINE CLOSED DOWN Dec. 14, 1957
 & MINE WORK - WAS NOT BROUGHT UP TO DATE.

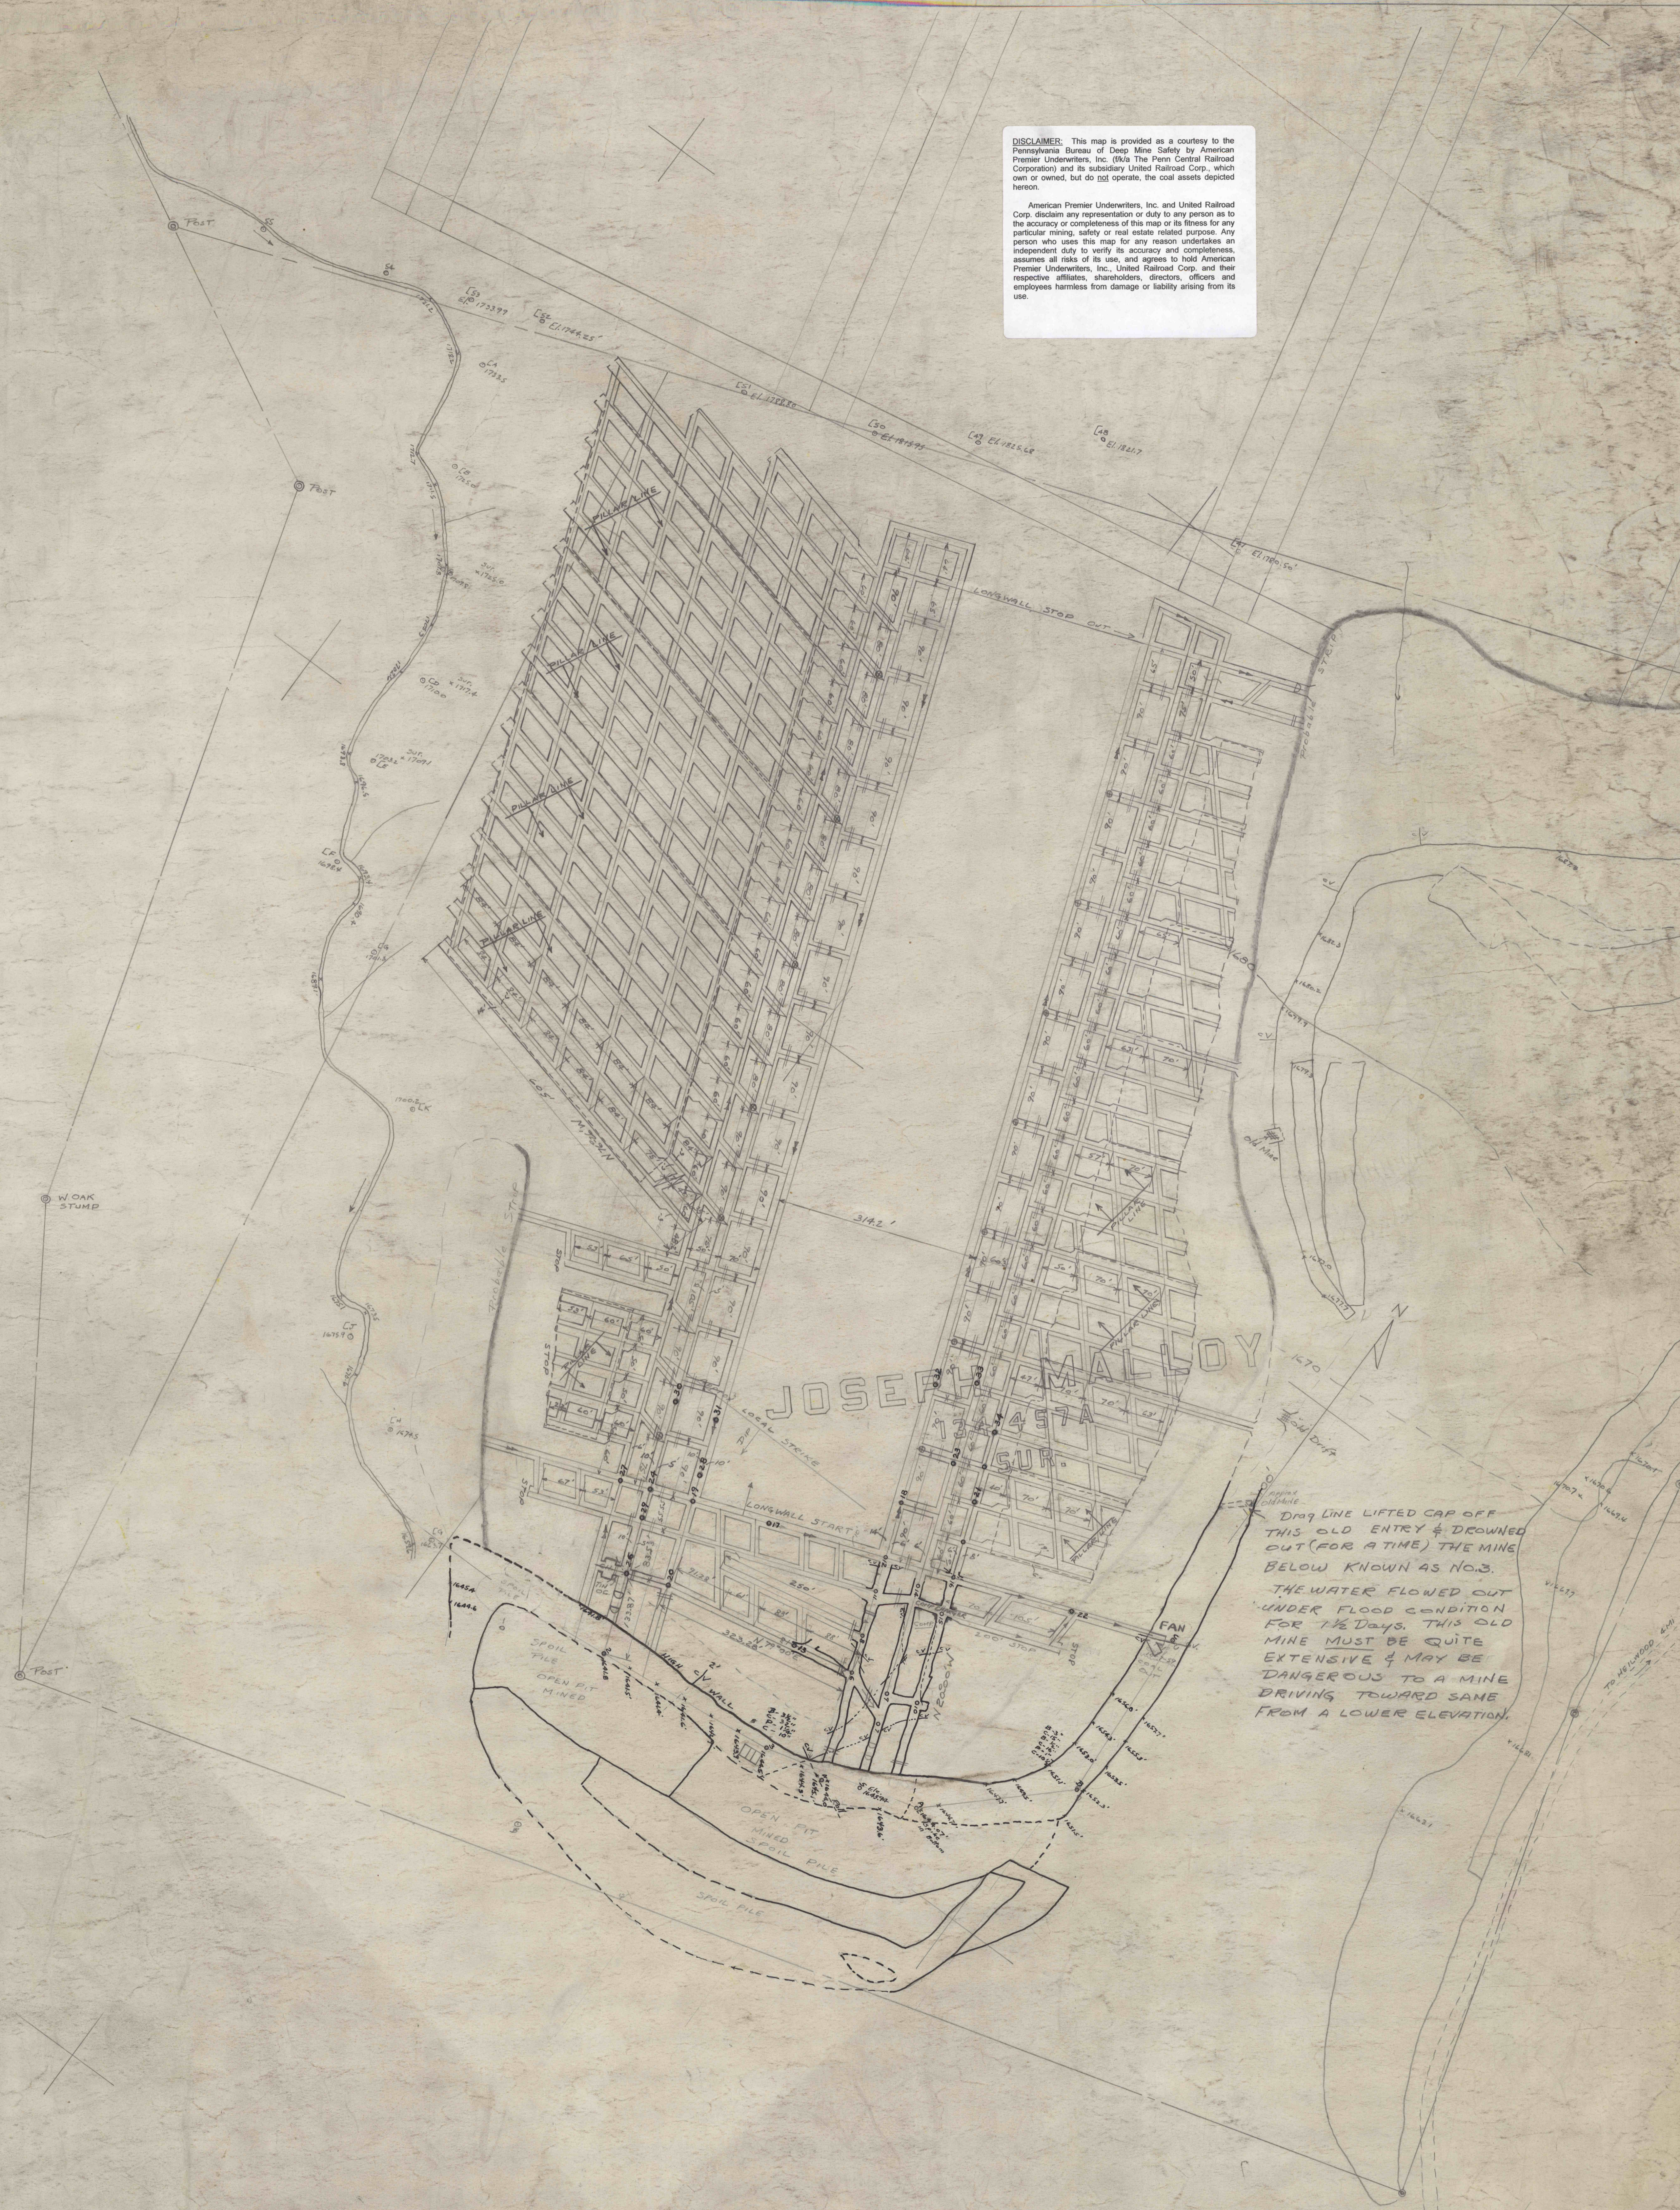
DRAG LINE LIFTED CAP OFF THIS OLD ENTRY & DROWNED OUT (FOR A TIME) THE MINE BELOW KNOWN AS NO. 3. THE WATER FLOWED OUT UNDER FLOOD CONDITION FOR 1 1/2 DAYS. THIS OLD MINE MUST BE QUITE EXTENSIVE & MAY BE DANGEROUS TO A MINE DRIVING TOWARD SAME FROM A LOWER ELEVATION.
