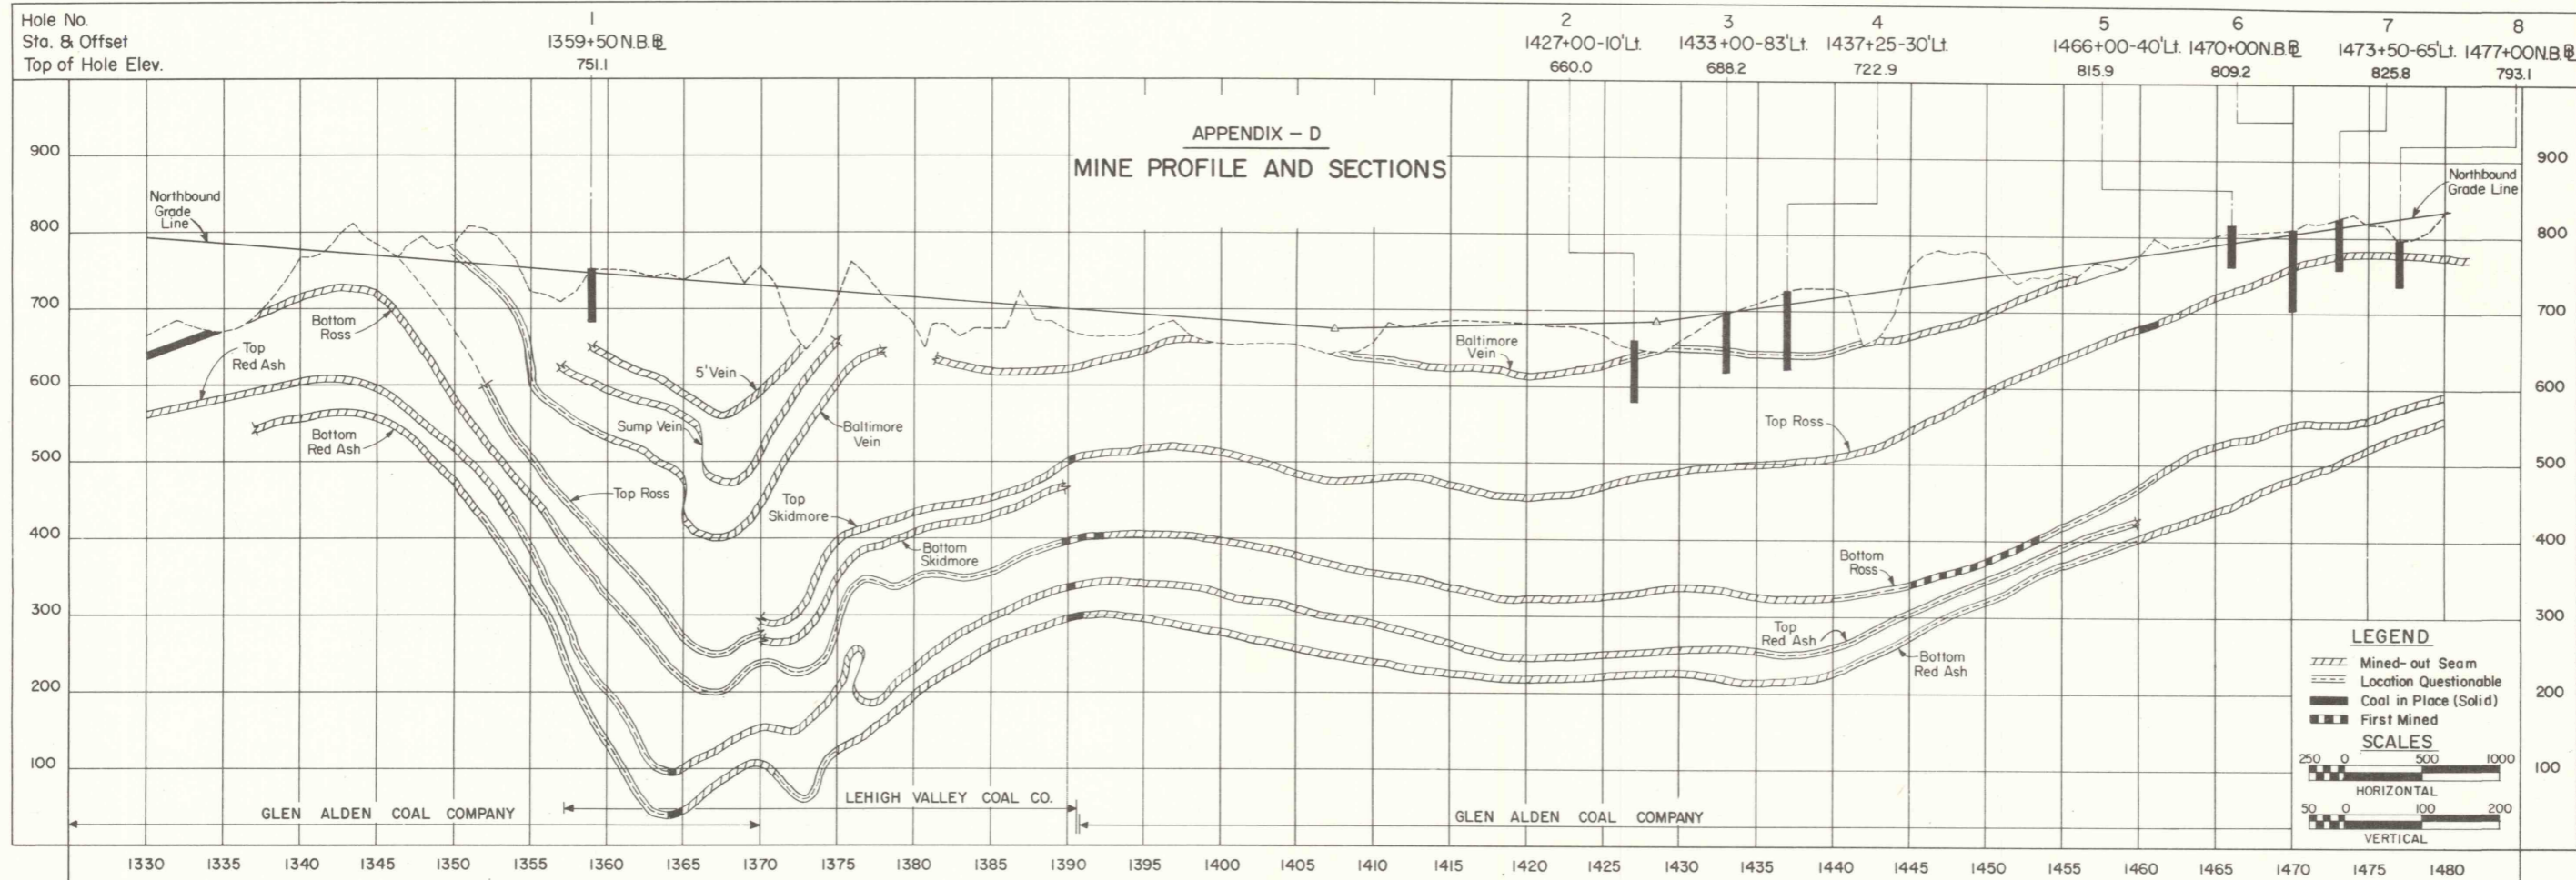
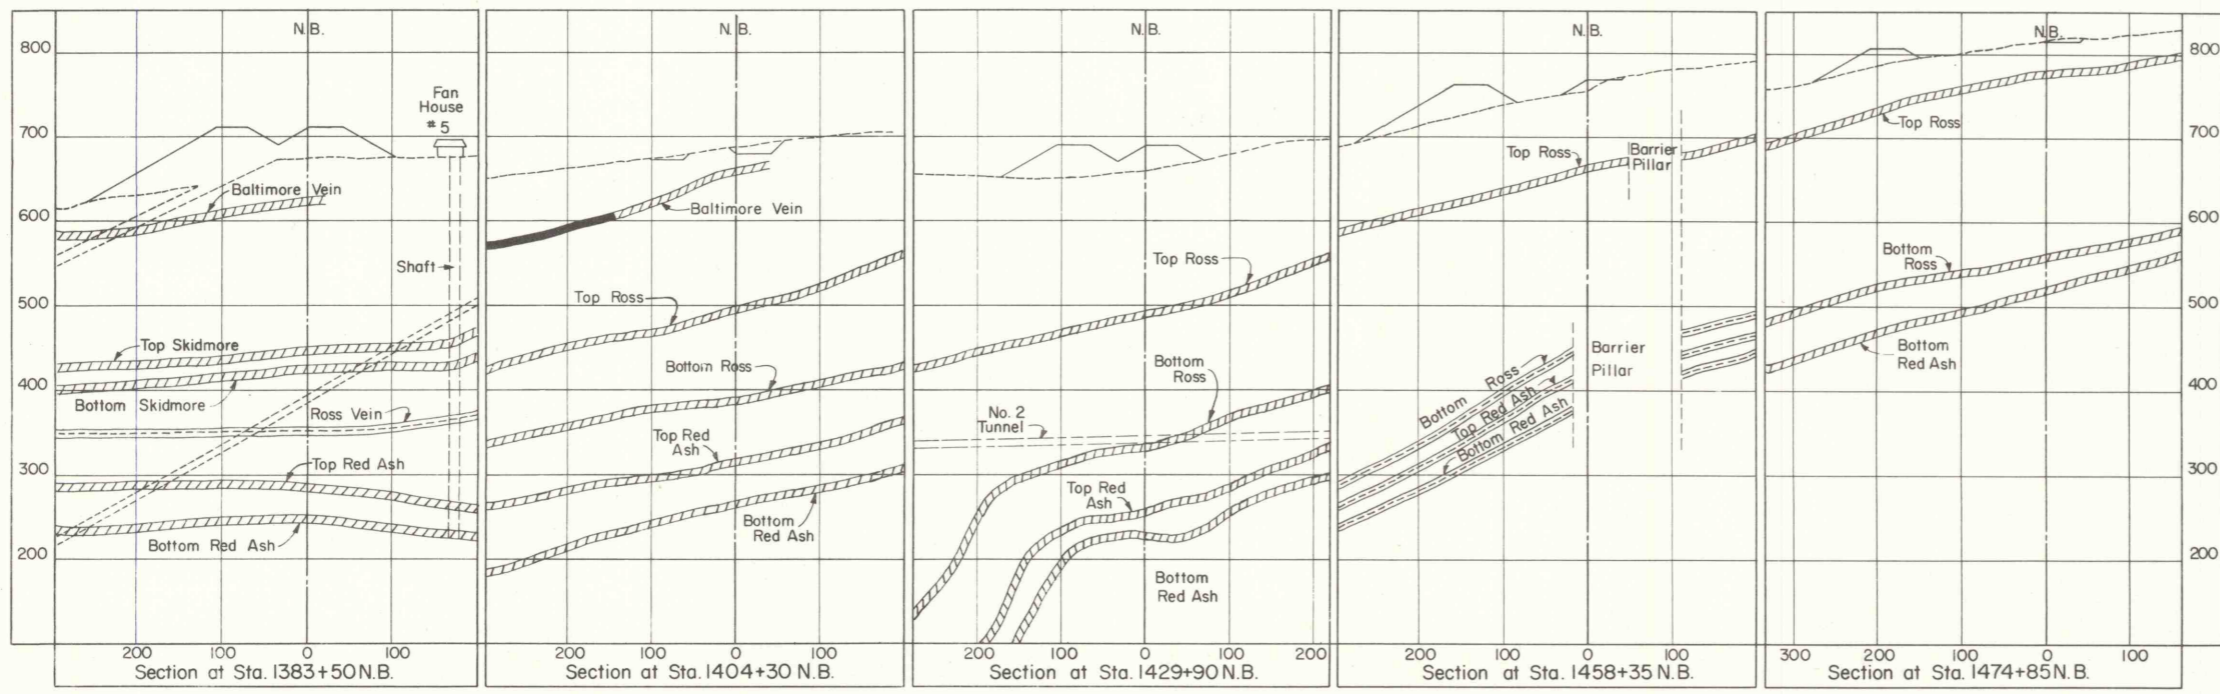
Core holes located right or left of northbound  $\bar{L}$  have been superimposed on the profile at their true elevations.

This drawing shows the coal measures and the extent of recorded mining operations along the proposed route as compiled from information made available to the Pennsylvania Department of Highways by the mining companies.

Adjustments have been made to relate the various datums and stationings used by the coal companies to the datum and stationing on which this project is based.

Core borings were made at locations suggested for investigation of underlying strata by the apparent close proximity of mine workings to the grade line as shown on the mining drawings.

The hole locations are plotted on these profiles and the drillers' logs for the mine holes are presented with the roadway core boring logs in Appendix E of this report.

A comparison of the test boring results with the mine company information indicates that the mined-out seams investigated by coring have been reduced to insignificant vertical dimensions over the years by the normal processes of squeezing and rock fall.
