NO. 14 COLLIERY
 No. 14 Shaft - - Bot. Checker Vein
 Scale 1" - 100'

Cross section of Bot. Checker Vein
 underlying Leg. Route No. 5 in
 Jenkins Township, Luzerne County,
 Penna.

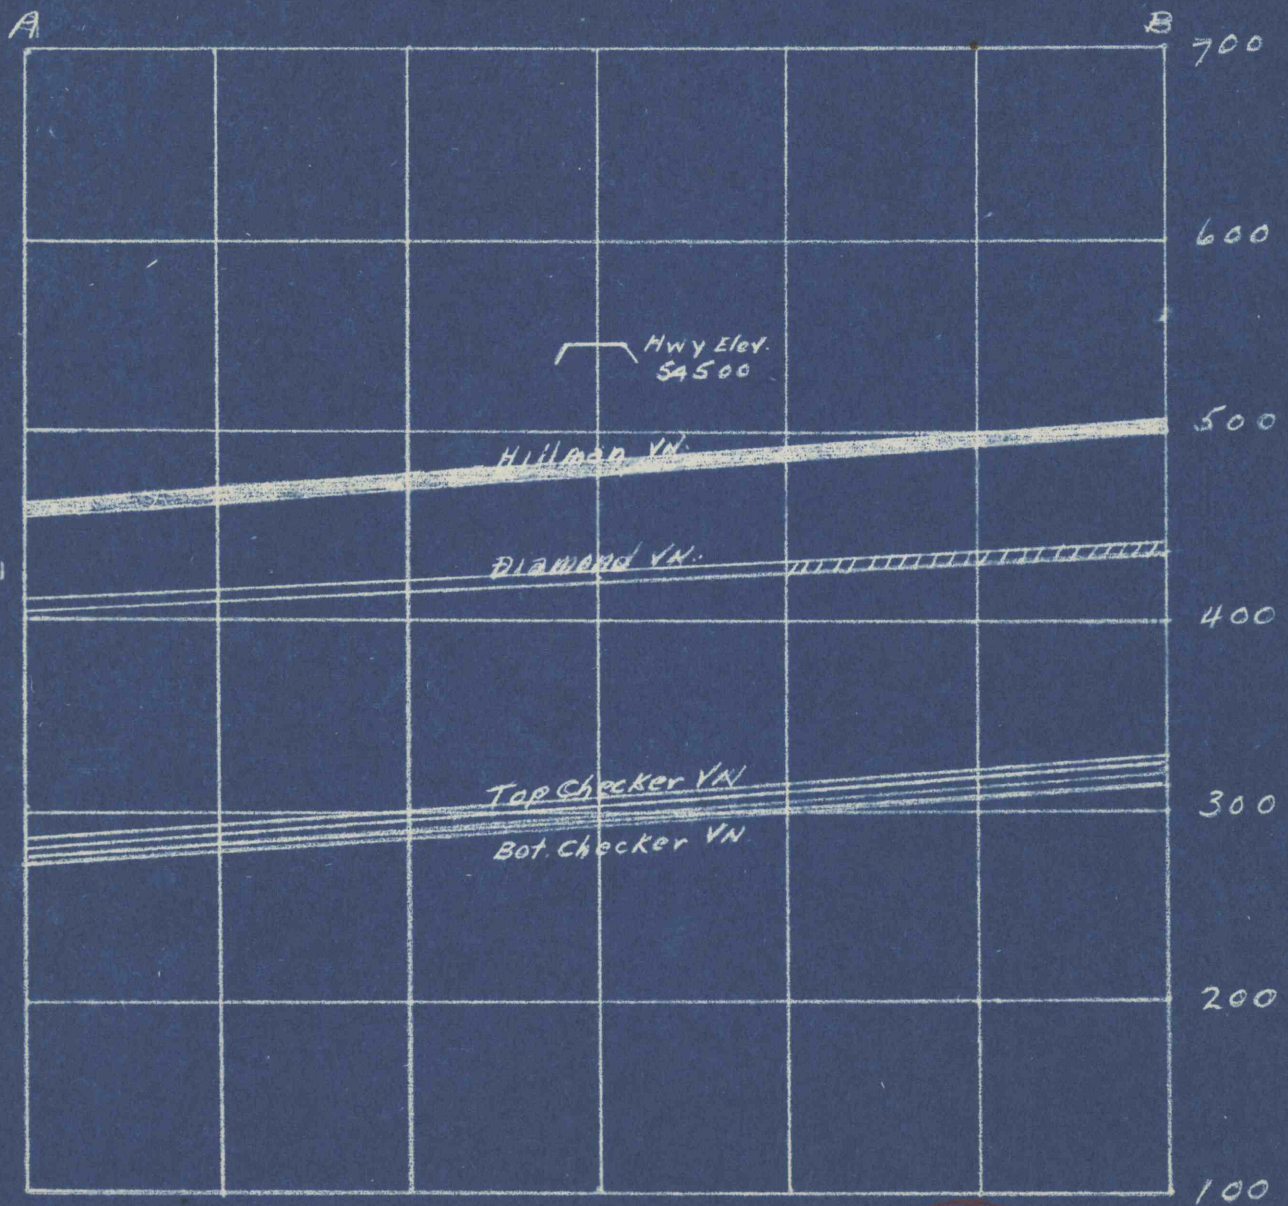
Section A-B

Virgin coal
-

First mined
-

Complete mining
