SECTION A - B

NO. 14 COLLIERY
 No. 14 Shaft --- Top Checker Vein
 Scale 1" = 100'
TOP.
 Cross section of ~~Bot.~~ Checker Vein
 underlying Leg. Route No. 5 in
 Jenkins Township, Luzerne County,
 Penna.

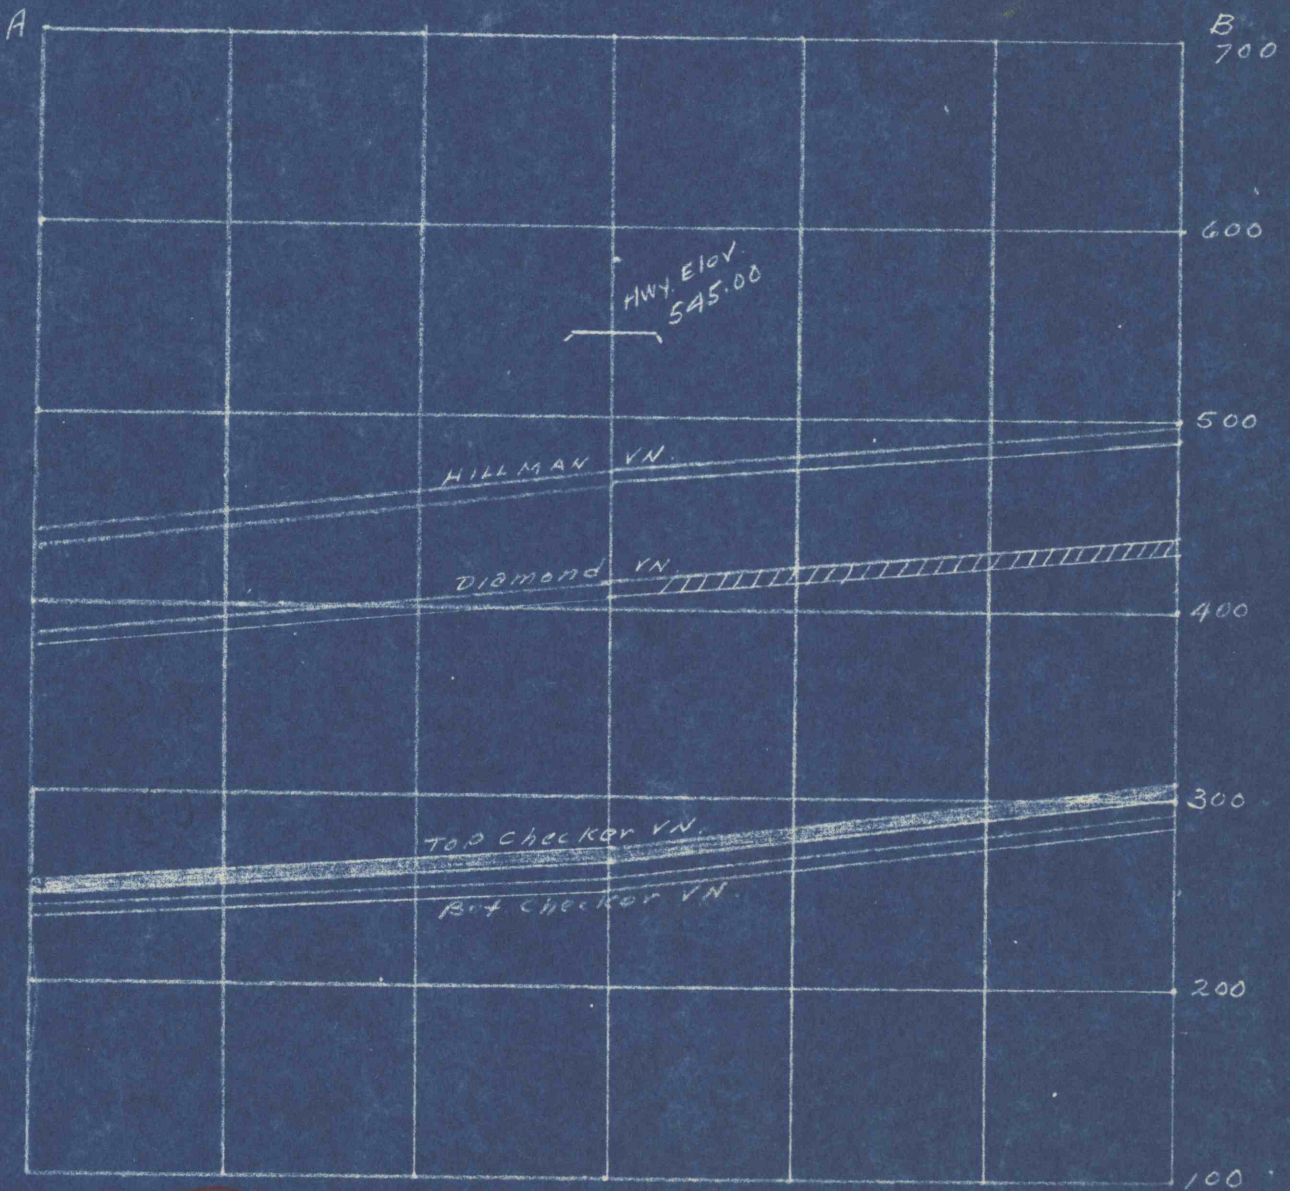
Virgin coal

First mined

Complete mining
