NO. 14 COLLIERY  
 No. 14 Shaft - - Bot. Checker Vein  
 Scale 1" - 100'

Cross section of Bot. Checker Vein  
 underlying Leg. Route No. 5 in  
 Jenkins Township, Luzerne County,  
 Penna.

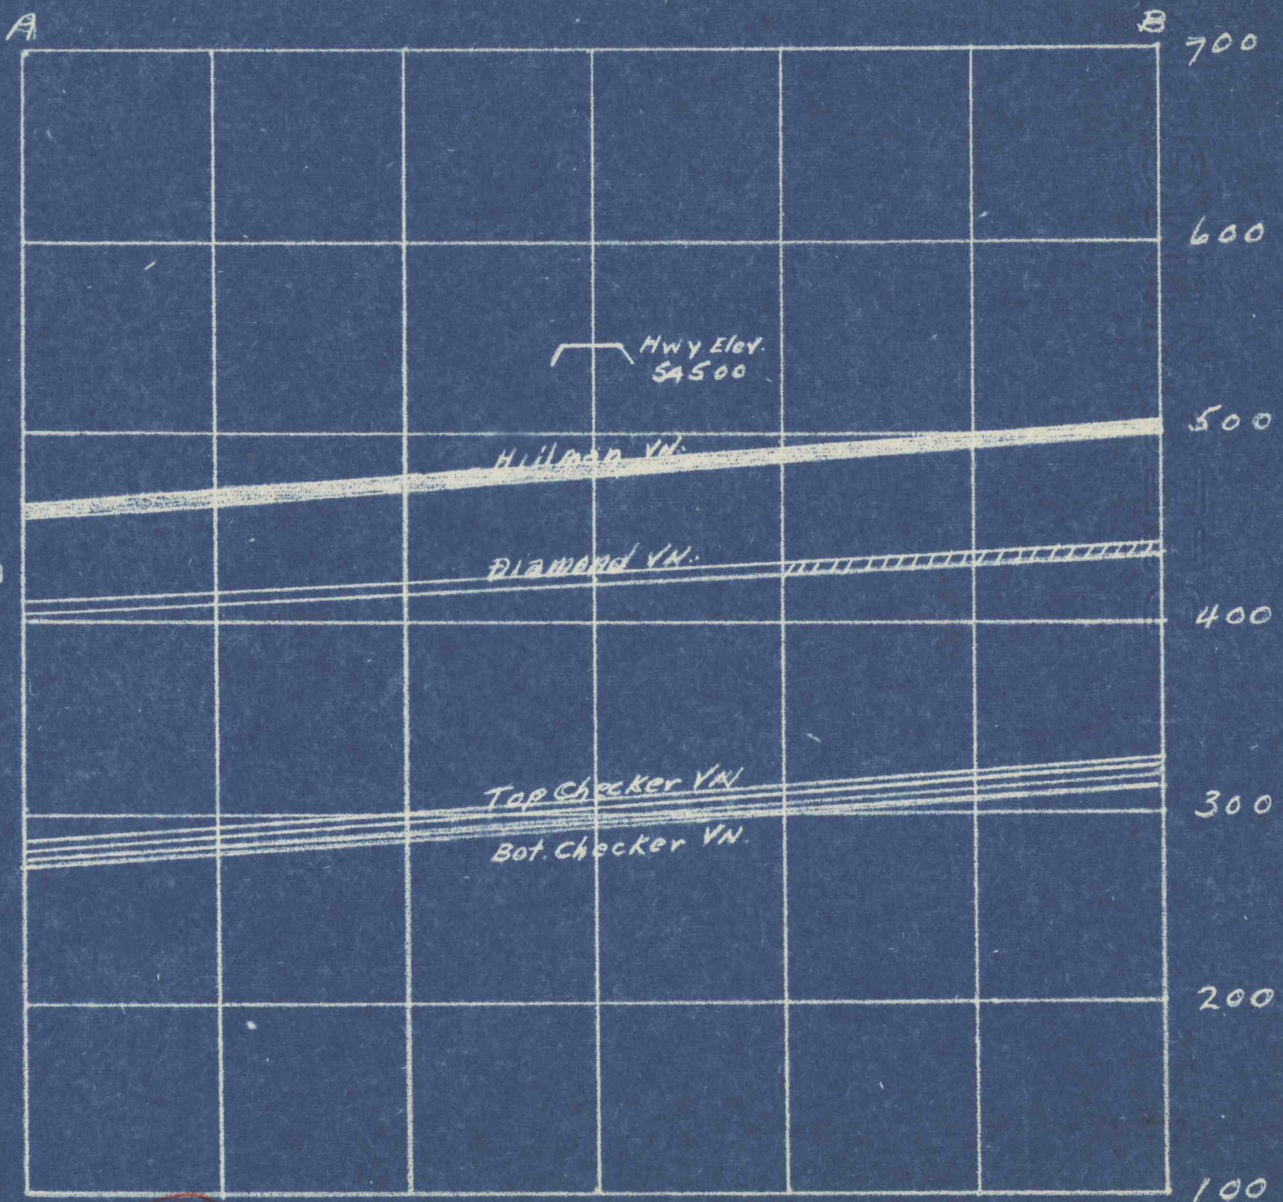
Section A-B

Virgin coal
-

First mined
-

Complete mining
