SKETCH
 SHOWING SUBSIDENCE IN ROUTE 515
 BETWEEN STA. 272 and 274 CAUSED
 BY PILLAR ROBBING IN CHECKER BED
 AT DELAWARE COLLIERY
 Scale 1"=100' October 14, 1936
 Copied from Hudson Coal Co. Map.
 October 14, 1936 Scranton Penna.

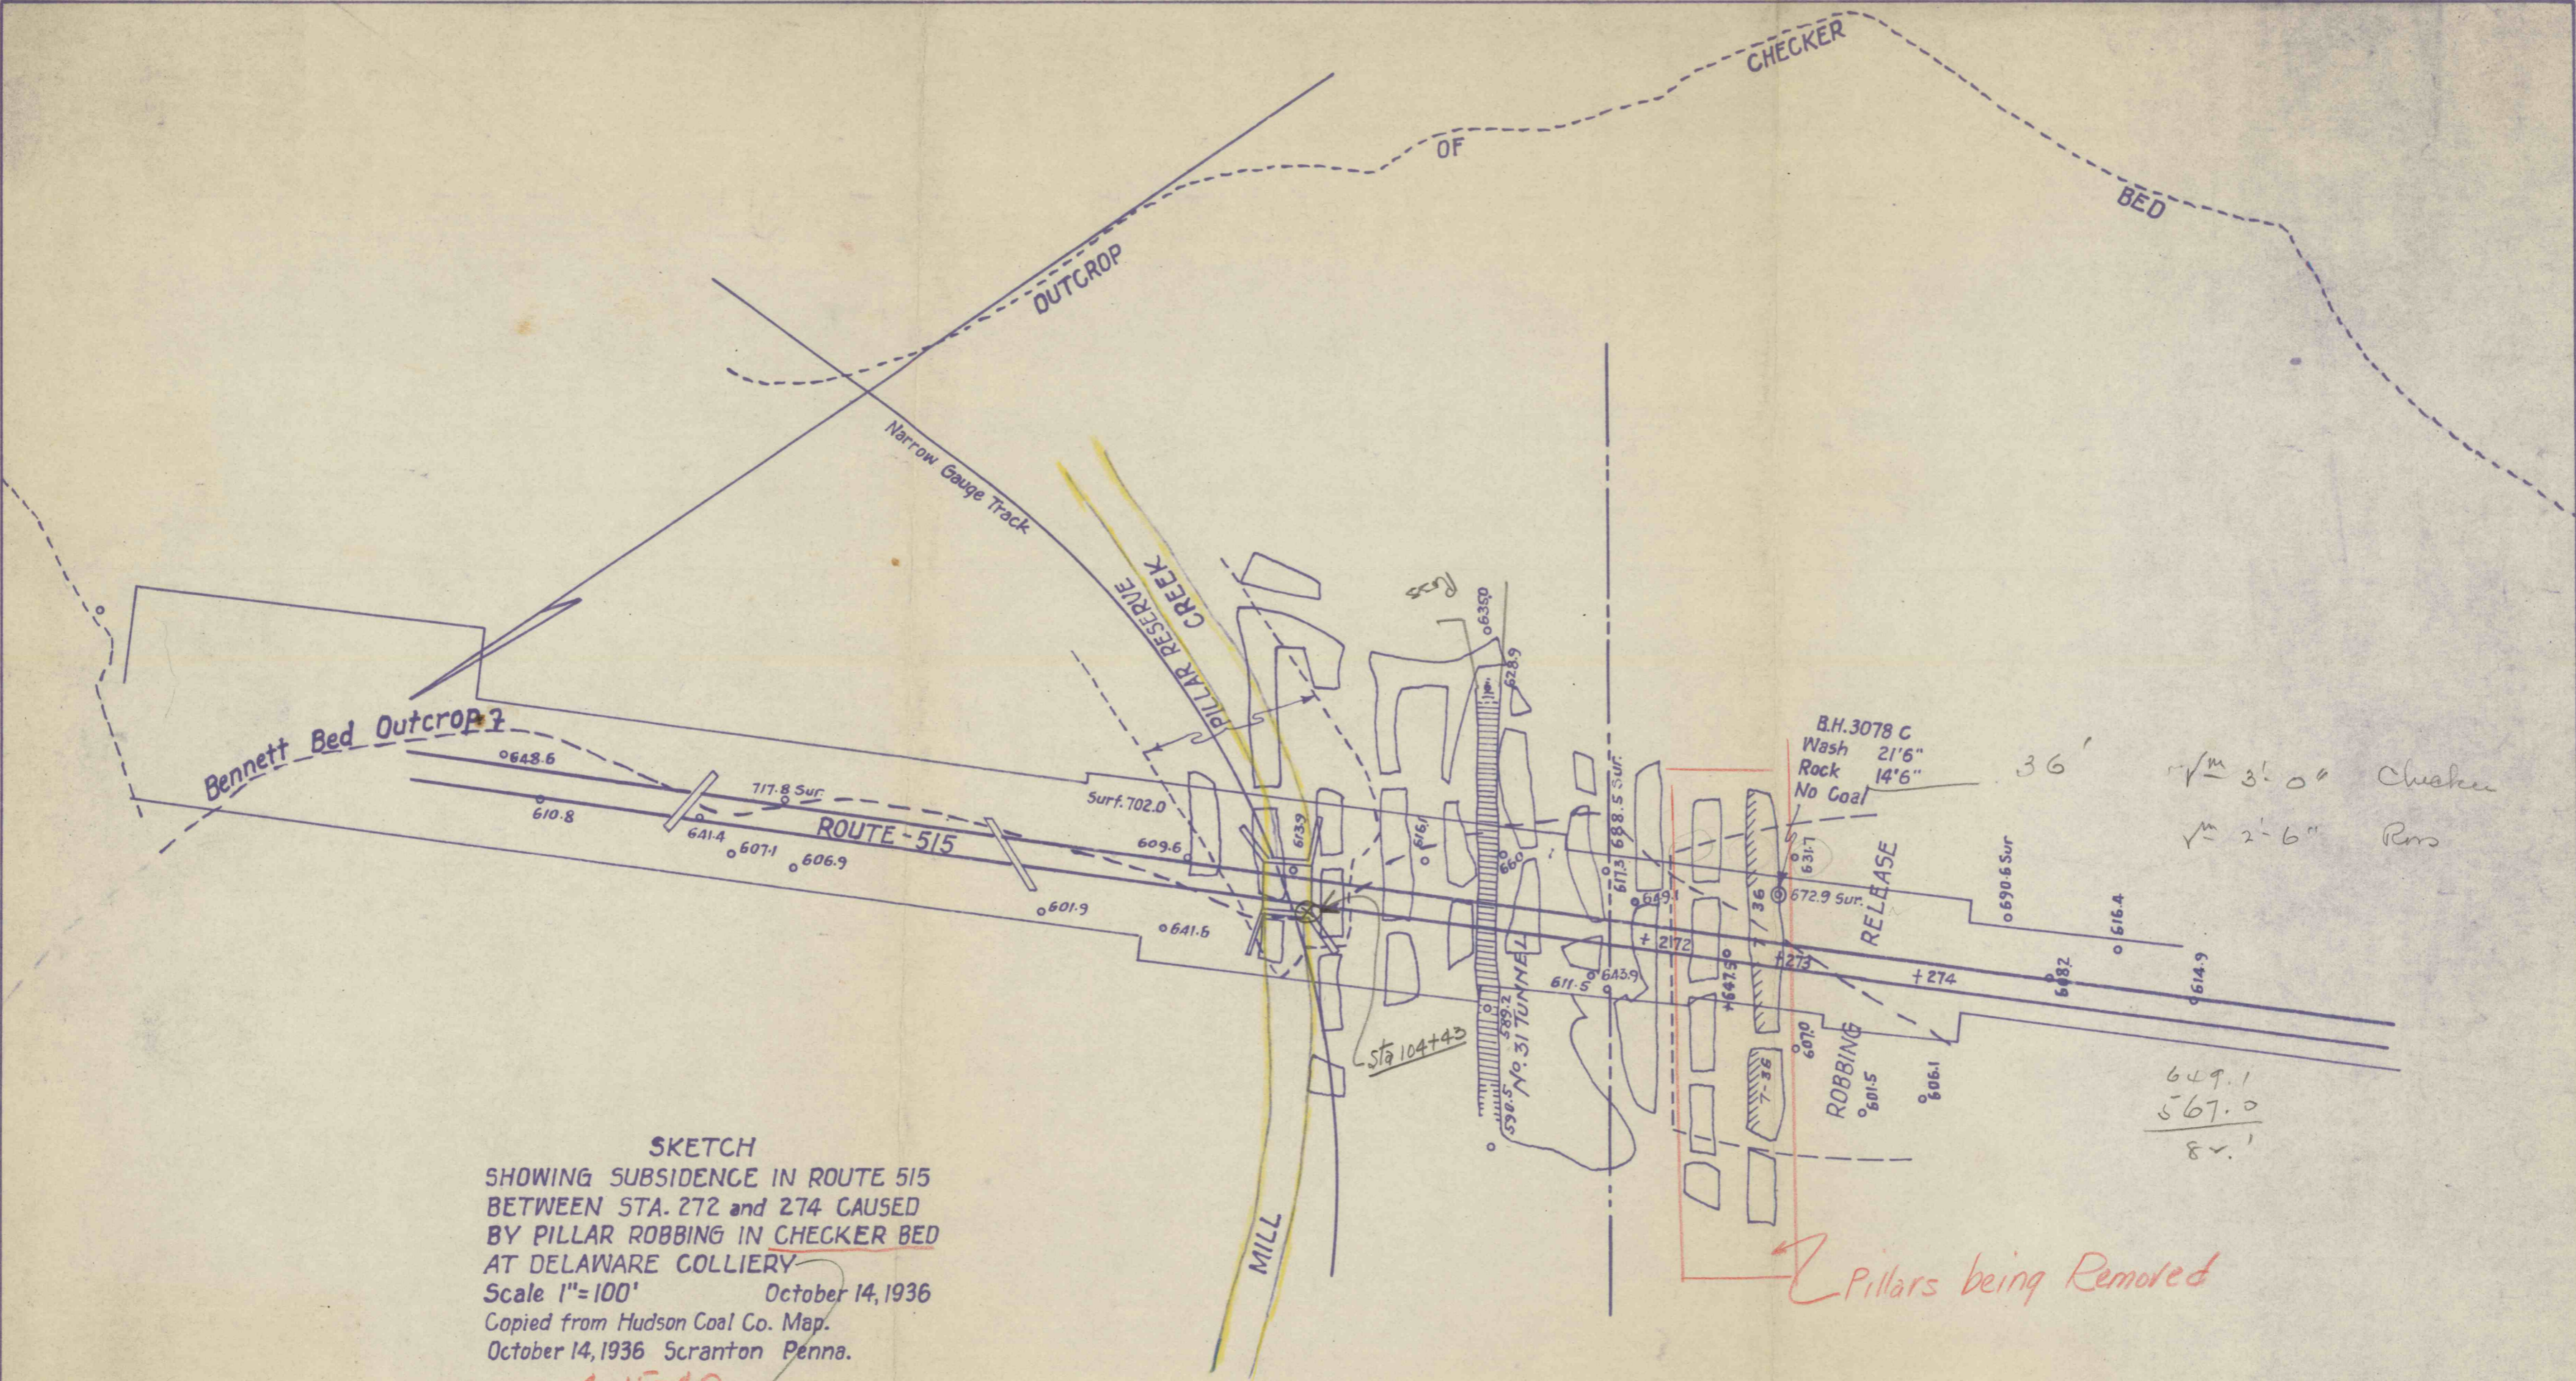
B.H. 3078 C
 Wash 21'6"
 Rock 14'6"
 No Coal

36' \sqrt{m} 3'-0" Checker
 \sqrt{m} 2'-6" Pms

Pillars being Removed
