FIGURE 8. MAP SHOWING, BY ARROWS, DIRECTION AND PATH OF FLOW OF MINE WATER IN AND FROM MINES AFFECTED BY BARRIER-PILLAR SYSTEM IN WESTERLY PART OF AREA STUDIED

Northern Coal Field
 Mine Water Flow
 Luzerne County
 Various Townships
 Various Collieries
 Surface

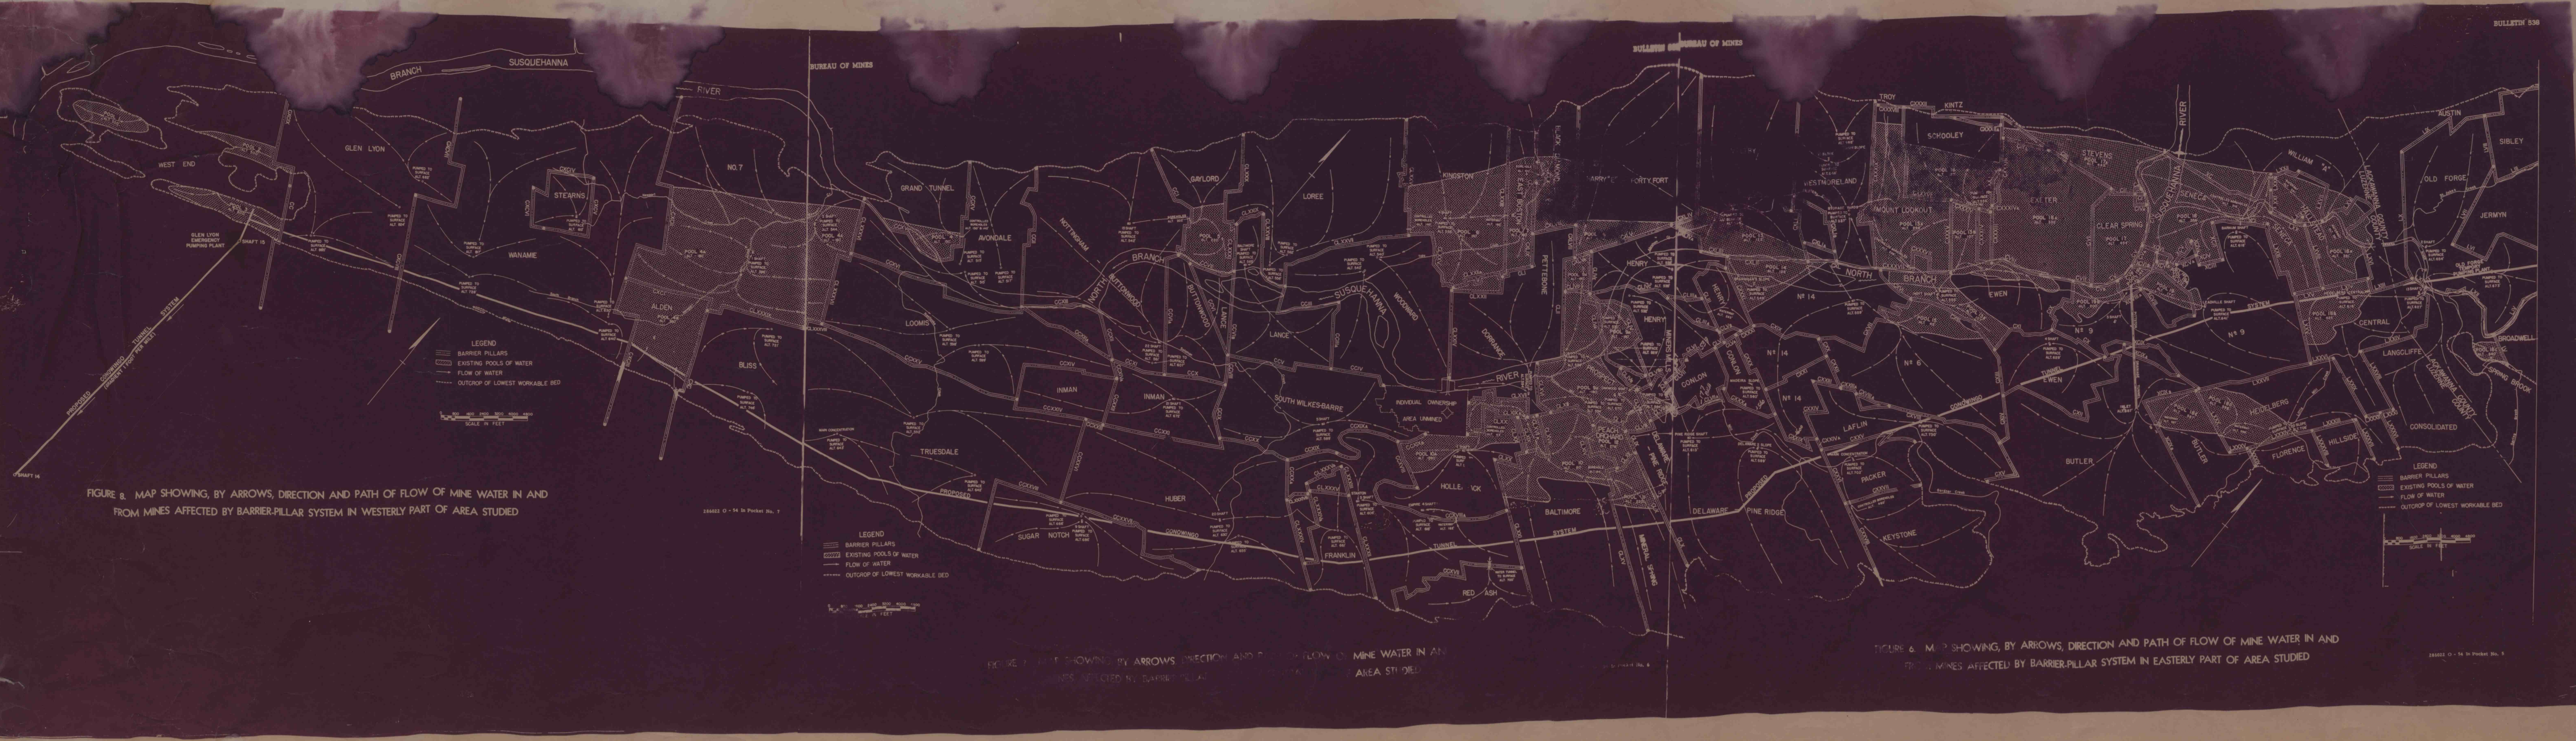
9377

FIGURE 6. MAP SHOWING, BY ARROWS, DIRECTION AND PATH OF FLOW OF MINE WATER IN AND FROM MINES AFFECTED BY BARRIER-PILLAR SYSTEM IN EASTERLY PART OF AREA STUDIED
