PERMIT NO. 3084153
 PREPARED BY OWNER & OPERATOR CONSOLIDATION COAL COMPANY

CONSOLIDATION COAL COMPANY
 DILWORTH MINE
 PITTSBURGH SEAM OWNED OR CONTROLLED BY
 CONSOLIDATION COAL COMPANY
 WHEATON COUNTY, PA.

SCALE: 1" = 200' SURVEY DATE: 6-30-94

SUBSIDENCE CONTROL PLAN LINE

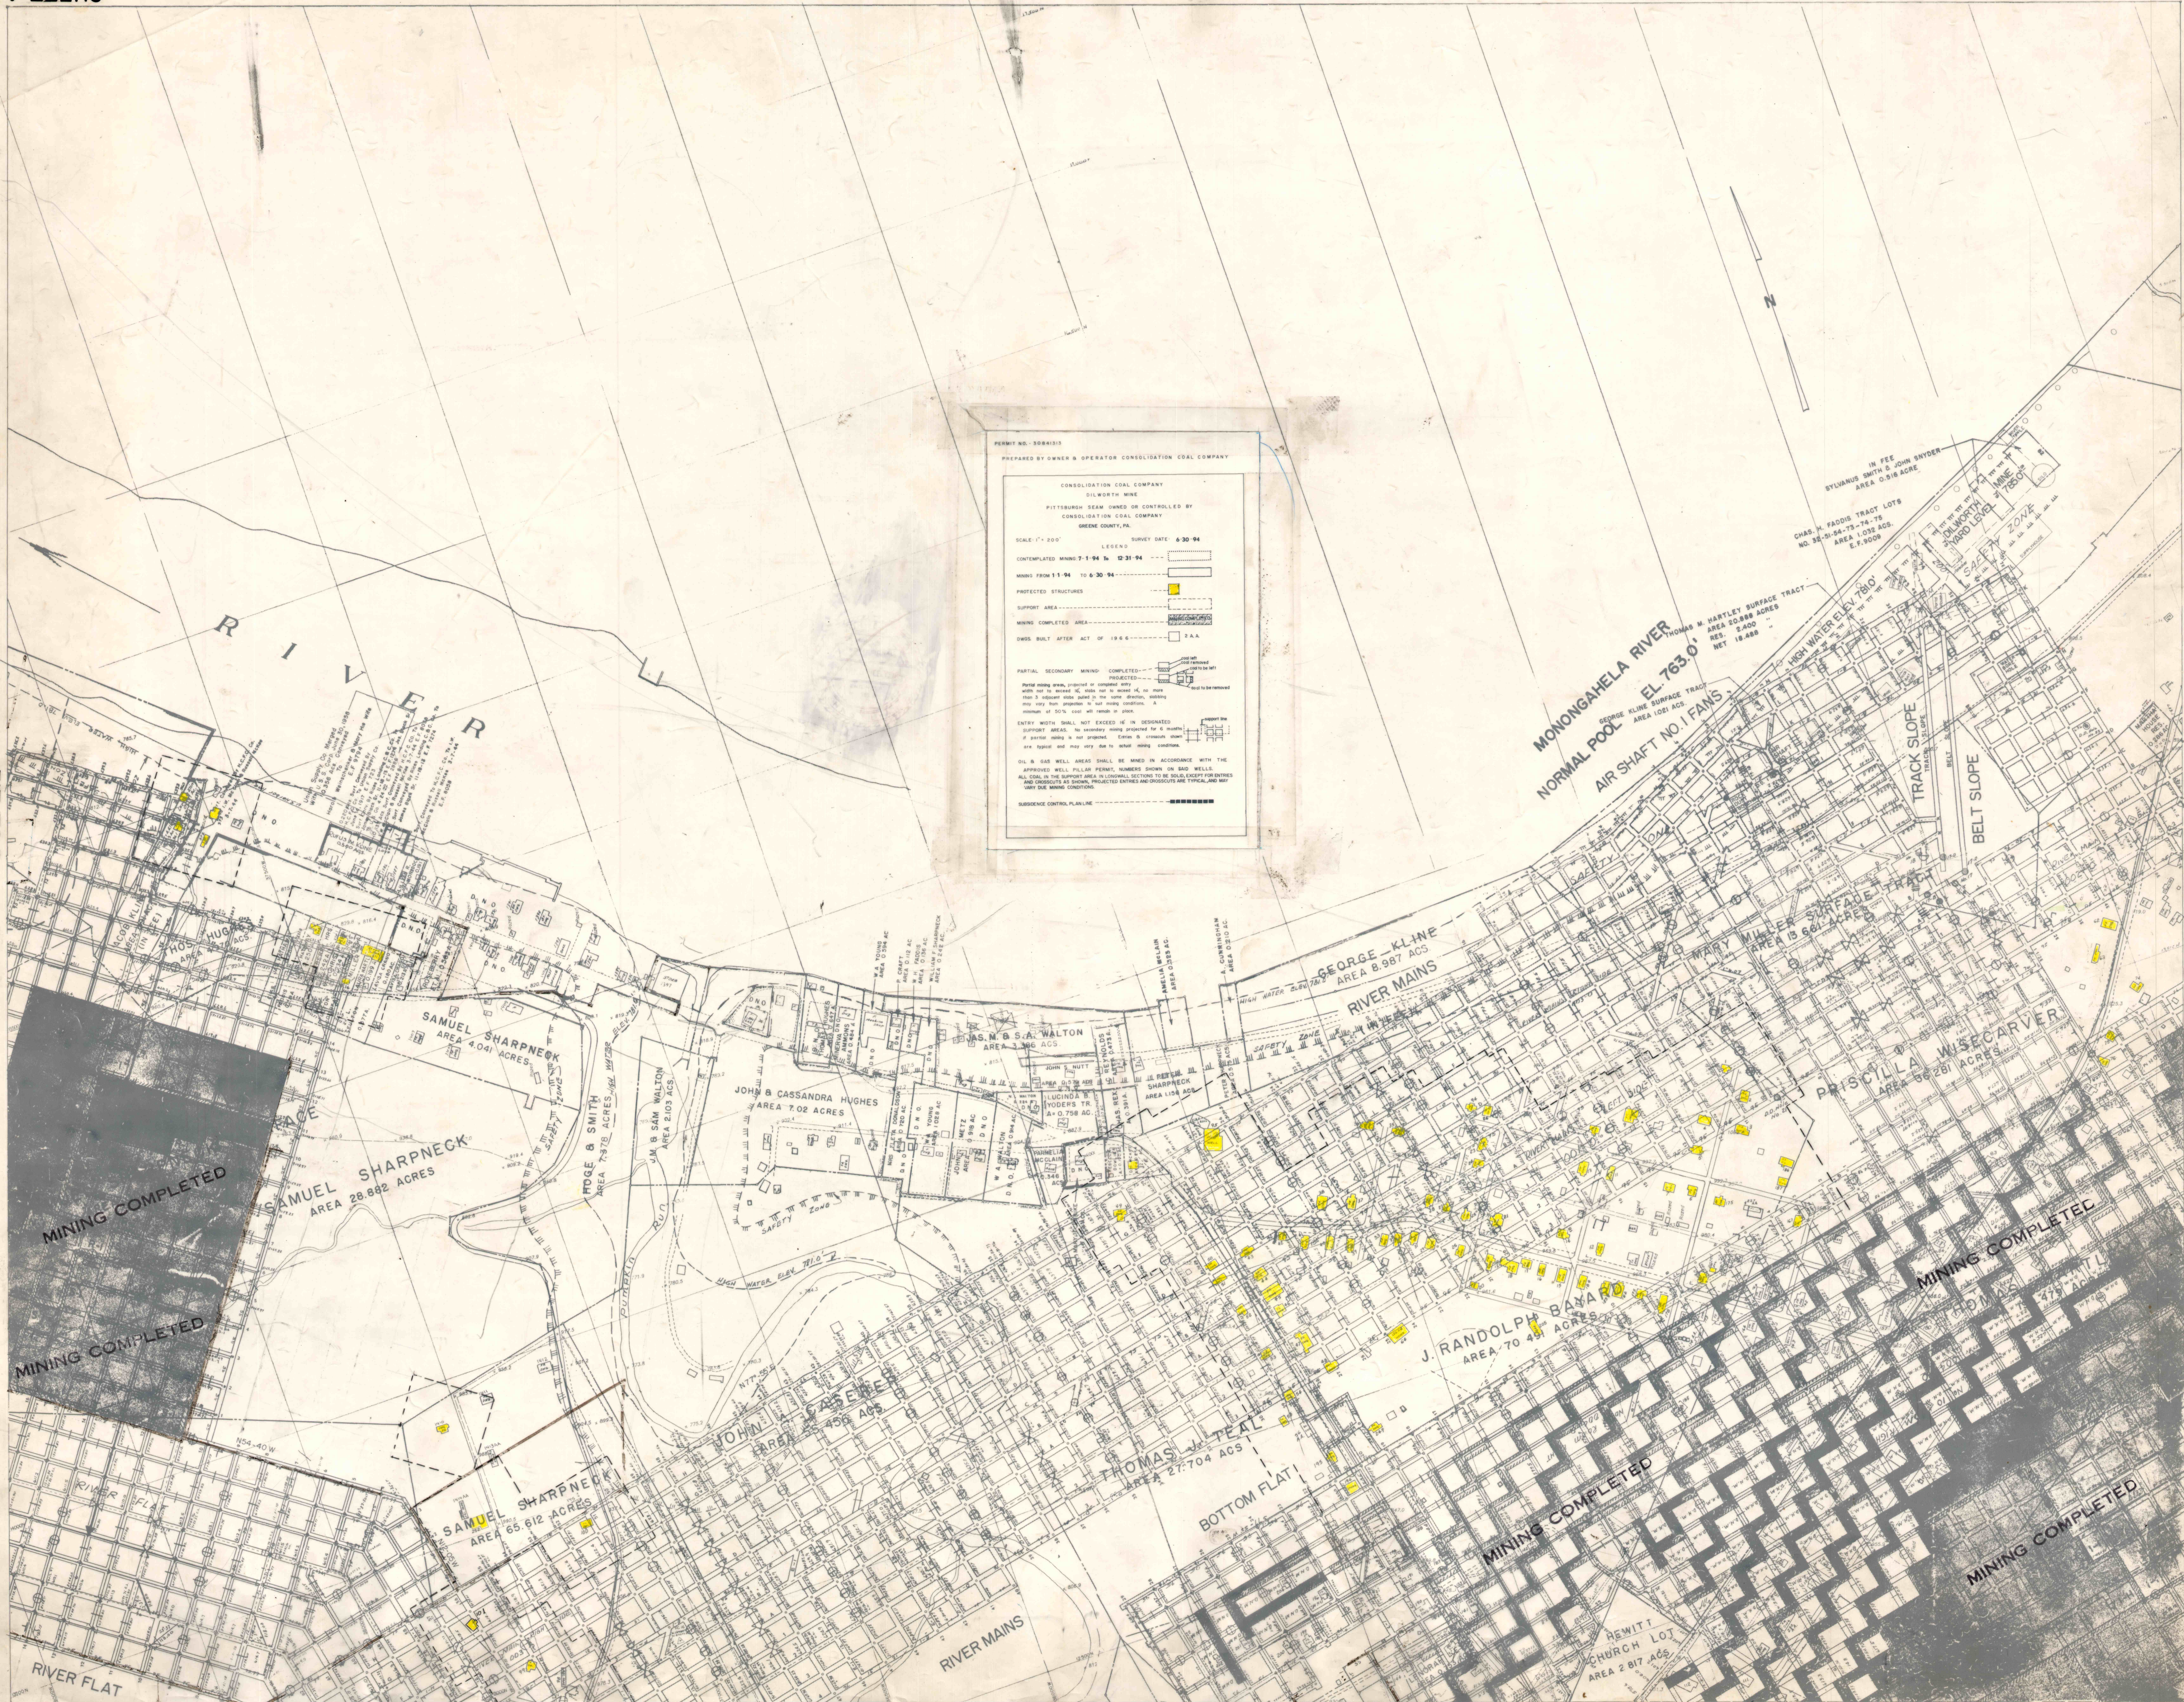
Partial mining areas, projected or unprojected, which are to be mined by 12/31/94 are shown in yellow. Areas to be mined from 1/1/94 to 6/30/94 are shown in white. Areas to be mined after 6/30/94 are shown in light gray. A minimum of 50% must be mined in areas.

Safety walls shall not exceed 60' in unconsolidated support areas. No secondary mining is permitted in support areas. No secondary mining is permitted in areas to be mined after 6/30/94.

All coal in the support area in longitudinal sections to be sold, except for surface and prospects as shown, projected entries and prospects are typical, and may vary due to mining conditions.
