Accident-Fatal - Aug. 12, 1937, 11:00 P.M.  
 Victim - Attilio Lorenzi, Check No 637,  
 Age 40, Married, 2 Children, Ages 3 &  
 8 years.

THE VESTA COAL CO.  
 CALIFORNIA, PA.

MINE No 4 PLAN AT LOCATION  
 OF FATAL ACCIDENT-ATTILIO LORENZI

D-771

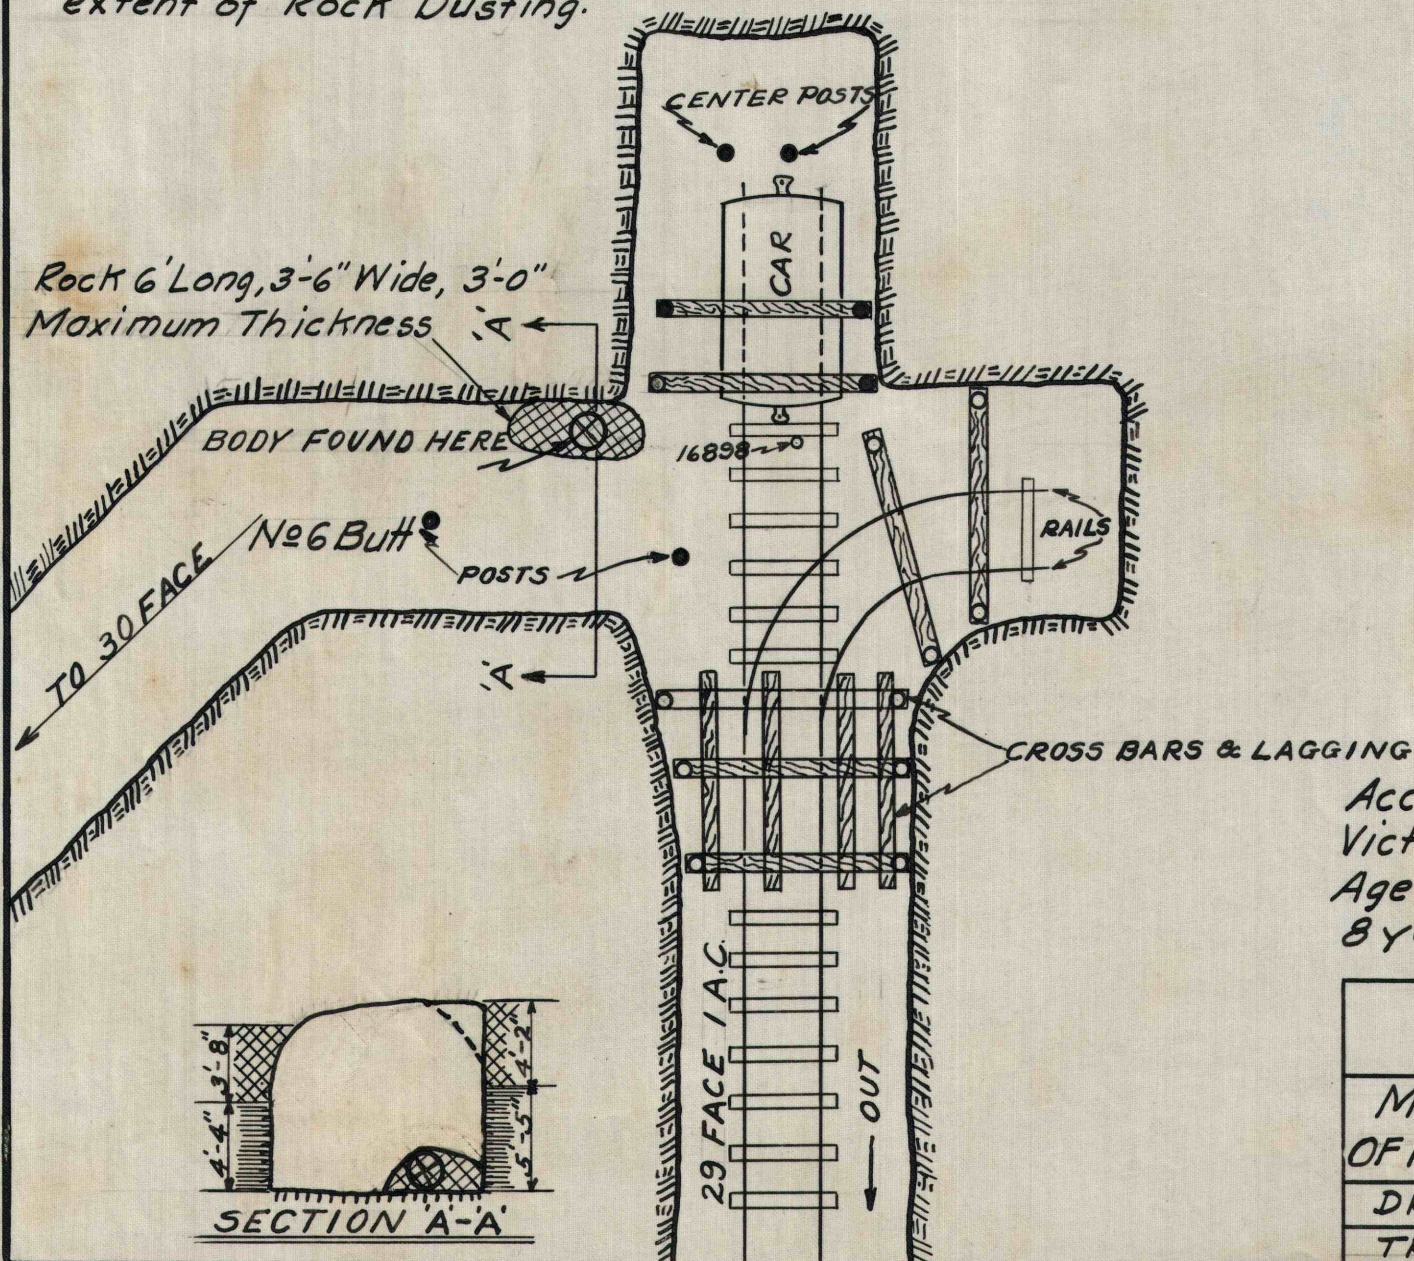
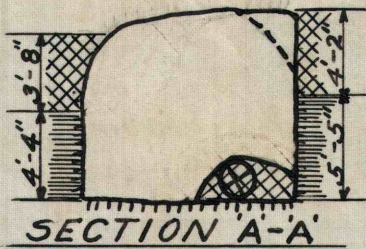
Victims place was practically "cleaned up", and car was approximately half filled. He evidently was taking some coal off in by corner of No 6 Butt to finish car, as coal in front end of car had rock dust on it, and his tools were with body. Location of Accident was approximate in by extent of Rock Dusting.
