Shock Victim, Tony O'Savage Was Shoveling At (A) To Make Place To Set Leg For Proposed Crossbar C.B.-3. Shocked Through Right Ear At (A) Sept. 18-1935, Rendered Unconscious For 30 Mins.-Revived By Art. Resp.

THE VESTA COAL CO.		D-721
CALIFORNIA, PA.		
MINE N ^o 4 PLAN OF N ^o 2 BEALLSVILLE		
AT LOCATION OF TONY O'SAVAGE ACCIDENT		
DR. <i>W.B.</i>	DATE SEPT. 19-35	D-721
TR. <i>W.B.</i>	SCALE 1/4" = 1'-0"

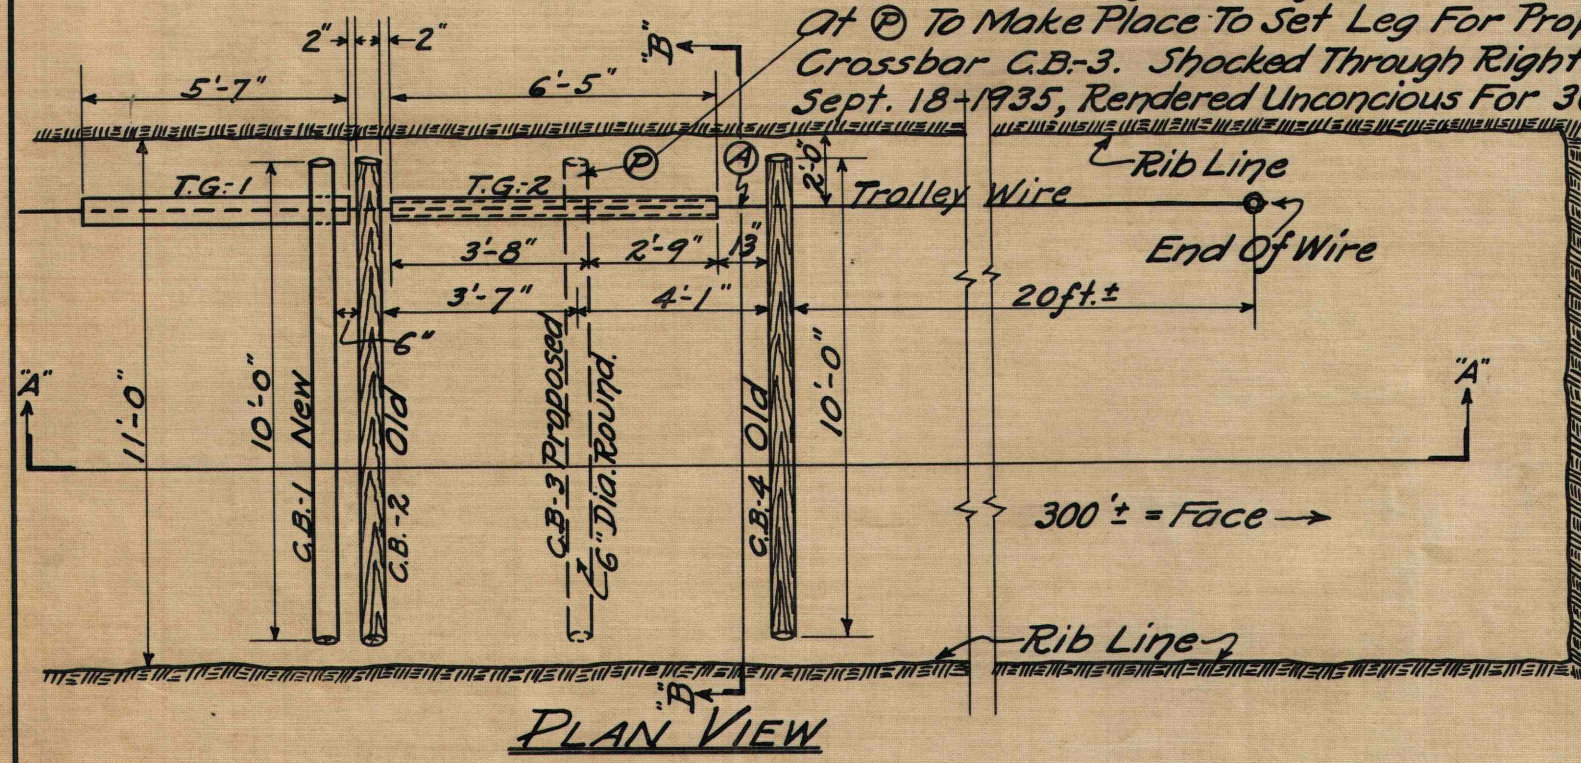
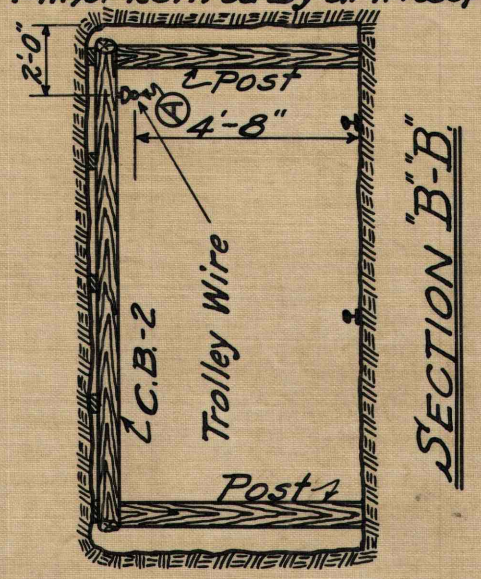
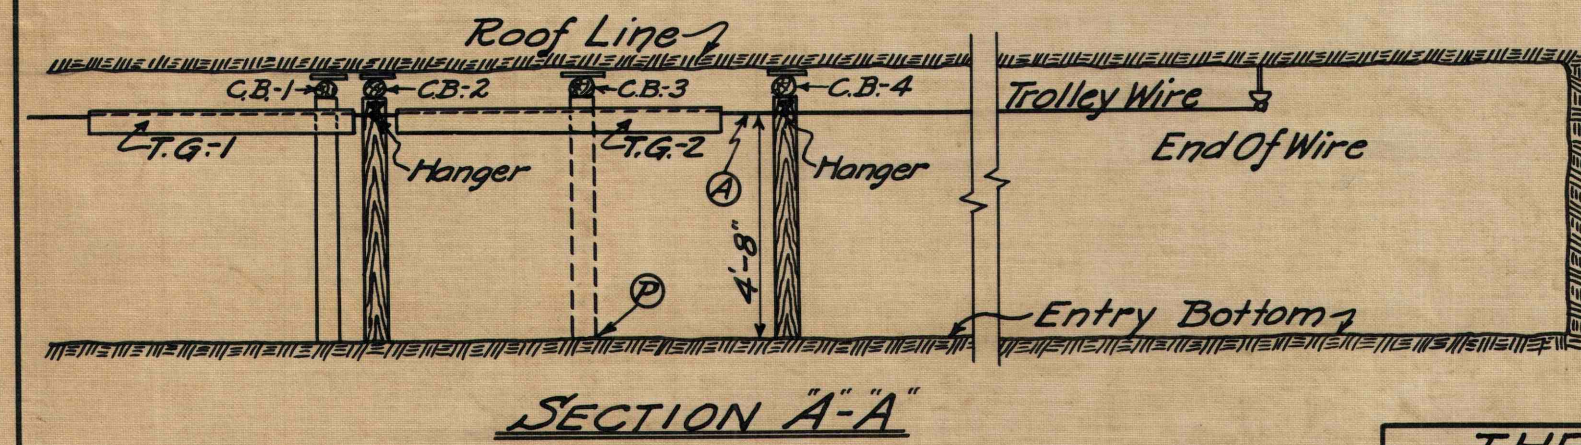
- C.B.-1 New Cross Bar Placed By T. O'Savage & Buddy Andy Sovich.
- C.B.-2 & C.B.-4 Old Crossbars Placed When Entry Was Driven.
- C.B.-3 Proposed New Crossbar Being Placed By O'Savage & Buddy 9/18/35.
- T.G.-1 & T.G.-2 = Temporary Guard Boards Placed Over Trolley Wire.
- (P) Where Preparations Were Being Made To Set Post For Crossbar Leg.
- (A) Where Tony O'Savage Came In Contact With Trolley Wire.
