Accident - Fatal - Mar. 14, 1939, 8:00 P.M.
Victim - John Marish, Check No 204,
Age 53, Married, 2 children under 18 years.

THE VESTA COAL CO. CALIFORNIA, PA.	
MINE No 6. PLAN AT LOCATION OF FATAL ACCIDENT - JOHN MARISH	
DR. H.E.	DATE: MAR. 15, '39
TR. " MRW.	SCALE 1"=10'
C-873

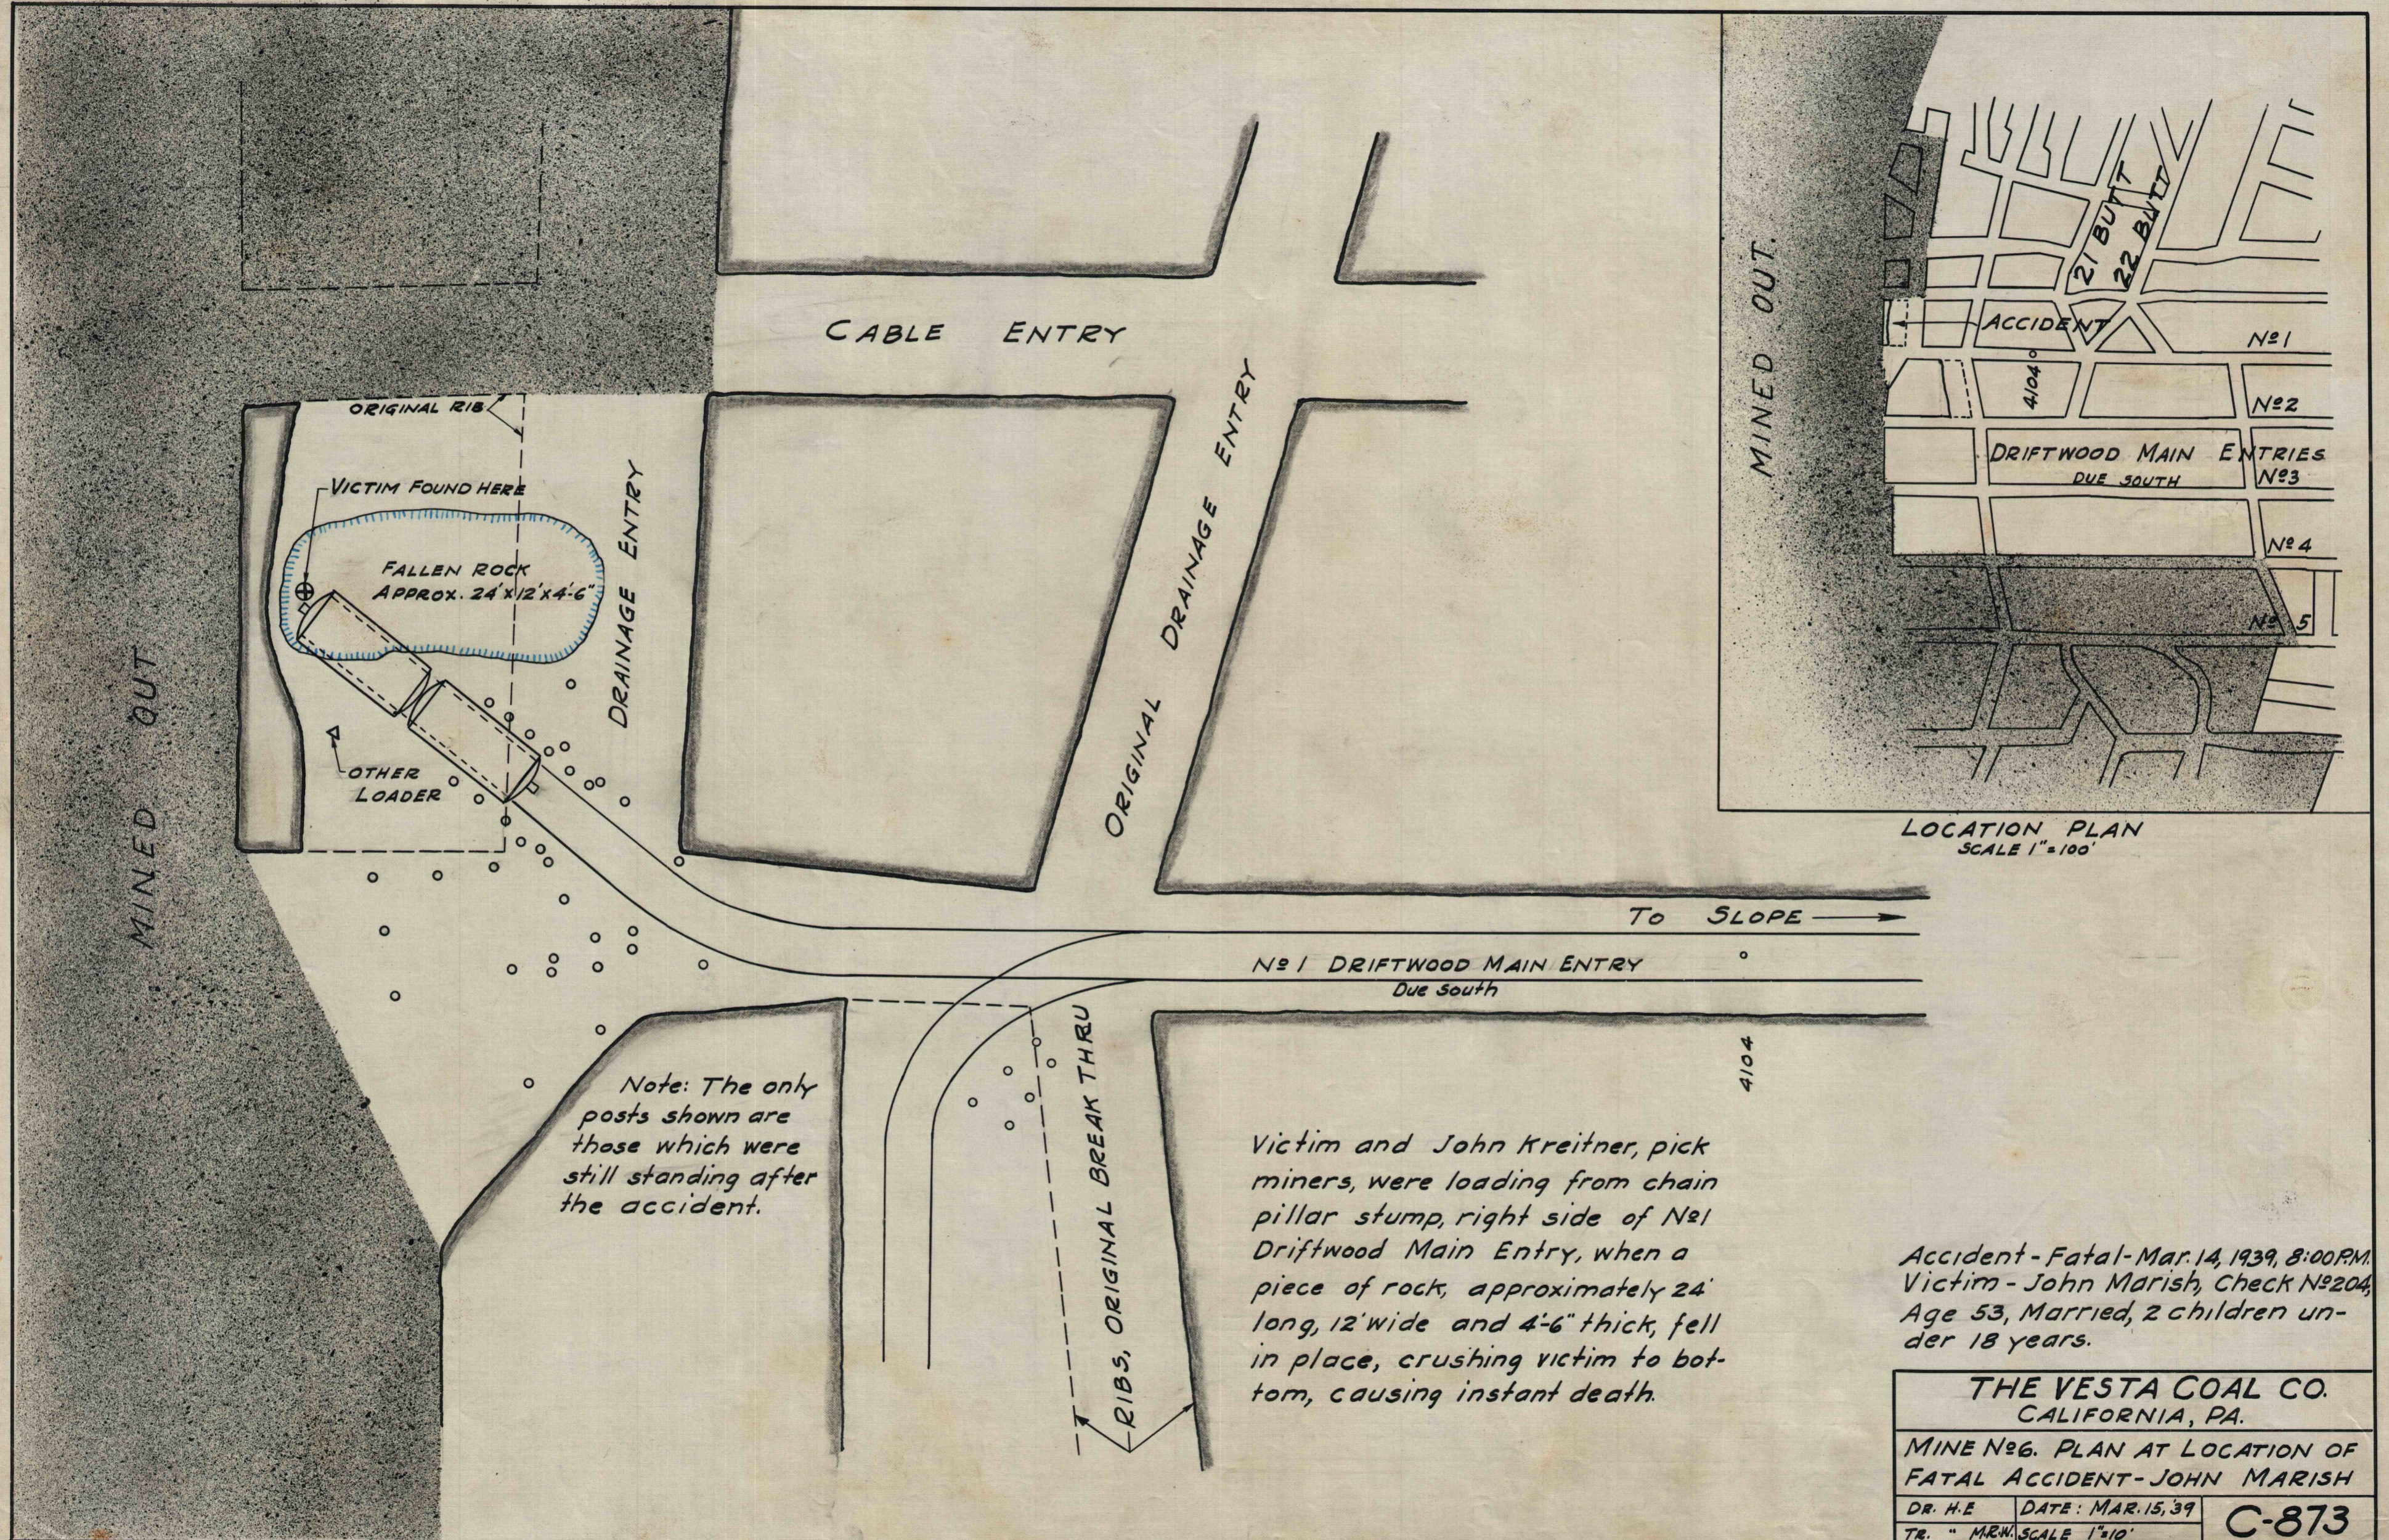
Note: The only posts shown are those which were still standing after the accident.

Victim and John Kreitner, pick miners, were loading from chain pillar stump, right side of No 1 Driftwood Main Entry, when a piece of rock, approximately 24' long, 12' wide and 4-6" thick, fell in place, crushing victim to bottom, causing instant death.
