Joe Buchan, Age 45, Married. Pick Loader - Check No 506. Injured Thursday Nov. 15-'34 - 12.30 pm. Died Saturday Nov. 17-'34 - 8.00 a.m.

THE VESTA COAL CO.
CALIFORNIA, PA.
MINE No 6 Plan Of Mine At Location Of Joe Buchan Accident In "O" Face Barrier Pillar

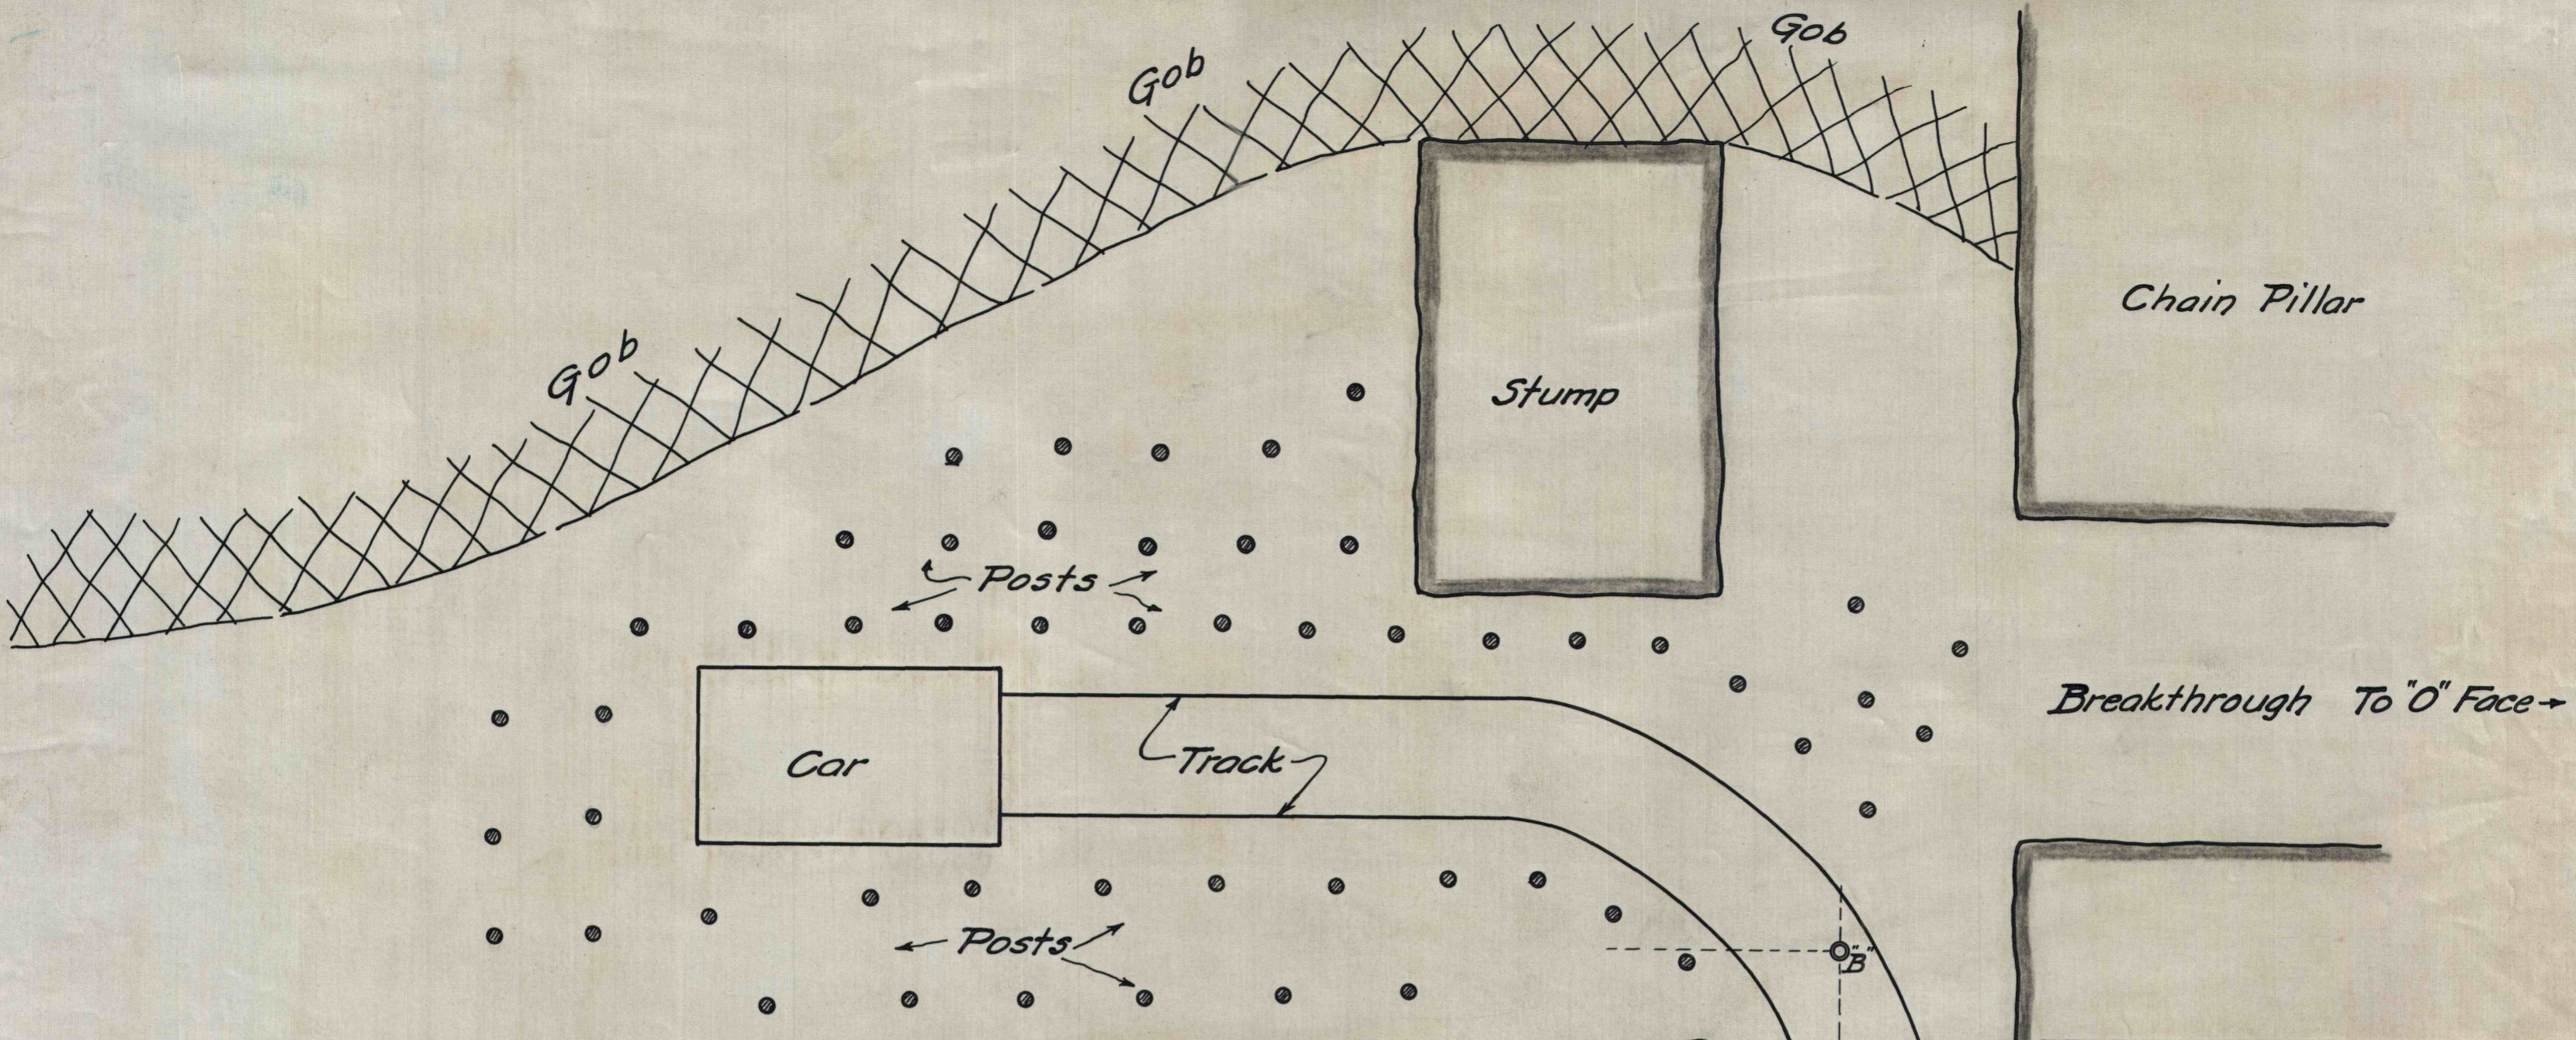
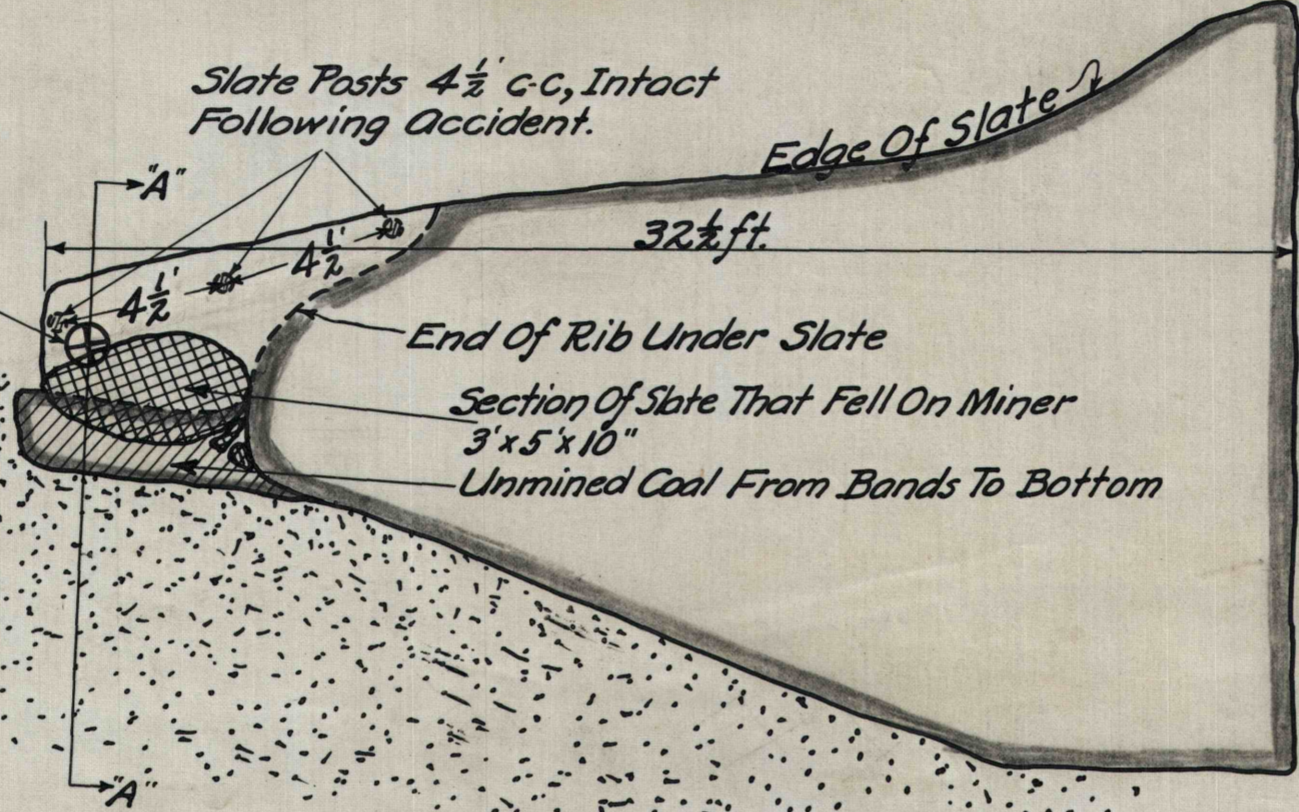
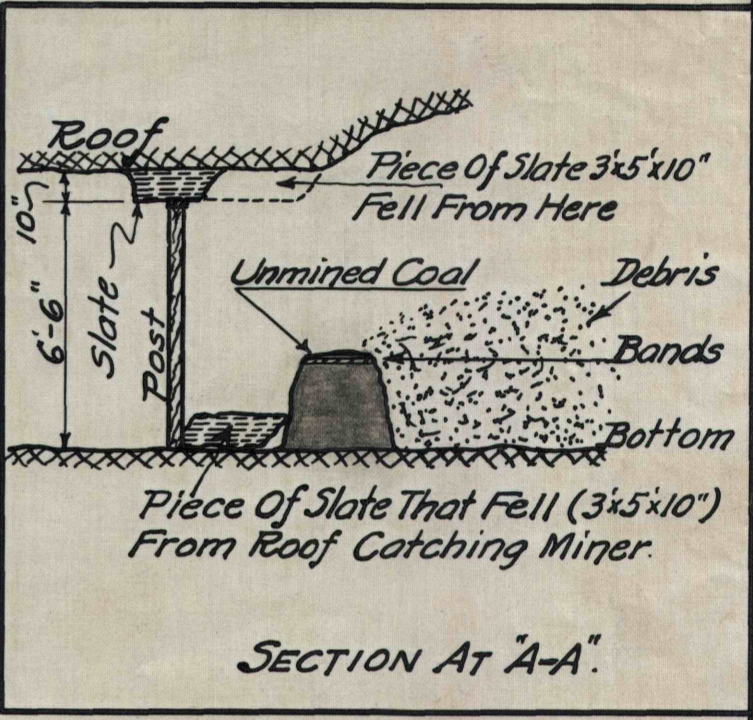
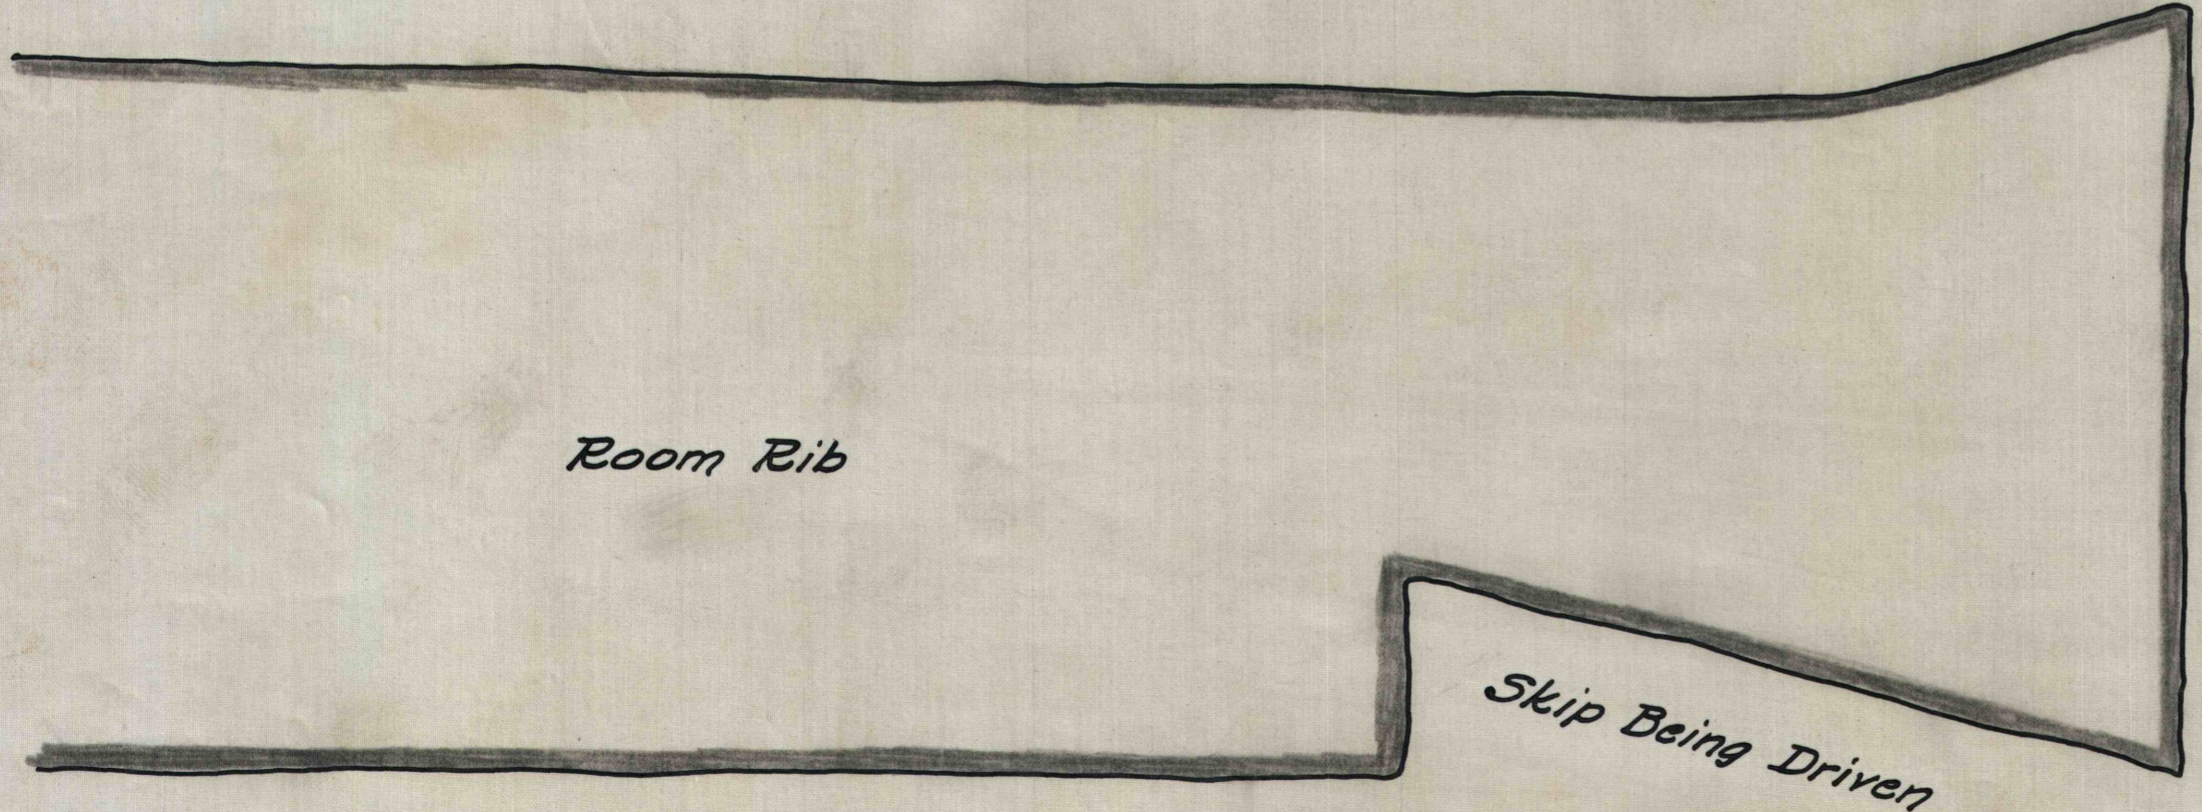
DR. E.E. Nov. 19-1934
TR. E.R.B. Scale 1" = 5'-0" **B-810**

⊕ Indicates Spot Where Victim Was Caught By Slate Fall, Being Pinned Down With Right Side On Bottom, Back To Slate Post And Feet Toward "O" Face Air Course

Slate Posts 4 1/2' c-c, Intact Following Accident.

Mixture Of Dirt Coal Rock, Slate etc.

Rib Was Being Taken Out By Two Men From This Room Until Roof Became Dangerously Bad. They Were Then Moved To Back Place To Assist The Two Men Who Were Working The Same Rib From The Opposite Side.

Butt Room Through Barrier Pillar - Fallen
